Kees d'Angremond

From Disaster to Delta Project: The Storm Flood of 1953

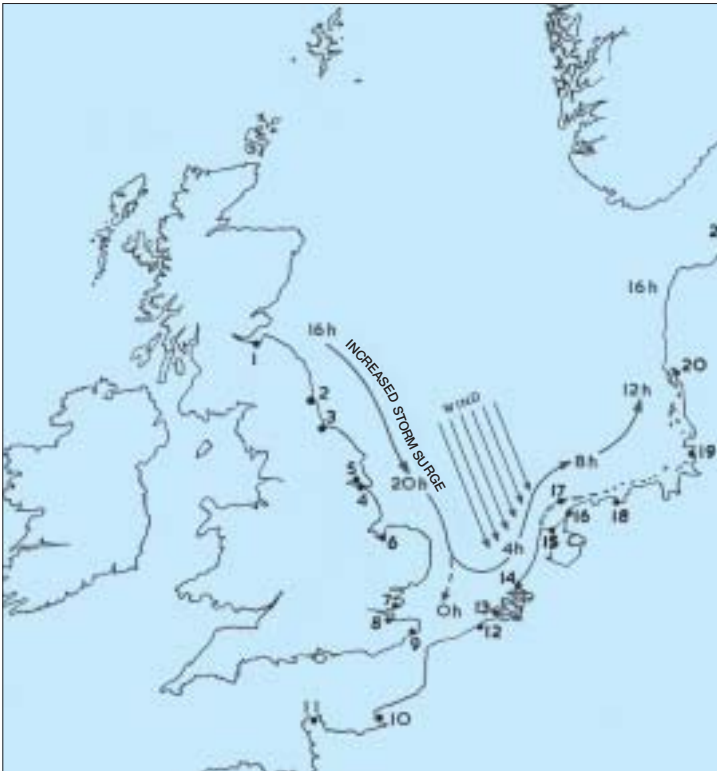
Figure 1. The path of the tidal wave into the southern North Sea with the times of high water (HW) indicated.

The path of the disastrous tidal wave into the southern North Sea with the times of high water (HW) is indicated in Figure 1. The resulting surge (set-up above the astronomical HW) along the coast of the southern North Sea is given in Figure 2, starting at the left-hand side with the coast of the UK from N to S, then across the Channel, the French and Belgian coasts to the Netherlands, ending on the right-hand side in Denmark. The draining effect of the Channel can clearly be seen between the mouth of the River Thames and Flushing. Looking at this figure, it is no surprise that serious damage to the sea defenses occurred in the region where the surge reached levels of 3 m [1].

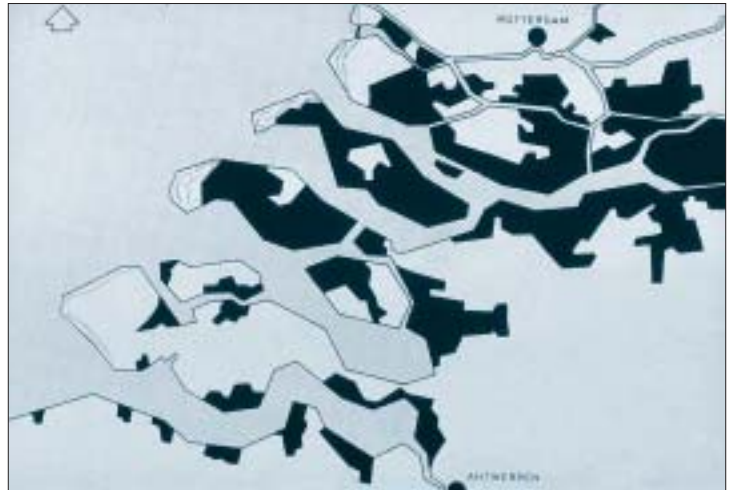
Figure 3. Areas of flooding in The Netherlands, 1953.

Only by the morning of 3rd February, a few days later, did the full scope of the disaster become clear. The extent of the flooding is shown in Figure 3. In total, 1835 people died, 200,000 cattle were lost and over 135,000 ha of fertile land were inundated.

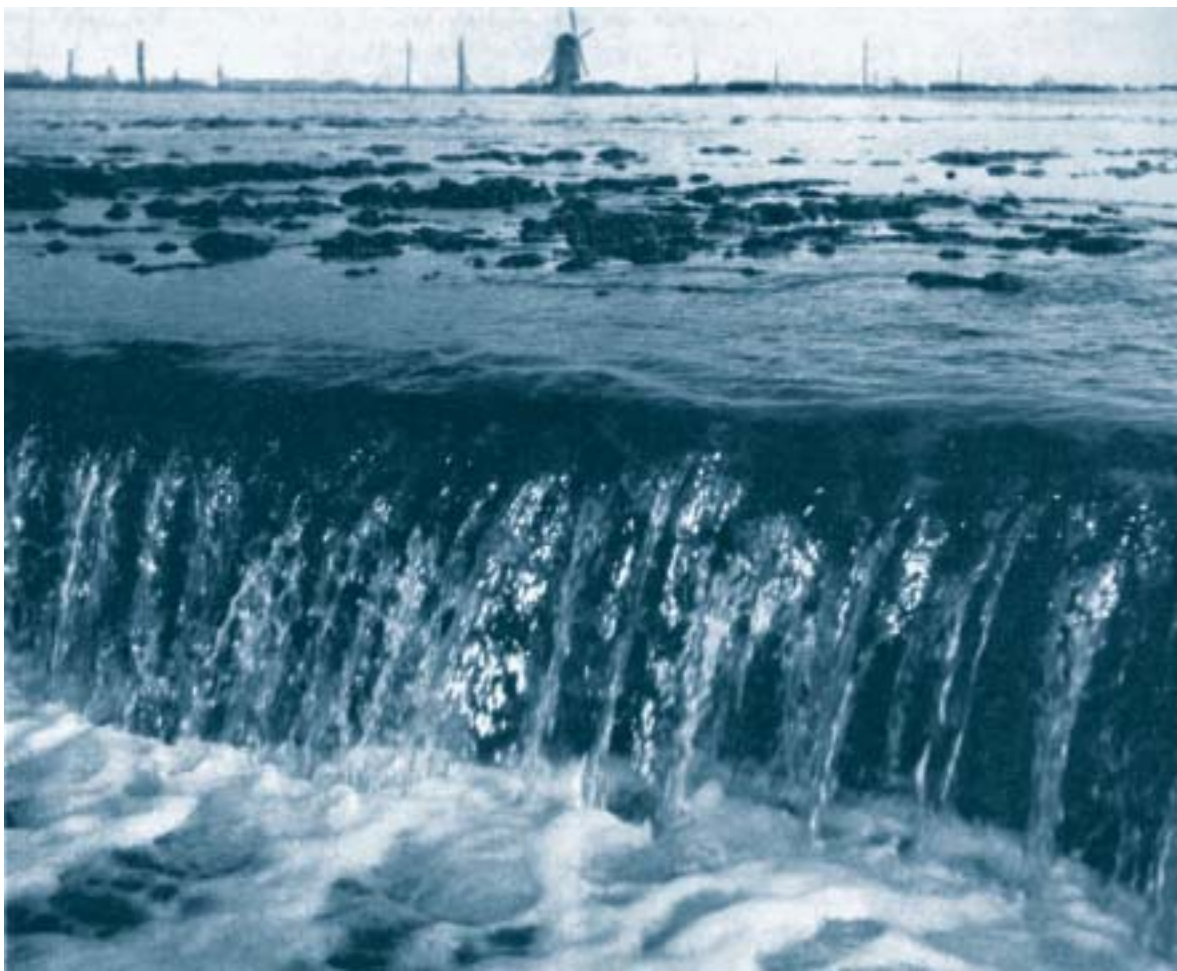
Figure 4. In some cases the streaming water through the breaches in the dikes caused deep gullies and waterfalls to form, which were difficult to close.

Some of the breaches, however, specifically in the dikes around the Island of Schouwen Duiveland, had grown into deep gullies by backward erosion owing to the in- and outgoing tidal currents (Figure 4). These gaps could not be closed by traditional means. Fortunately, some experience had been gained in 1945, when similar gaps in the dike around the Island of Walcheren had to be closed following the bombing by the RAF for the opening of the Port of Antwerp during World War II. At that time, several caissons constructed for the artificial port of Arromanches were used to block the gaps. The famous novel by Den Doolaard gives an accurate account of the earlier experience [3]. Some of these Phoenix caissons were still available in the UK in 1953. They were towed to the Netherlands, and along

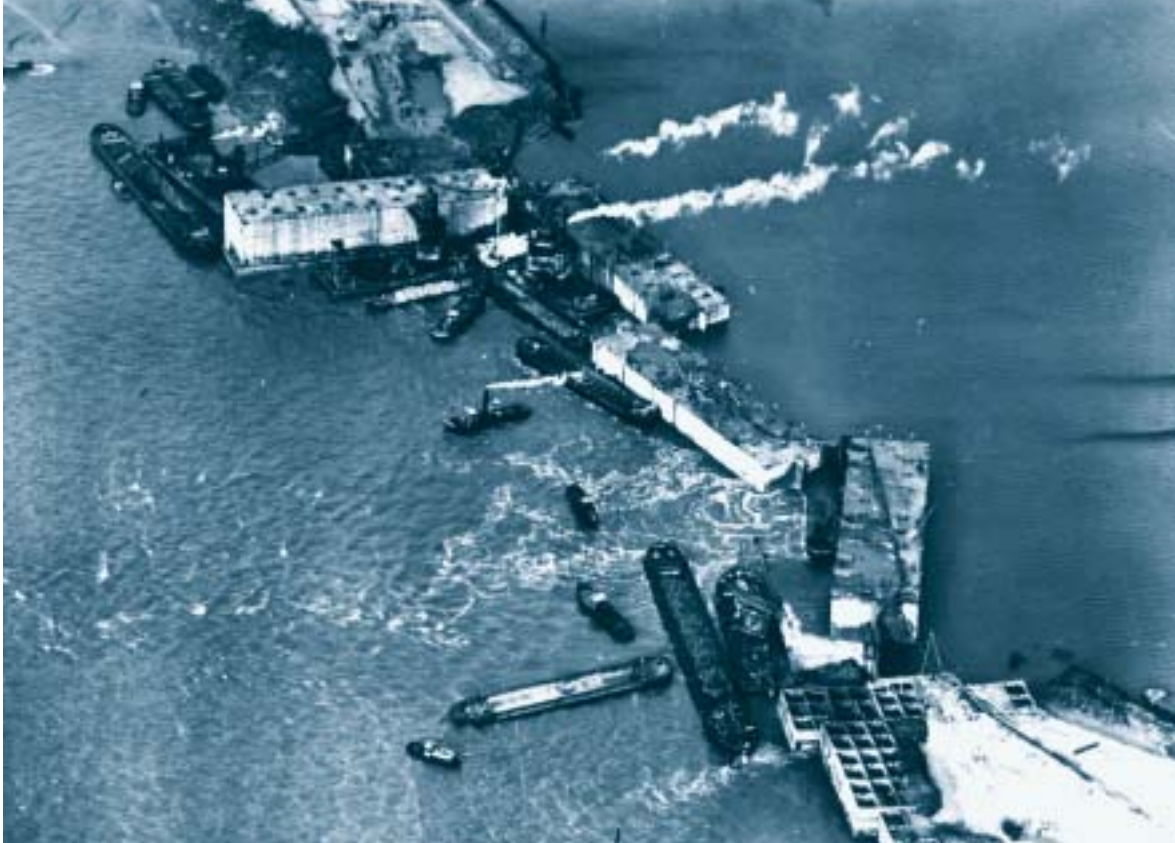
Figure 5. Caissons being used to close the gap at Ouwerkerk. The extent of the repair work was enormous.

with locally constructed smaller size caissons, they were used to block the final two gaps in Schelphoek and Ouwkerk. Figure 5 gives an impression of the scale of these repair works. The last gap at Ouwkerk was closed on November 6 and all flooded land was dry on 1st January 1954, less than a year after the flooding.

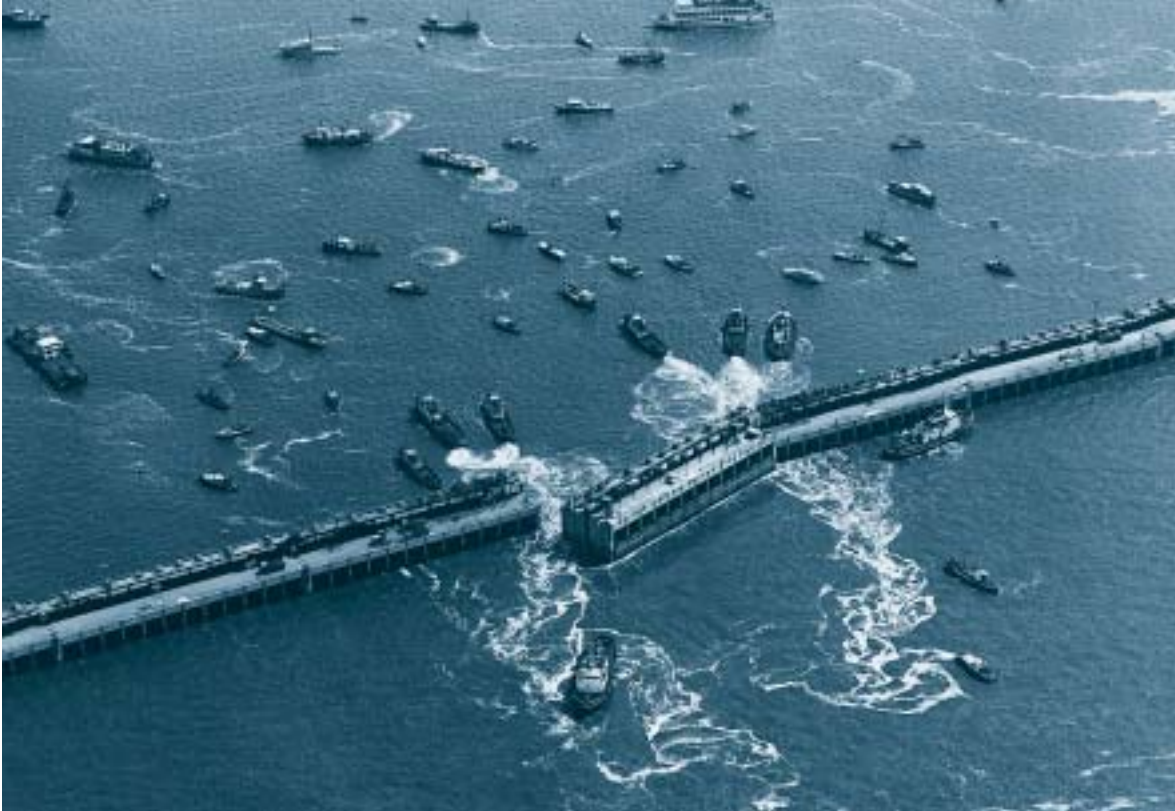
Figure 8. Concrete piers at the Oosterschelde works.

Preparation of the new design was not a task of Rijkswaterstaat alone; a design team was established with strong participation of the contractor. During the design phase, serious problems were encountered that forced the designers to make radical change several times. First, the idea of using the caissons was abandoned to make place for a design with piers cast in situ and a foundation deep in the Pleistocene deposits, with the aid of cellular rings. Construction of the piers and their foundation would take place in separate steel cofferdams. This idea was also abandoned, and eventually the choice fell on pre-fabricated concrete piers that would be placed on mattresses consisting of a granular filter (Figure 8).

In between the piers, a sill was to be constructed consisting of a sill beam and heavy quarry stone. The sill beam would be the lower support for the steel gates that would move in between the piers. In total, 66 piers had to be placed with a heart-to-heart distance of 45 m, distributed over 3 main channels, thus forming 63 openings. The soil, consisting of loosely packed, fine sand had to be densified before the foundation mattresses could be placed. Accuracy was essential while working under extremely difficult conditions in

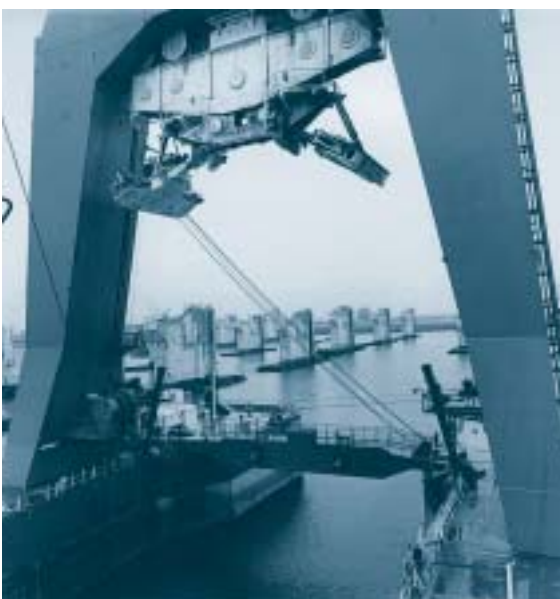
Figure 9. One of the spin-offs of the Delta Project: discharge caissons at the Oosterschelde, being built in 1976.

- Quantitative insight in scour
- Extensive study of wave impact forces
- Large-scale application of geotextile and asphalt mats for scour protection
- Closure of tidal channels by dumping material from cable cars
- Application of geocontainers
- Use of discharge caissons (Figure 9)
- Large-scale use of asphalt and sand asphalt for slope protection instead of labour-intensive stone revetments
- High capacity dredging of sand;
- Extensive use of pre-stressed concrete in the marine environment
- Compaction of sand by vibration to a depth of NAP -60 m
- Placement of foundation mattresses consisting of 3 layers of granular material

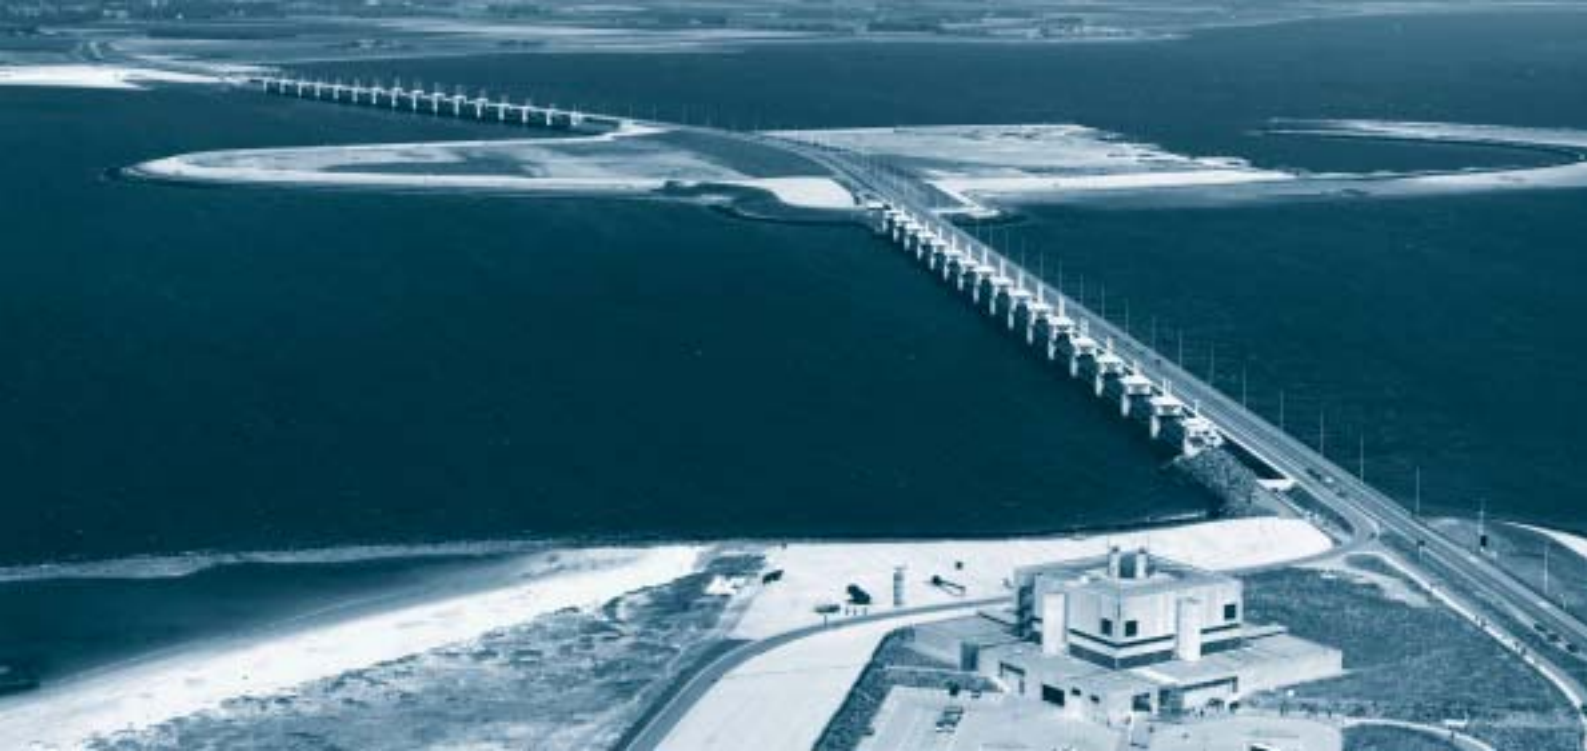
Figure 10. Aerial view of the completed Oosterschelde Storm-Surge Barrier.
