BREAKWATER REHABILITATION PROJECT AT THE PORT OF POTI, GEORGIA

ABSTRACT

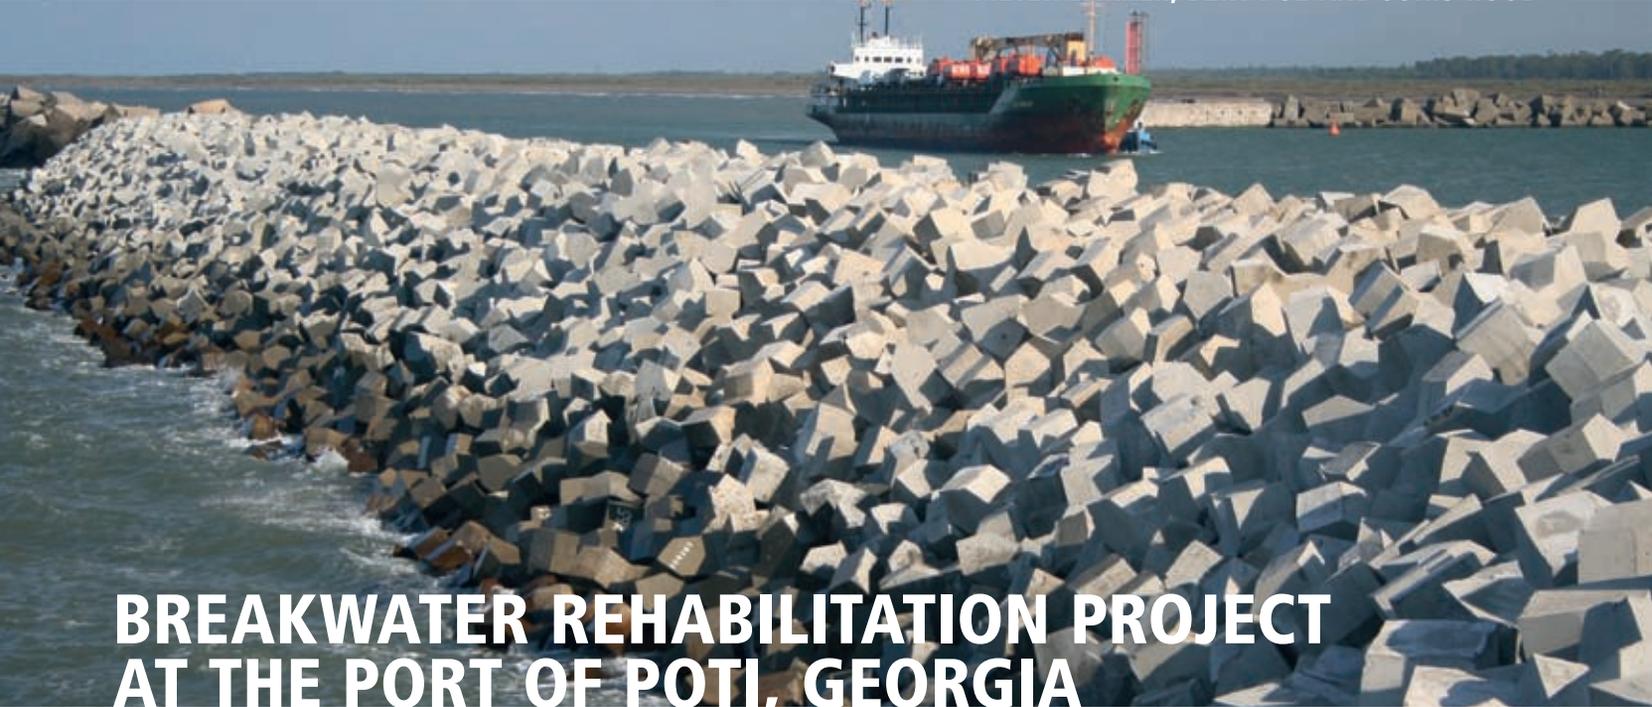
Above: At the Port of Poti, Georgia, located on the eastern coast of the Black Sea, the old breakwater was in disrepair. An economical and sustainable solution was found to be the use of the Xbloc® and Xbase® armour units seen here for the rehabilitation.

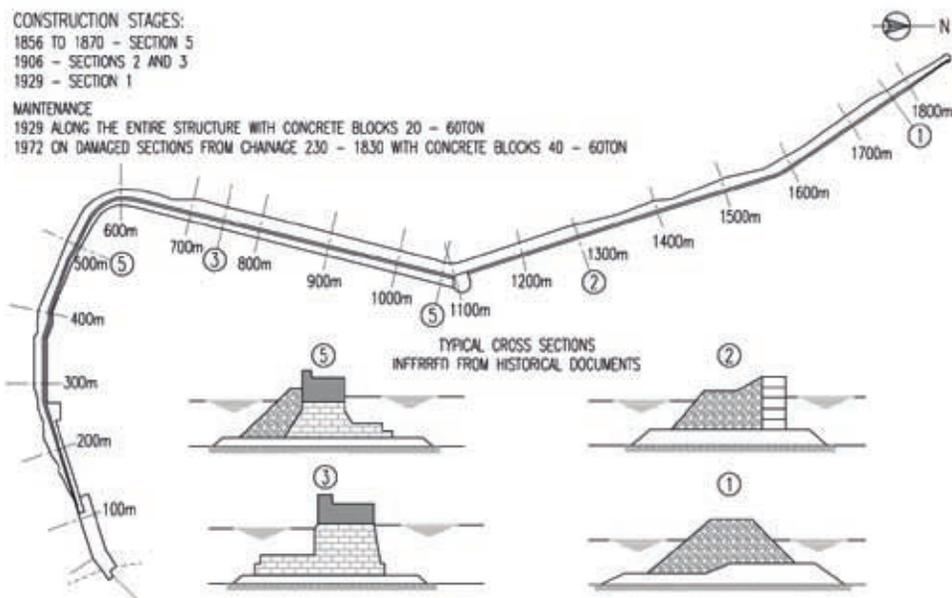
Figure 1. Historical overview of construction stages of the existing old cube breakwater.

Built in multiple phases with various cross sections between 1856 and 1929 (Figure 1), this main breakwater has endured because of a history of continual maintenance. 20 to 60 tonnes of concrete cubes have frequently been added to the armour layer of the structure. Still, as a result of significant settlement of the structure over time, the crest level has been reduced considerably. This has resulted in large overtopping volumes which then cause an inordinate amount of down-time for port operations. Consequently, the port authority decided to undertake a rehabilitation project. This project, executed between 2006 and 2008 by Royal Boskalis Westminster nv, aims

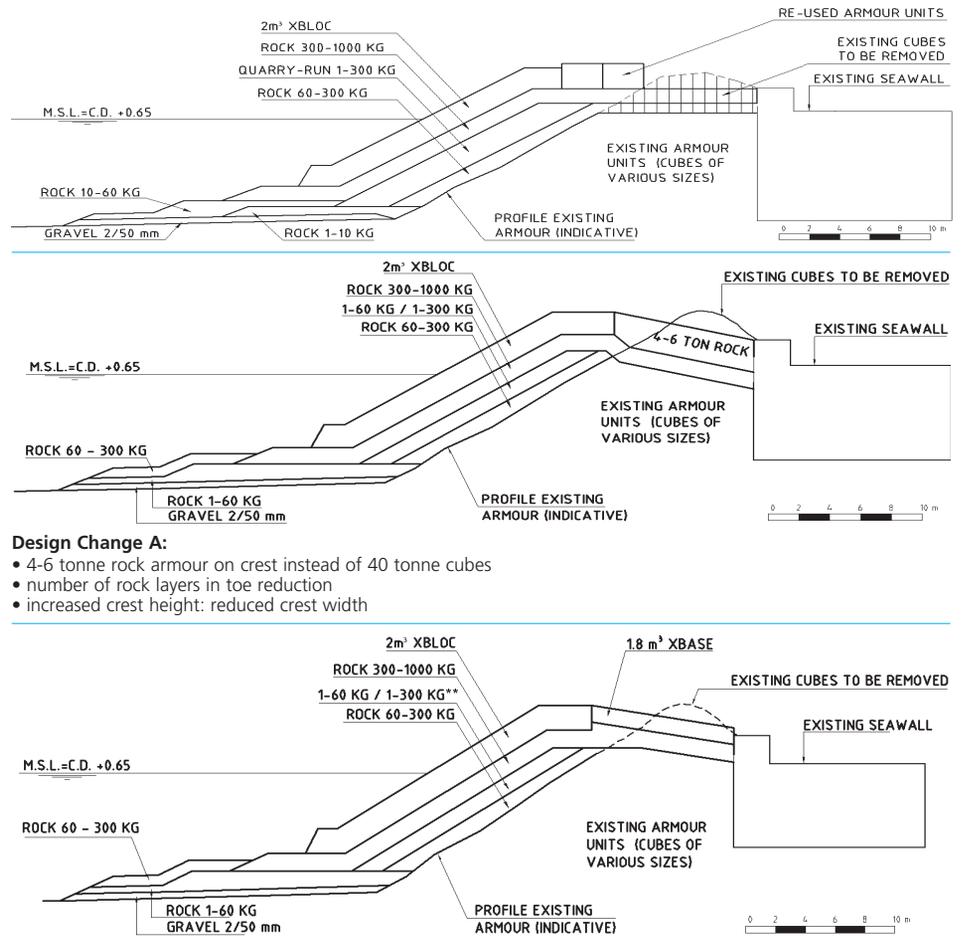
Design Change A:

- 4-6 tonne rock armour on crest instead of 40 tonne cubes
- number of rock layers in toe reduction
- increased crest height: reduced crest width

Design Change B:

- Xbase Units instead of 4-6 tonne rock armour on crest

Figure 2. Development of the cross section: Top, original plan and below, design change A and design change B.

During the detailed design and preparation for the construction rehabilitation, three different design solutions were developed to protect the low and wide crest of the breakwater as shown in Figure 2.

Consequently, a new design was model tested with large 4 to 6 tonne rocks on the breakwater crest (Design Change A, Figure 2). Although this solution was stable under the design and overload cases that were tested, during the production of the different rock gradings at the quarry it became apparent that the required quantity of 4 to 6 tonne rock was insufficient and a third design was made.

This third design consisted of a crest protection made of 1.8 m³ Xbase® units instead of Xbloc® units (Design Change B, Figure 2).

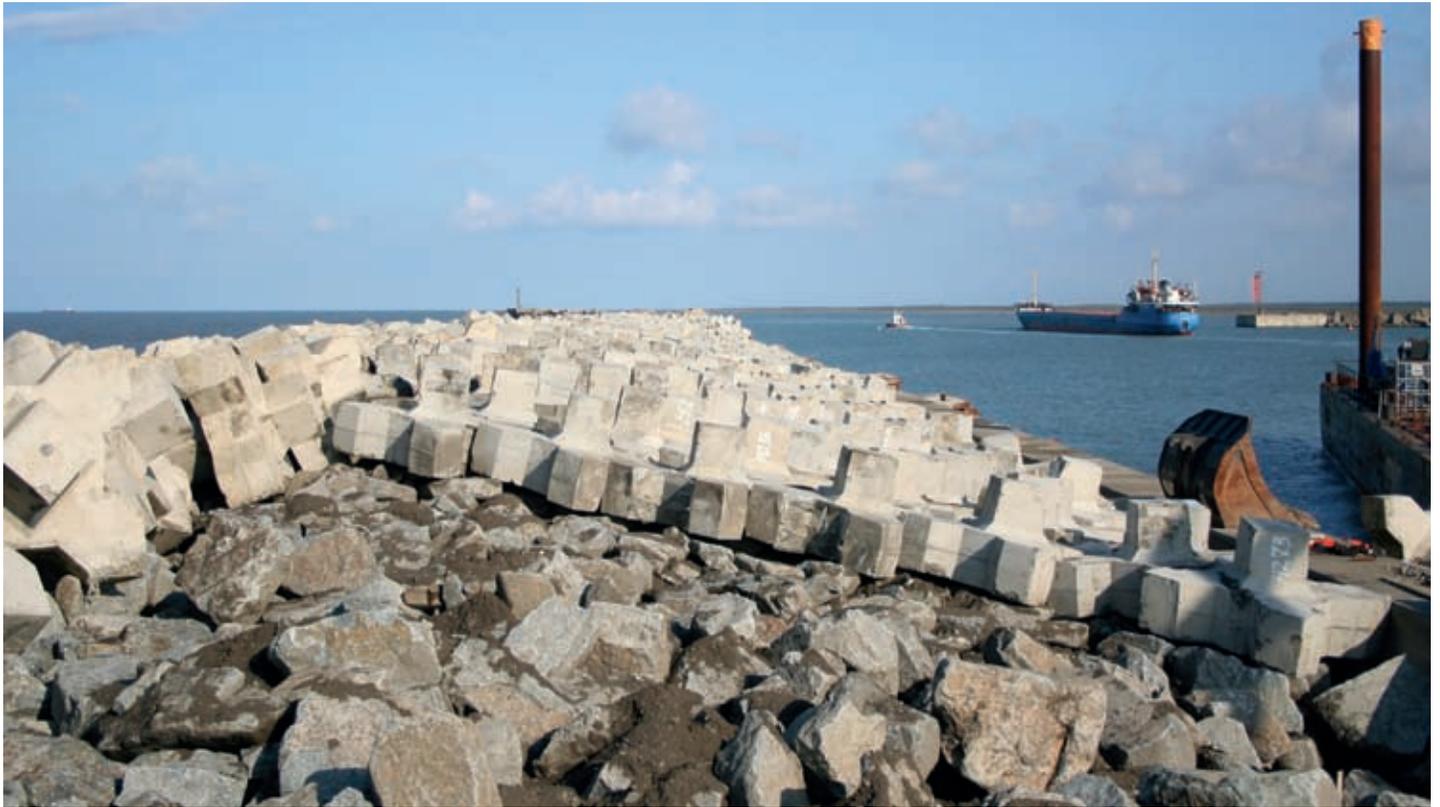
Figure 3. Xbase® layer on the crest of the breakwater.

The 1.8 m³ Xbases® were cast in the same formwork as those used for production of the 2 m³ Xblocs®. One of the “noses” in the Xbloc® moulds was simply closed off. The design with Xbase® units on the crest was model tested in March 2007 and was found to be stable under all design and overload tests (wave height varying between H_s = 2.6 m and H_s = 5.3 m; 14 test series with durations of 3 hours in prototype scale). No notable rocking movements or settlements of the Xbase® layer were found (Figure 3).

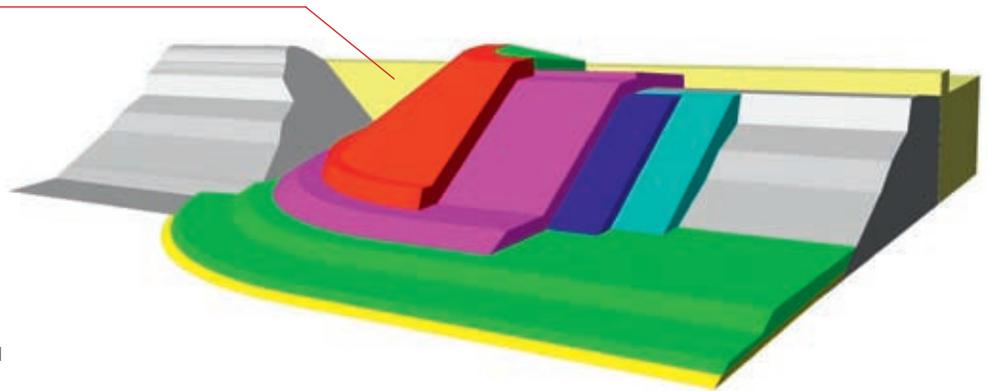
Wedge of cubes removed by hammering; filled after construction with Xblocs® to reduce wave forces on wall.

Figure 4. One quarter (¼) circle roundhead at transition with existing cubes.

Other options were considered including using heavy in-situ filled grout bags. Ultimately the decision was taken to create a ¼ circle roundhead against the existing wall structure and lock in the Xblocs® firmly against this wall (Figure 4). Following placement of the Xbloc® roundhead, the remaining wedge is filled completely with Xblocs® thus reducing the impulsive wave forces on the wall.

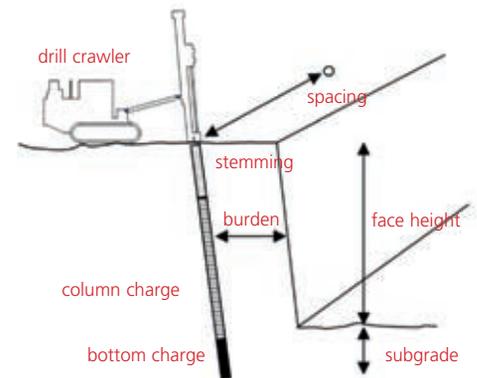
Figure 5. Sketch of the blasting set-up.

reduced column diameter so that the explosive ratio was reduced). The drill hole diameter was 89 mm. The results of the drilling and blasting parameters were monitored in order to adjust the blast geometry and to obtain the optimum yield throughout the quarry operations (Figure 5). Applying loosely poured ANFO (ammonium nitrate/fuel oil) commonly used for blasting was not an option as the drill holes contained water. Although the water could be blown out of the hole with air, the water returned before the round of explosives could be fired. Instead Gelignite (primed with a millisecond delay non-electric detonator) was placed in the drill hole.

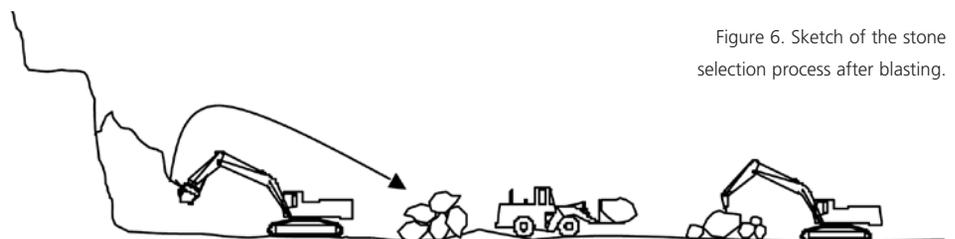
Figure 6. Sketch of the stone selection process after blasting.

Stones from the blast pile that were bigger than required (and consequently too big to handle) were left at the face. When the major of rock was removed and the cleaning of the face was begun, small holes were drilled into these large stones and measured amounts of explosives were inserted to break the stones into 2 or 3 pieces. Inspection of the quality of these armour stones occurred at the face. Flat or elongated stones (with a ratio of $L/d > 3.0$) were placed aside and using a hydraulic excavator with a break hammer the stones were broken into pieces to improve their shape. These stones were then placed in the appropriate stockpile (Figure 6).

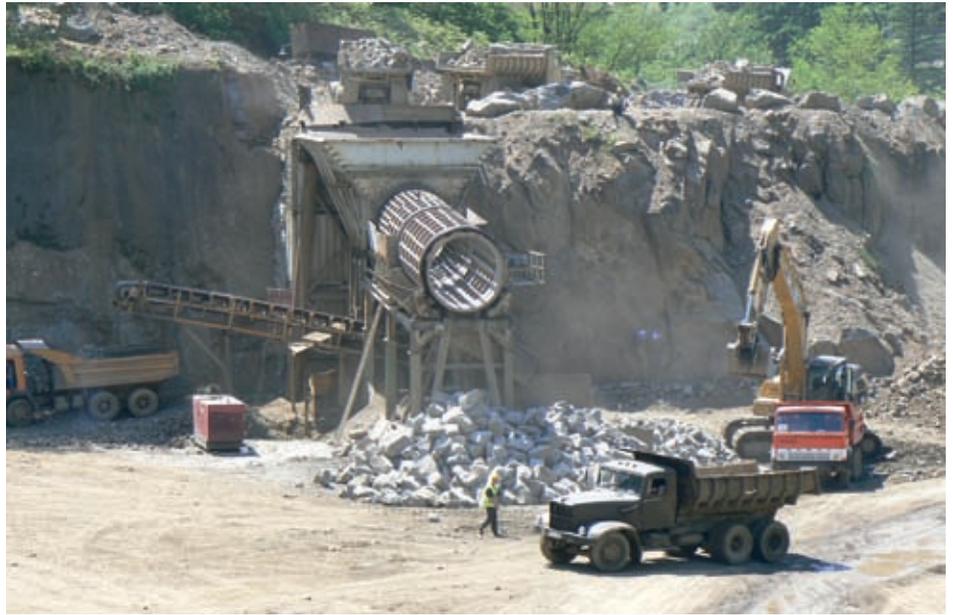
Figure 7. The Drum Screen, the crane and the dump truck.

After removing the larger stones, the remaining stones were loaded into dump trucks and hauled to the selection plants. A drum screen was used for the major quantity of the rock selection, i.e. producing 0-1 kg, 1-60 kg, 60-300 kg and 300-1,000 kg. The separated material fell into separated sections and a wheel loader then loaded the materials onto the road trucks travelling to the various graded stockpiles on the stockpile area (Figures 7 and 8).

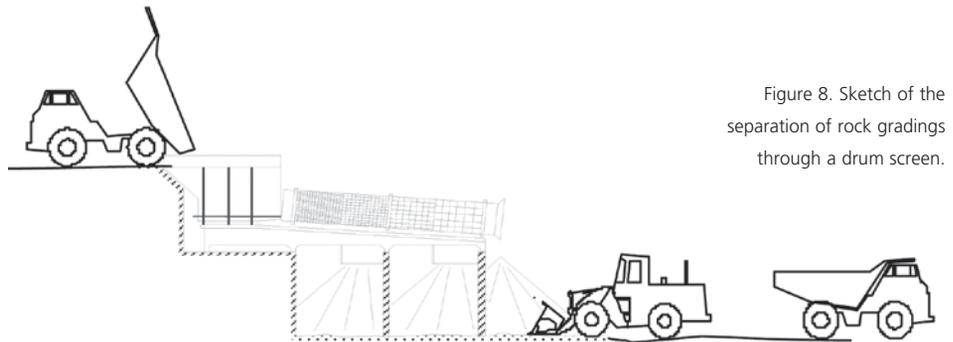
Figure 8. Sketch of the separation of rock gradings through a drum screen.

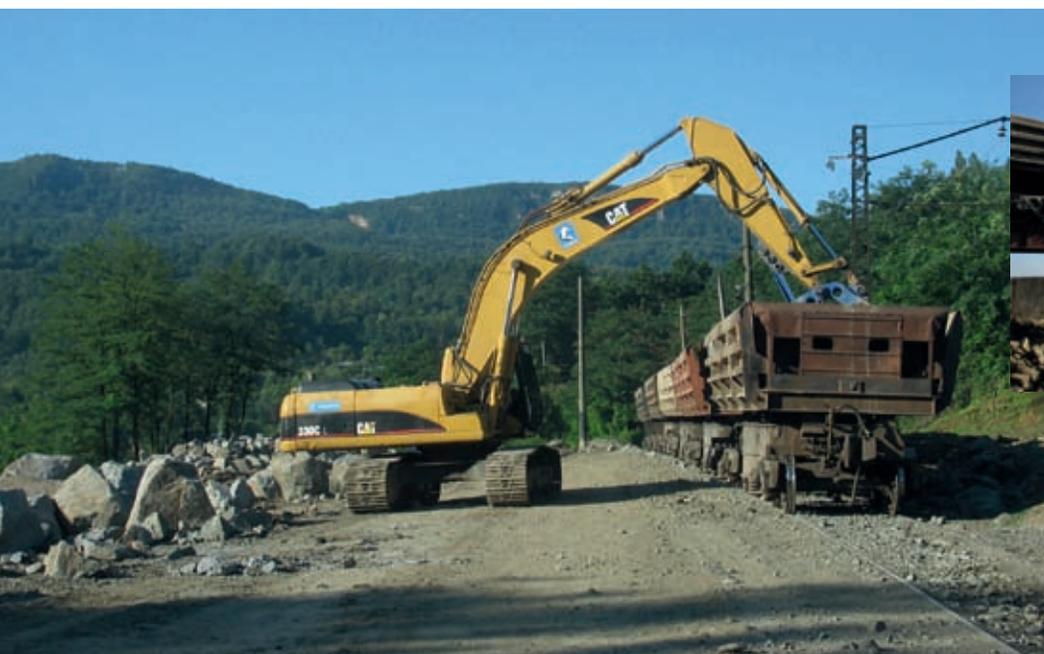
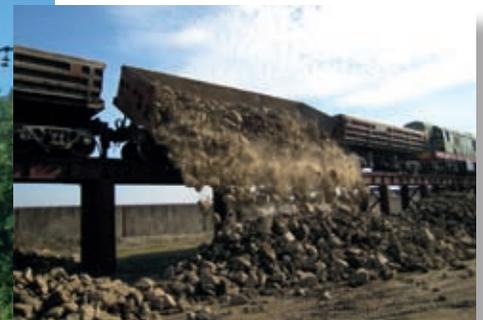
Figure 9. Loading (left) and unloading (right) of rock from the railway transport wagons.

dumped, the rock was loaded onto trucks of 6 to 10 m³, which hauled the rock on the purpose-built construction road towards the stockpile area in the vicinity of the port (Figure 9).

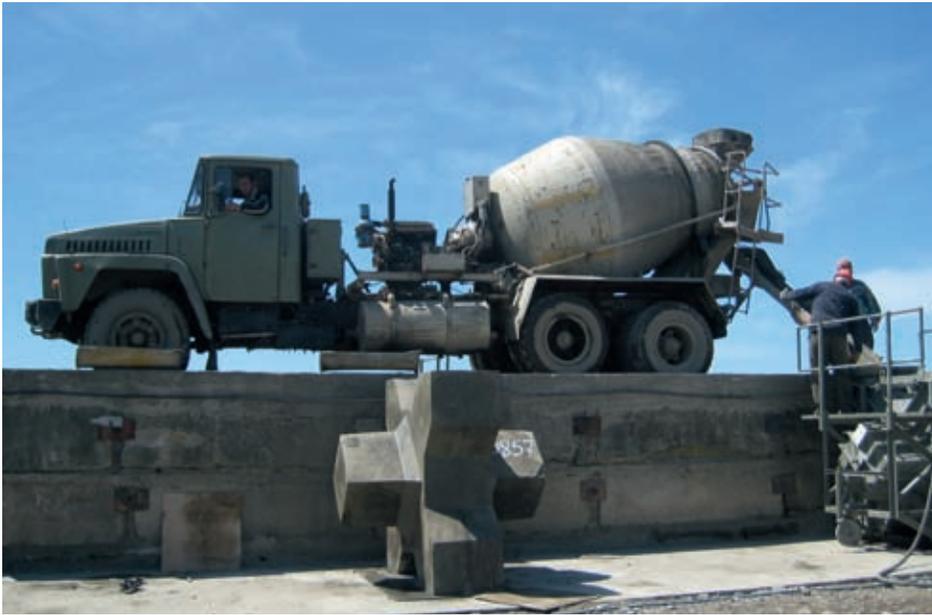
Figure 10. Xblocs® being poured from concrete mixing truck.

Using 30 steel Xbloc® moulds that were produced in the Netherlands and transported to Georgia by road, the Xblocs® were cast on site. The moulds were filled directly from concrete mixing trucks, which reached the moulds by means of an elevated roadway. The trucks were filled under a batching plant at close distance from the production site. The moulds consist of two identical mould halves, so that each mould half could be connected to the other mould half. This optimised the production cycle because two adjacent mould halves could be

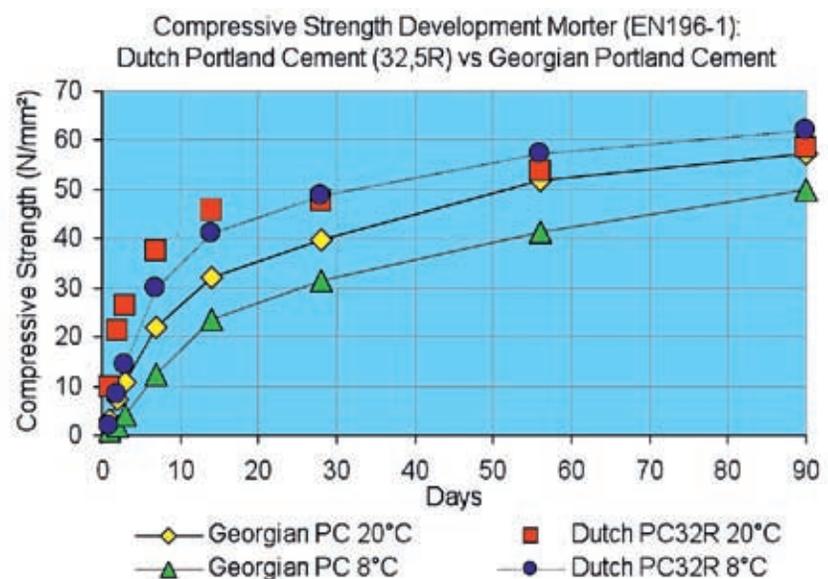
Figure 11. Compressive Strength at 8°C and 20°C.

In addition, the compressive strength development of the cement was tested over a 90-day period at temperatures of 20°C and 8°C (Figure 11). These results were compared to the strength development of more standard type Dutch cement at the same temperatures. The test results indicated that the strength development of the Georgian cement, especially at low temperatures, was indeed slow, but that the strength increased significantly between 28 days and 90 days.

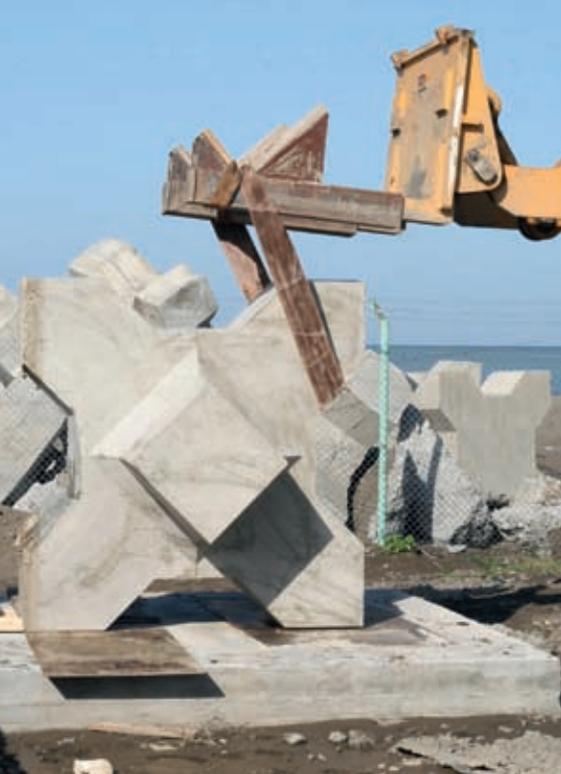
Figure 12. Set-up for the drop tests.

To test the robustness of these units, several units were subjected to drop tests on a solid concrete floor covered by a steel plate (Figure 12). Although the drop tests were done with units that were considered to be the more severe units, no damage was caused by the drop tests in which units were dropped on a leg with fall heights increasing in increments of 5 cm, up to a fall height of 50 cm. Other units were rolled over 25 times.

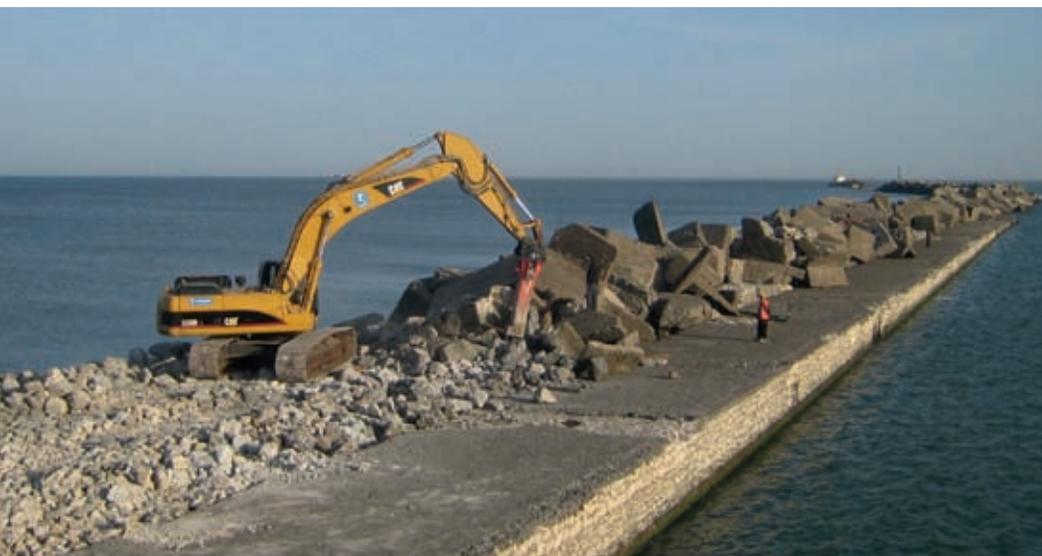
Figure 13. Destruction of the old blocks in a controlled manner using hydraulic hammers.

To create a platform for the new construction, first some 8,200 cubic metres of old concrete cubes had to be removed. The average weight of the cubes was approximately 60 tonne per piece and they were of varying quality. Lifting these cubes was considered a potentially unsafe operation, and a safer solution was found which consisted of destroying the blocks in a controlled manner using hydraulic hammers. Rammer 100s hammers mounted on a CAT330 and a CAT375 long reach excavators were used. The hammers with a working weight of 4 tonne were equipped with pointed chisels of 10-cm in diameter (Figure 13).

When the first machinery entered the breakwater, the first job was to create a working space by hammering a path through the cubes. The hammers of the excavators were aimed perpendicular to the cubes surfaces to constantly break the cubes into smaller pieces, e.g., concrete fragments of approximately half a metre. As the excavators moved over the hammered material they broke these into even smaller pieces. The resulting material was not removed but simply fell into the voids between the remaining cubes. The cubes above a level of one metre CD were removed in this way at an average rate of 400 m³ per 24 hours.

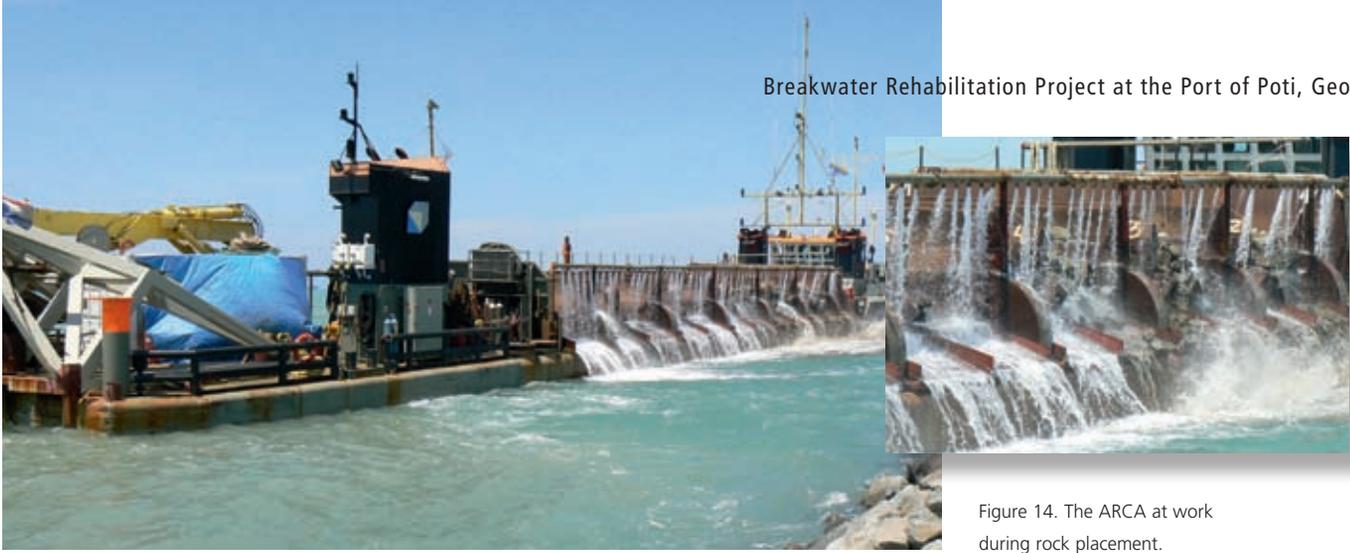
Figure 14. The ARCA at work during rock placement.

- 1) with land-based machinery; and
- 2) with the SSDV ARCA (Figure 14).

The ARCA works with a multi conveyor-belt dumping system. The loading deck consists of six pairs of conveyor-belts which are separated by five coamings. The conveyors work perpendicular to the vessels hull. Upon arrival at the dumping site, the conveyor belts are started and the loaded material is moved from the deck into the water. A DGPS system ensures the correct position for dumping and sailing speed during the dumping. The vessel can carry 550 tonnes of rock and she did a maximum of four trips in a 12-hour working day.

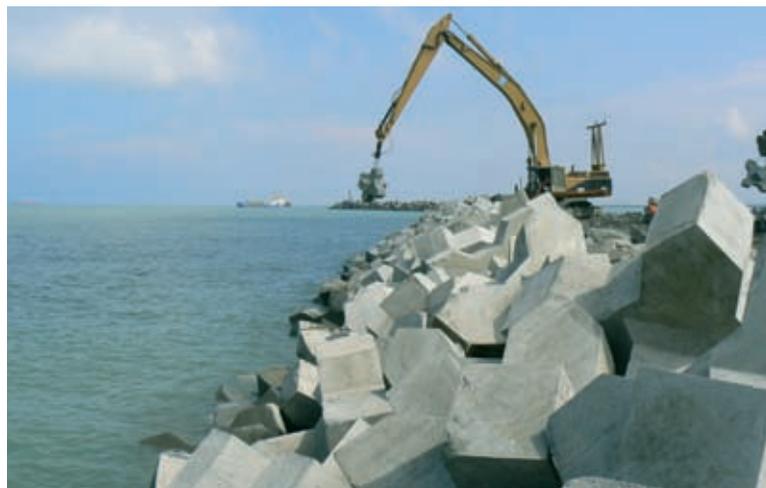
Figure 15. Xbloc® placement with the crane.

The Xblocs® were transported by barge from the storage area to the breakwater where they were unloaded by excavator and placed with the CAT375 long boom excavator equipped with the Boskalis Crane Monitoring System (CMA). This system enables the crane operator to know the position of the boom and accurately release the units at their predefined location (Figure 15).
