Ennore Breakwater Construction

ECPP/C4 BREAKWATER CONSTRUCTION

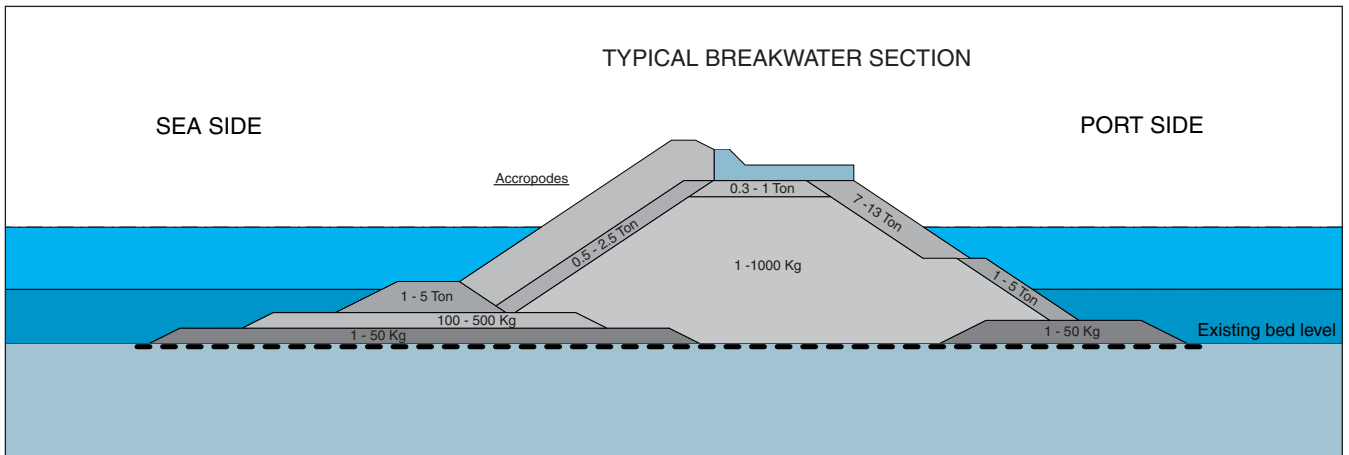
Figure 1. A cross-section of a typical breakwater.

The main features of the port consist of a Northern Breakwater with a length of approx. 3200 m and a Southern Breakwater with a length of approx. 1300 m, distanced approx. 2500 m, thus creating a harbour basin of approx. 2500 x 1500 m² to be dredged at a depth of -15.50 m, with an access channel to be dredged at -18.00 m (Figures 1 and 2).

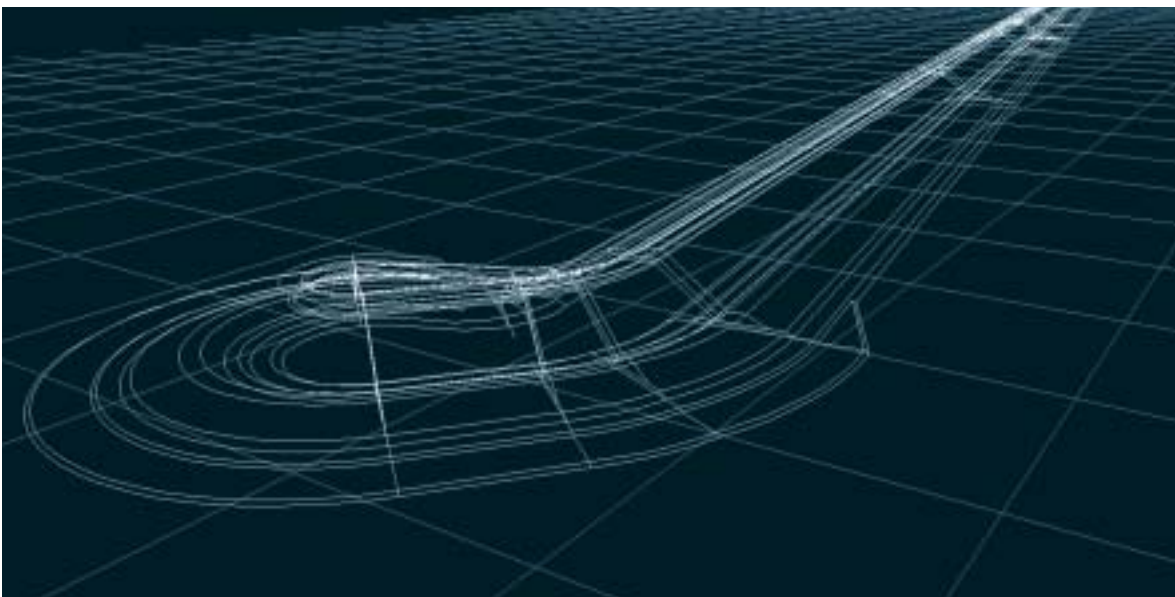
Figure 2. A three-dimensional model of the North Breakwater at Ennore.

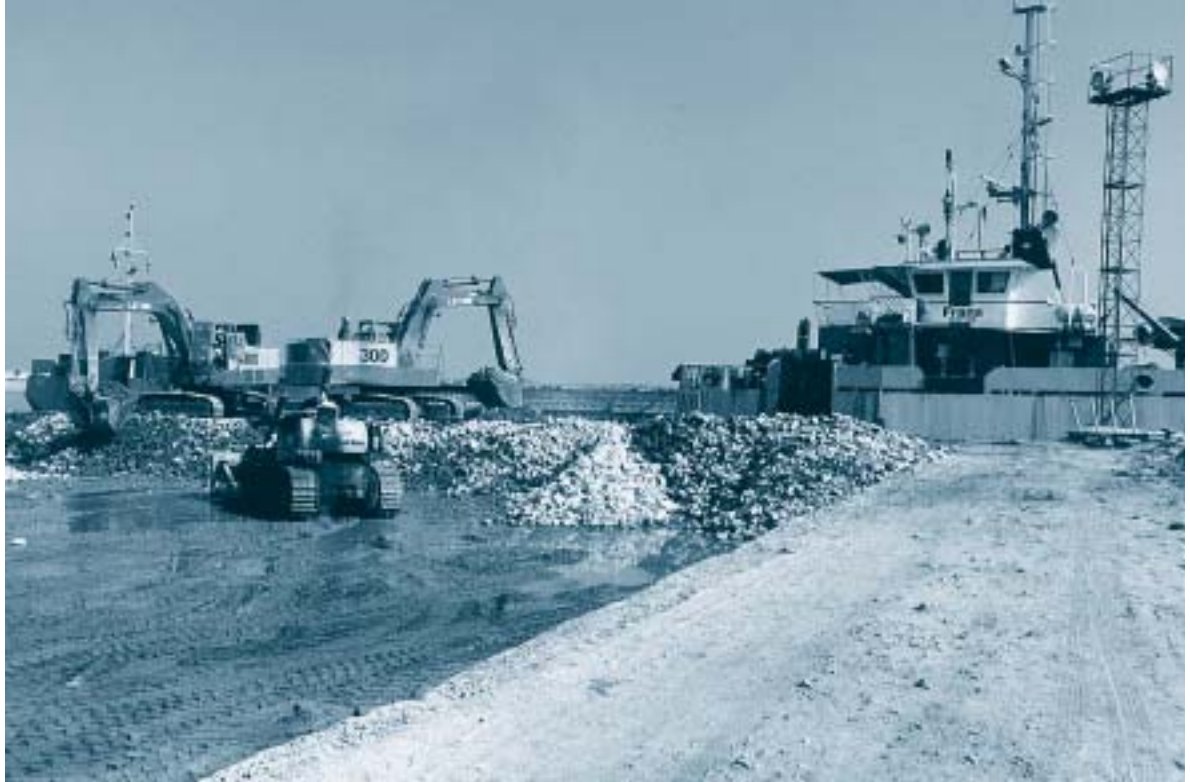
Figure 3. The side stone dumping vessel Frans being loaded at the temporary work harbour.

After the trenches of the Northern and Southern Breakwaters had been filled in and compacted, the rock-dumping operation was carried out by VOACZ up to 4 m below sealevel with the side stone dumping vessel *Frans* (Figures 3, 4 and 5). Approximately 1,250,000 tons of rock had to be placed by this method. Above the – 4.00 m CD level, HCC then took over the rock dumping with land-based equipment by back tipping method, for which they used 40 tonne dumpers (Figure 6). By this method, HCC completed the breakwaters by dumping the remaining core and placing the armour layers, accropodes and concrete capping. In total over 2,500,000 tons of rock had to be placed.

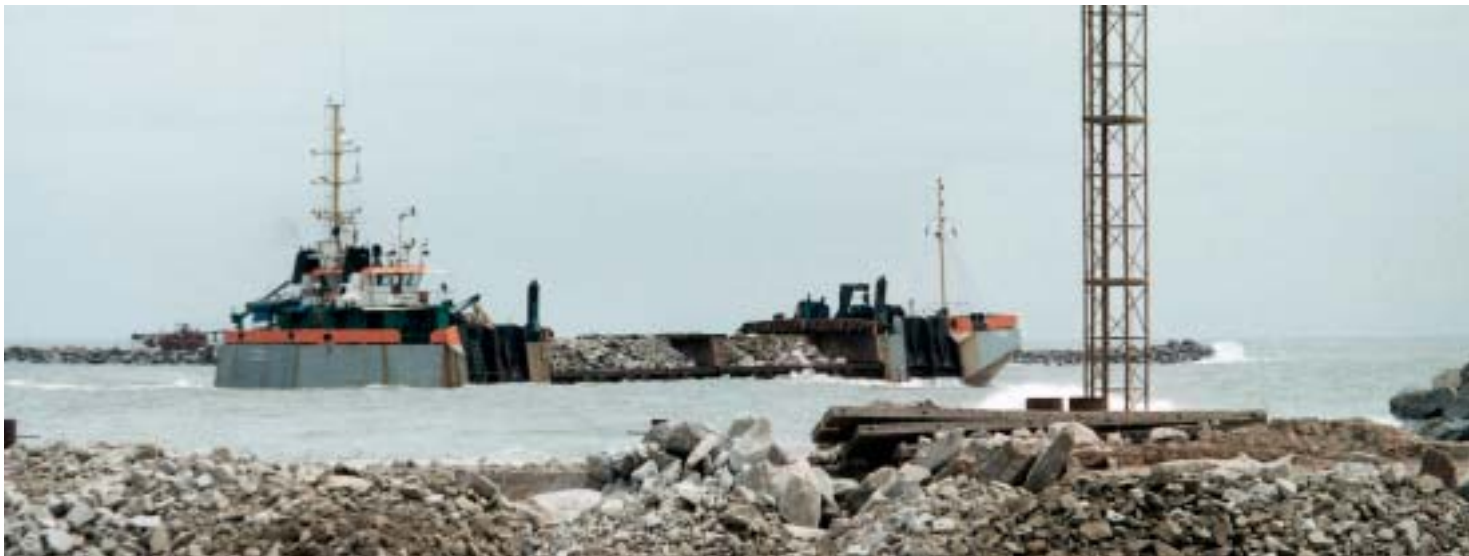
Figure 4. The fully loaded SSDV Frans leaving the workharbour.

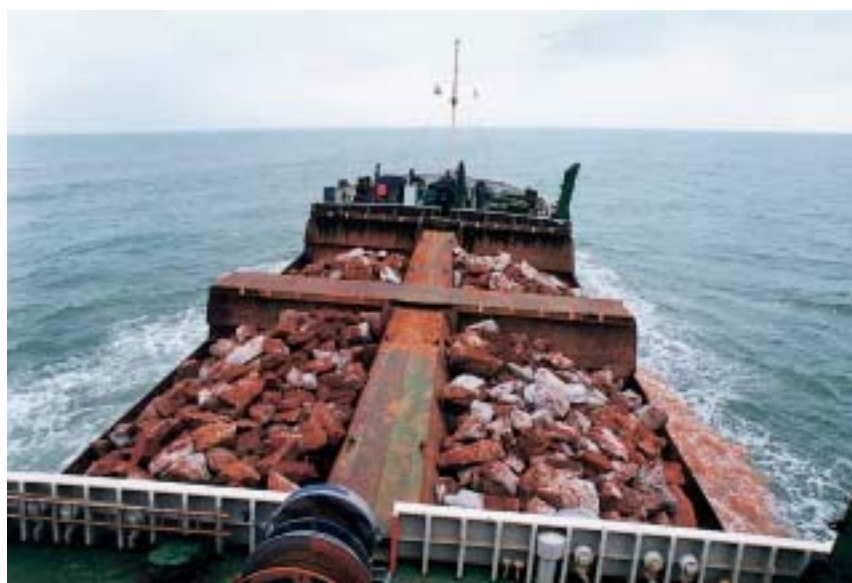
Figure 5. Close up of the *Frans* sailing to the South Breakwater.

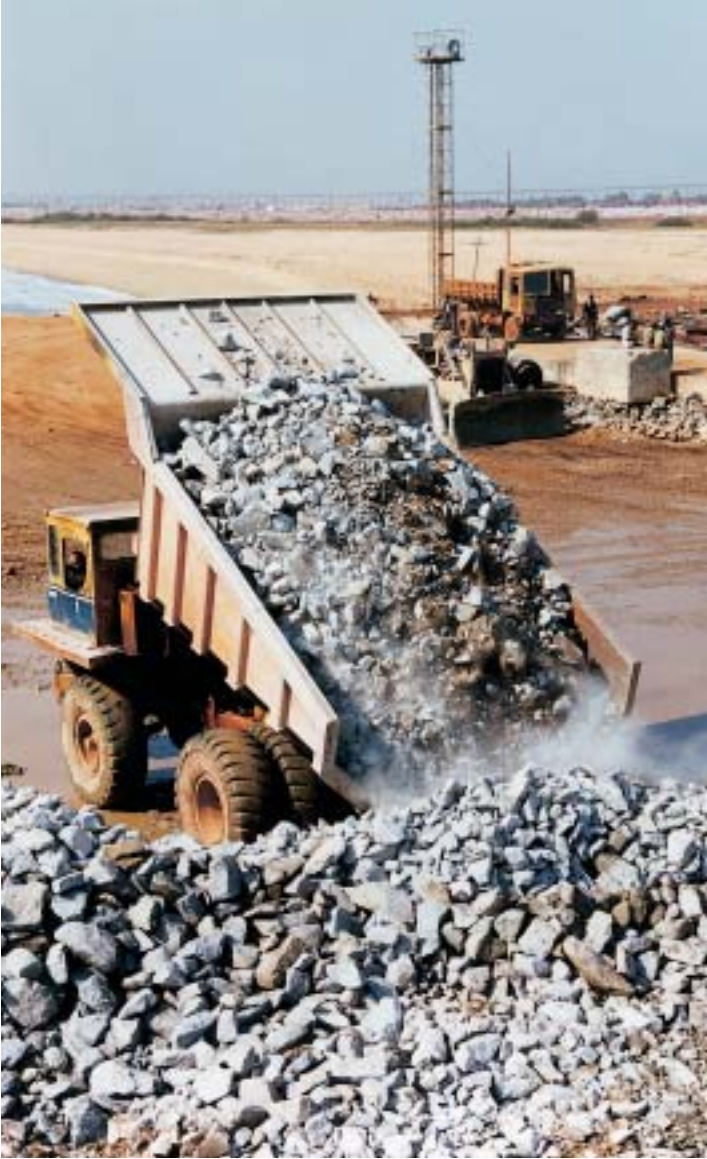
Figure 6. Stone dumpers discharging rock class G at the work harbour.

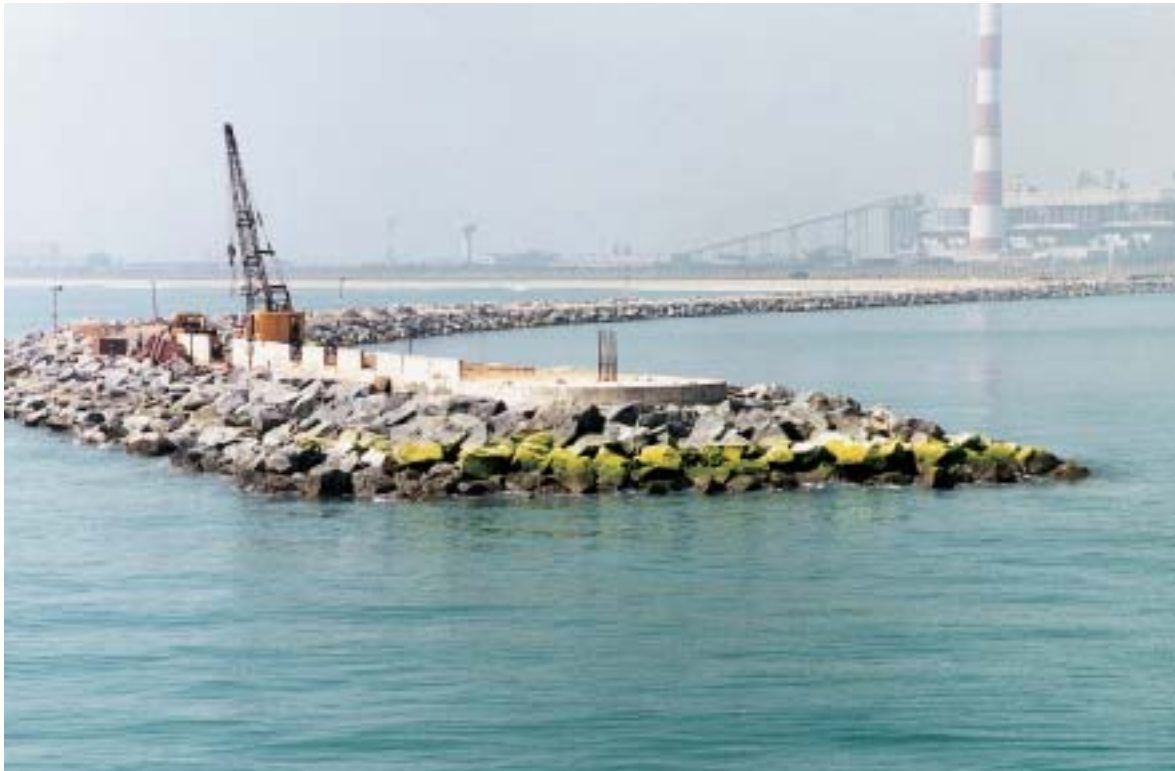
Figure 7. The placing of in situ concrete slab and wave wall at the South Breakwater under construction.

To construct the Ennore breakwaters, 3 million tonnes of rock were needed for the rock-dumping operations (Figure 7). The Employer and the Engineer had appointed an area at Karikal, situated approximately 80 km inland east of Chennai, for the development and exploitation of the rock quarry. Former investigation tests had established that the specific gravity of the rock (SG 2.6) in that area complied with the contract criteria.
