Martijn van Doorne

# Penny's Bay Reclamation Phase 1: Fairytale in Hong Kong

## Abstract

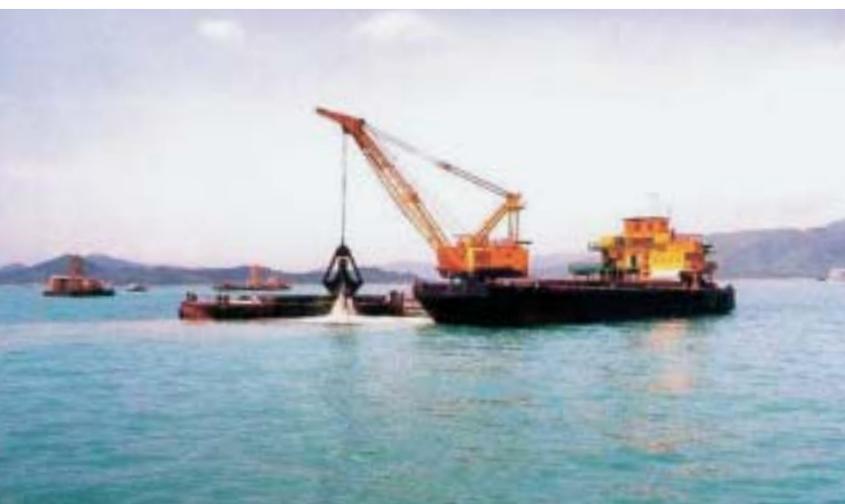
Figure 2. Grab dredgers were used to remove mud to provide access in the bay for the larger trailer dredgers.

Three grab dredgers were used for mud removal, mainly to provide access for the trailer dredgers and in locations where rock layers were expected close to the surface (Figure 2). The grab dredgers created sufficient depth for the small trailer dredgers like *HAM 312* (Figure 3). The smaller trailers in turn dredged an access channel into the works and lowered the level of the working area for the larger dredging vessels such as *Geopotex 15*, *Amsterdam* and *Rotterdam* (Figure 4 and 5).

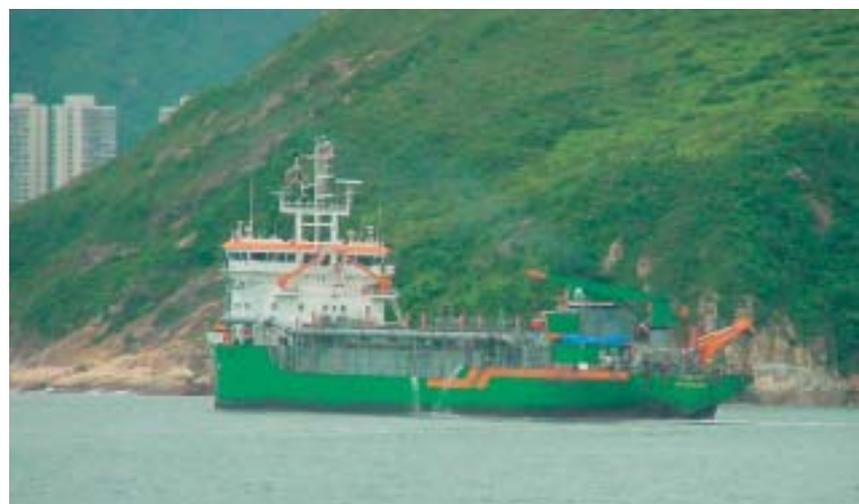
*Figure 3. Ham 312, one of the smaller trailers used for excavations at Penny's Bay.*

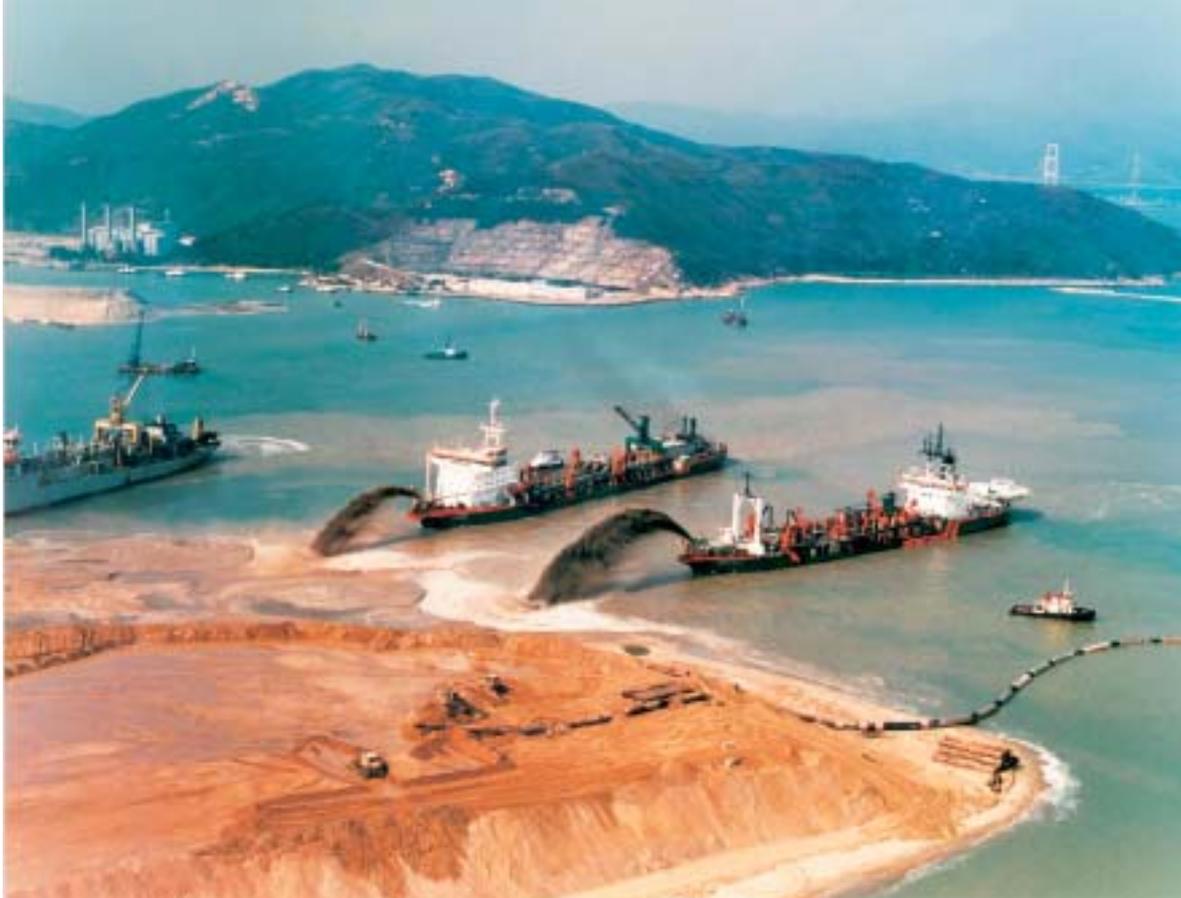
Figure 4. Large trailing suction hoppers during sand placement.

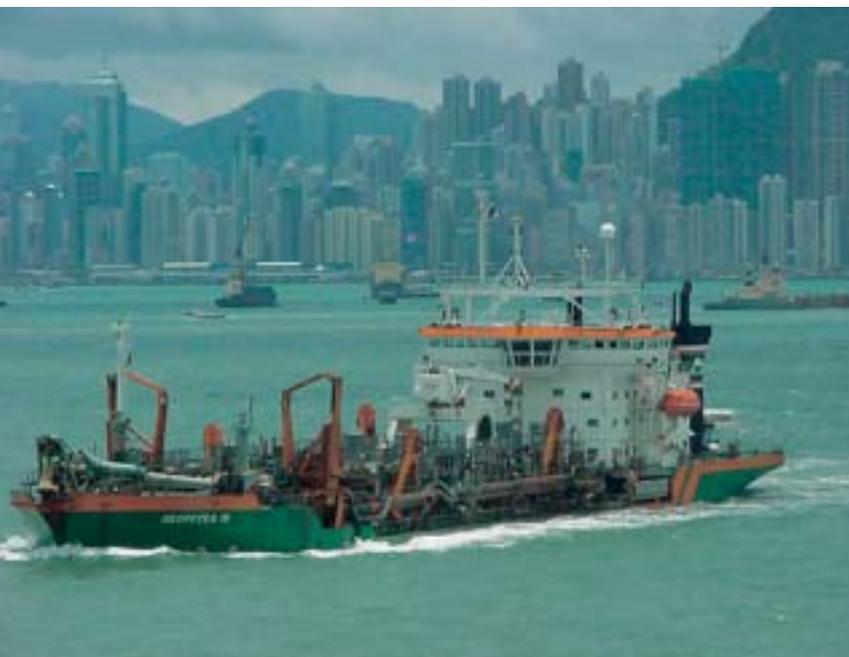
Figure 5. Geopotes 15 transporting sand.

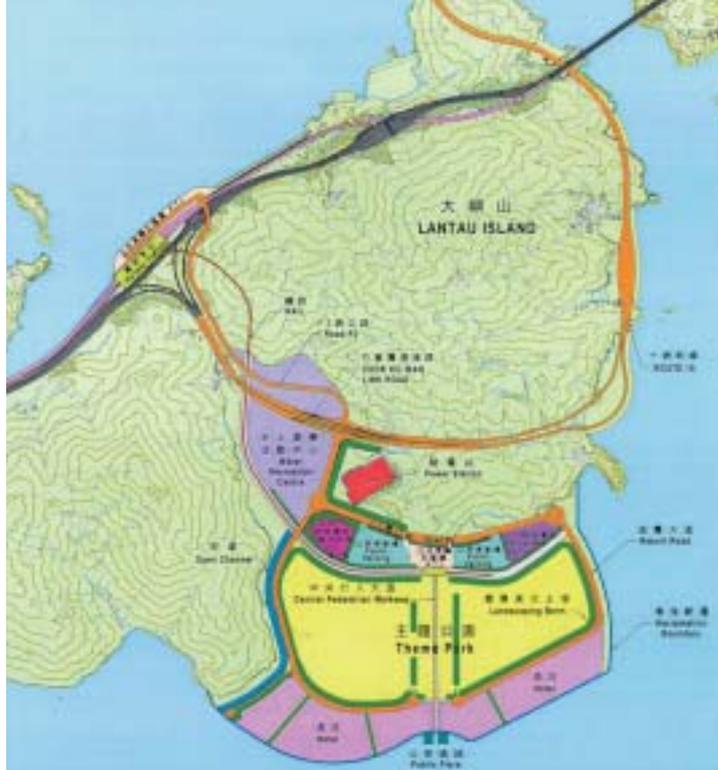
Figure 6. Land formation and infrastructure for the theme park on Lantau Island, Hong Kong. Theme park is situated at bottom of drawing.

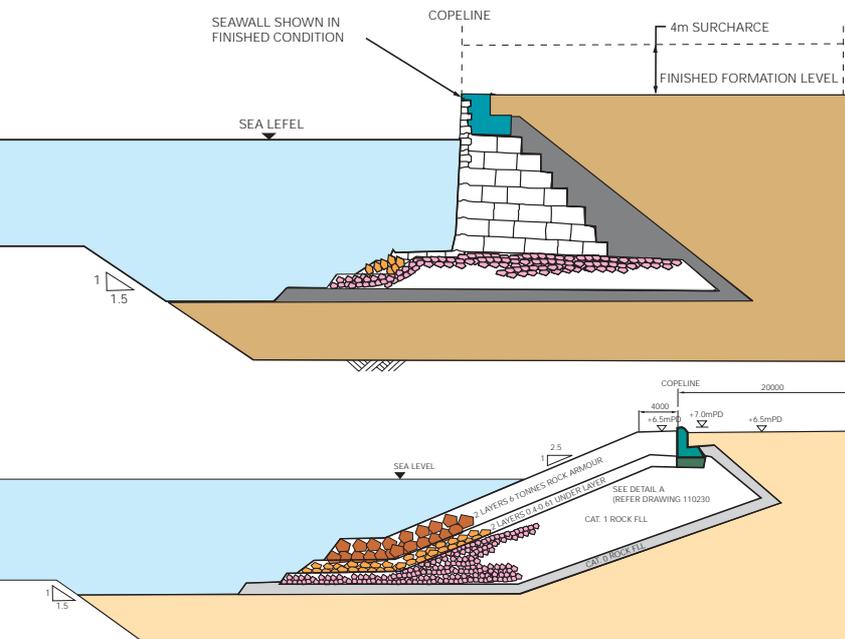
Figure 7. Two seawall designs were used: above, the vertical seawall and below, the sloping seawall.

The seawall was constructed along the southern perimeter of the reclamation, about two kilometres long and consisting of two sections; a vertical seawall and a sloping seawall. The designs used for the seawalls are fairly classic, well proven and often used in Hong Kong (Figure 7).

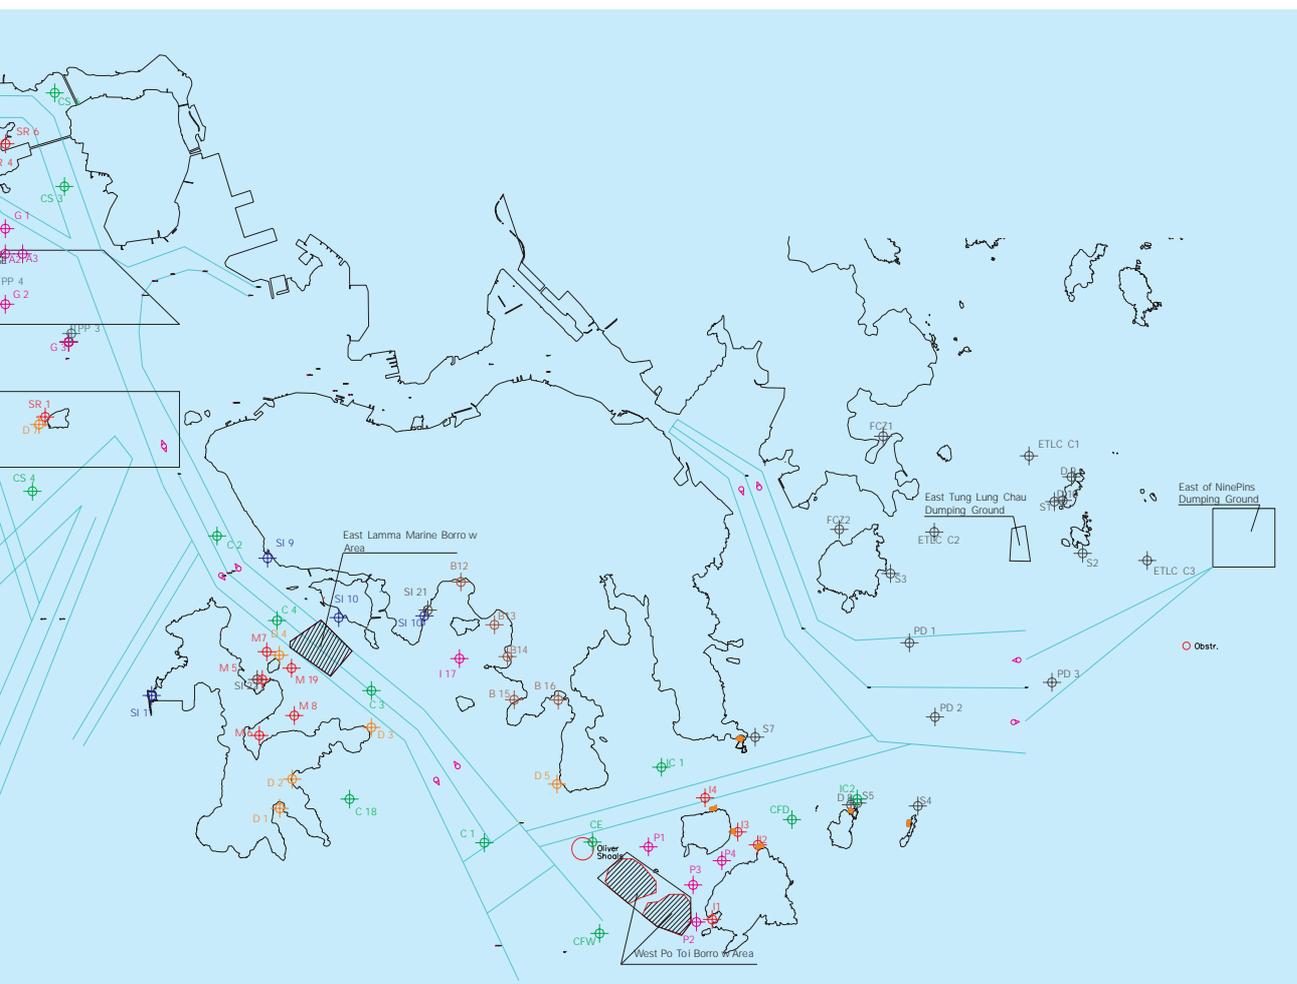
Figure 8. Overview of environmental monitoring locations

written, specifying the scope of environmental monitoring and mechanisms to avoid and mitigate any negative impact to the environment (Figure 8).

- installation of a 4 km silt screen and a temporary rock bund around the worksite;
- installation and data collection at 66 water quality monitoring stations;
- installation and data collection at 3 noise measurement station;
- installation and data collection at 1 air quality measurement station;
- installation of 13 coral monitoring stations including data collection dives; and
- ecological monitoring of wildlife around the site.

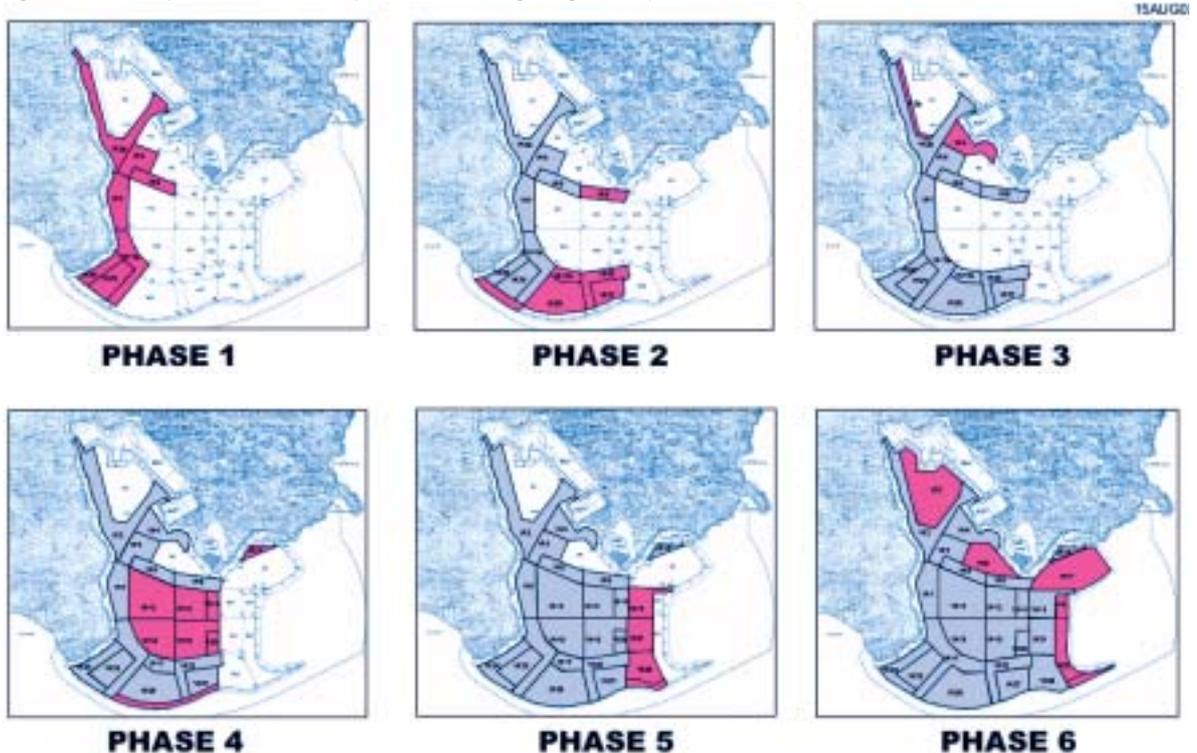
Figure 11. The six phases of the development of the Hong Kong theme park area.

The work on the future Hong Kong Disney Theme Park was divided into six phases (Figure 11). Each was completed and handed back to the client within its contractual period. As was the case for most of the works executed in Hong Kong, the next contractor started work on the newly reclaimed land only hours after handover of each of the areas.
