# ENVIRONMENTAL MANAGEMENT AND MITIGATION MEASURES: ADDU CITY PROJECT

Dredging and reclamation projects can significantly impact local ecosystems. Negative impacts can be minimised by adopting proper environmental management and mitigation, from preparation to completion phase. Addu City project sets an example of implementing novel construction methodologies and successfully addressing environmental challenges. The project has created over 200 hectares (ha) of climate resilient land for housing and touristic development. Enclosure of footprints, relocation of corals and seagrass (at pilot level) before reclamation process, and monitoring sediment impact in the nearby marine protected areas during dredging and reclamation are exemplary of the management approach applied to ensure minimisation of potential negative environmental impacts.

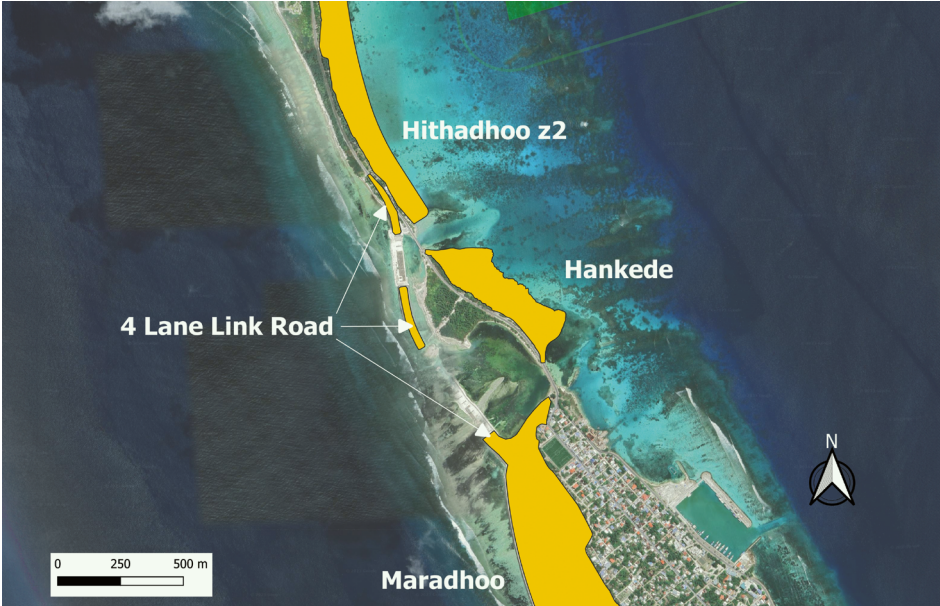
FIGURE 3  
Focus on the area of the Hankede island indicating the abutments for the new four lane link road.

This article will focus on the strategy and execution of points 1–4, with a specific focus on the dredging and reclamation sequence, and the impact on the environment. The reclamations can be seen in Figure 2 and Figure 3. The potential impacts of the project

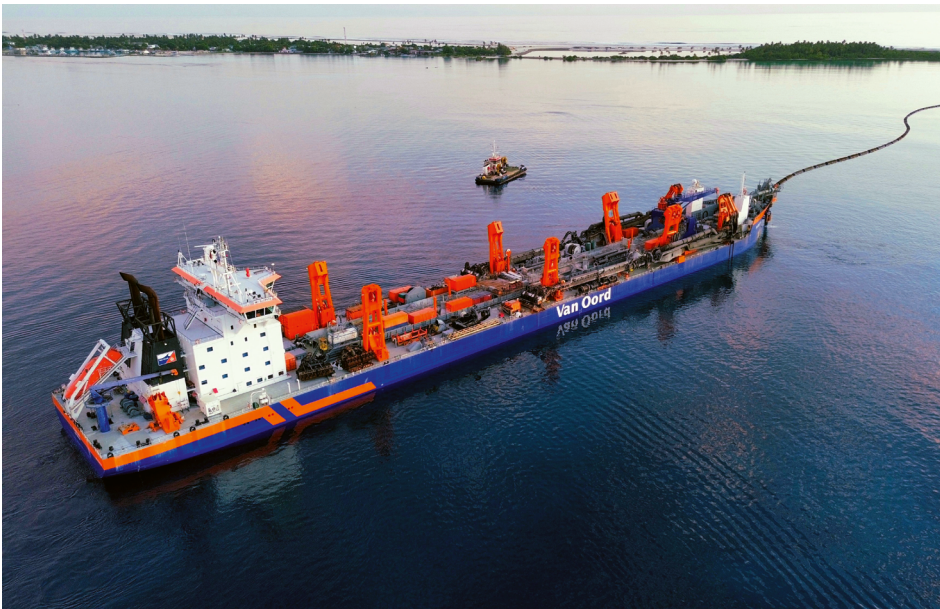
FIGURE 4  
The trailing suction hopper dredger HAM 318 in Addu City, Maldives during reclamation of Hithadhoo zone 2.

The dredging and reclamation was executed by the trailing suction hopper dredger (TSHD) HAM 318 with hopper capacity of 39,467 m³, two suction pipes of 1,200 mm and maximum dredging depth of 135 metres (Van Oord, 2016).

The vessel is capable of under-keel overflow and is equipped with an environmental or green valve (PIANC, 2010). The environmental valve is a butterfly valve in the overflow system of the TSHD aimed at reducing the formation of air bubbles in the overflow mixture. This results in more stability of the near-field overflow plume, which increases the settling of the generated plume on the seabed. This way the spatial extent of the plume is

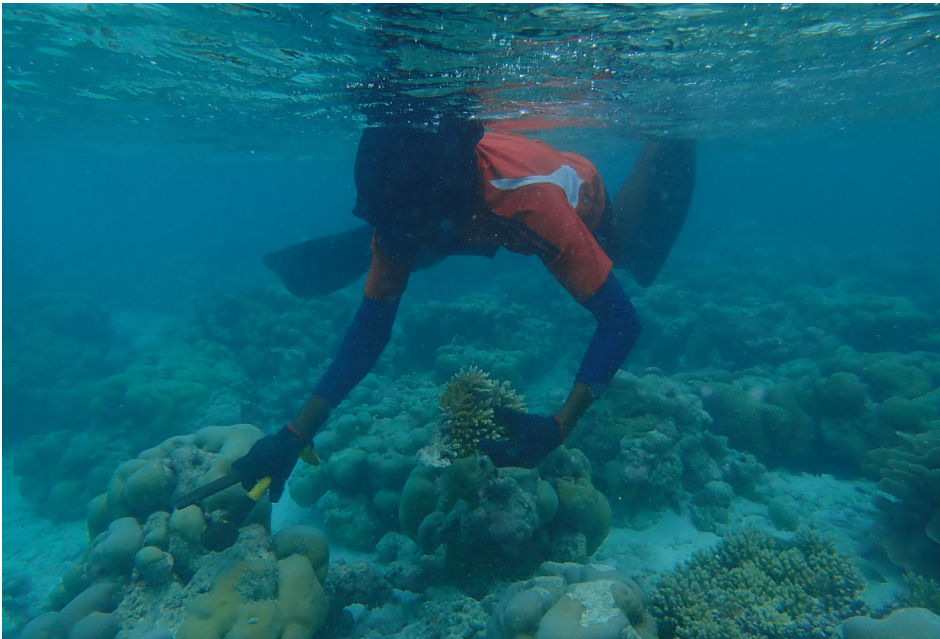
FIGURE 5

Corals collected within the reclamation footprint of island resort 3 during coral relocation works.

- Preparatory works for coral relocation. A selection of corals from the reclamation footprints needs to be transferred to suitable recipient sites. Van Oord, with the support of a local sub-contractor has performed coral relocation pre-survey in July 2022 to assess quantitatively and qualitatively existing coral reefs within reclamation footprints (see Figure 5) and immediate vicinity. Moreover, an assessment of potential recipient sites within Addu Atoll was made. Those sites should have the same or similar environmental conditions to ensure that corals will survive and grow in the new environment. The results of the pre-survey were used to identify number, species and type of donor corals and the most suitable recipient site for each category of donor corals.

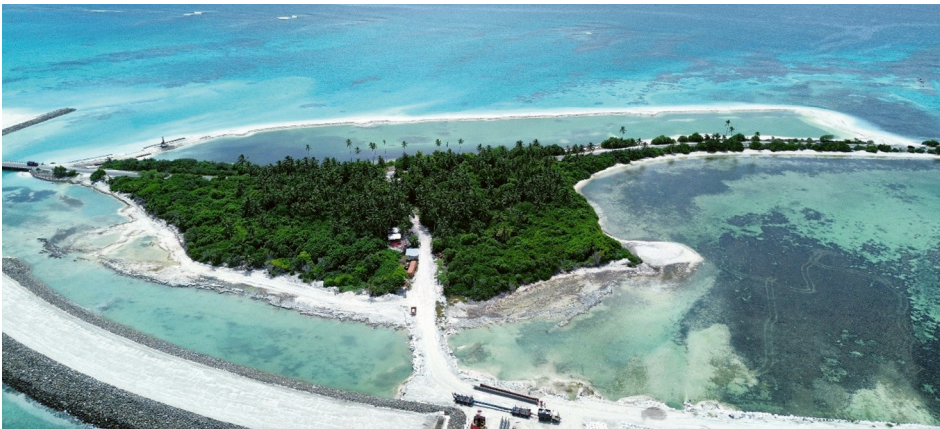
FIGURE 6

Sand bund for the enclosure of Hankede reclamation footprint (28/07/2023).

- Sand bunds, in case the final reclamation is expected to have a form of a beach. Such footprints include the Hithadhoo zone 2 and Hankede (Figure 6) reclamations.
- Sand and rock bunds up to the reclamation

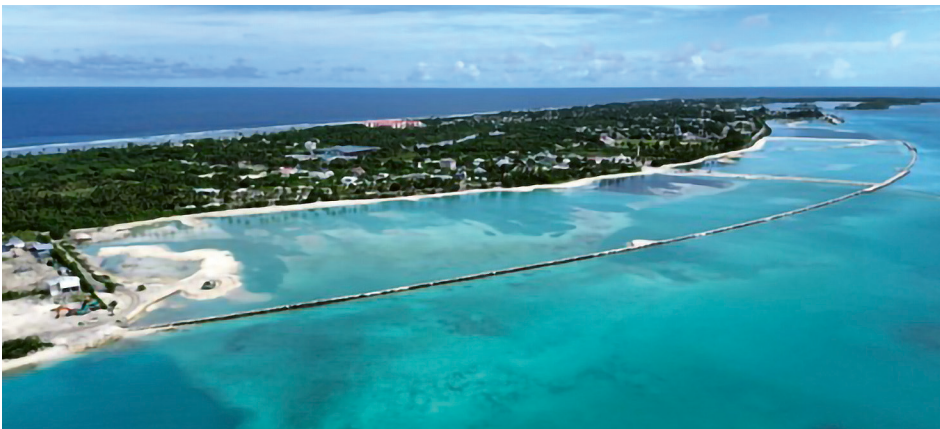
FIGURE 7

Rock bunds for the enclosure of Hithadhoo zone 1 reclamation footprint (24/06/2023).

level, in case that coastal protection works have been foreseen. Such footprints include Maradhoo and Hithadhoo zone 1 (Figure 7) reclamations.

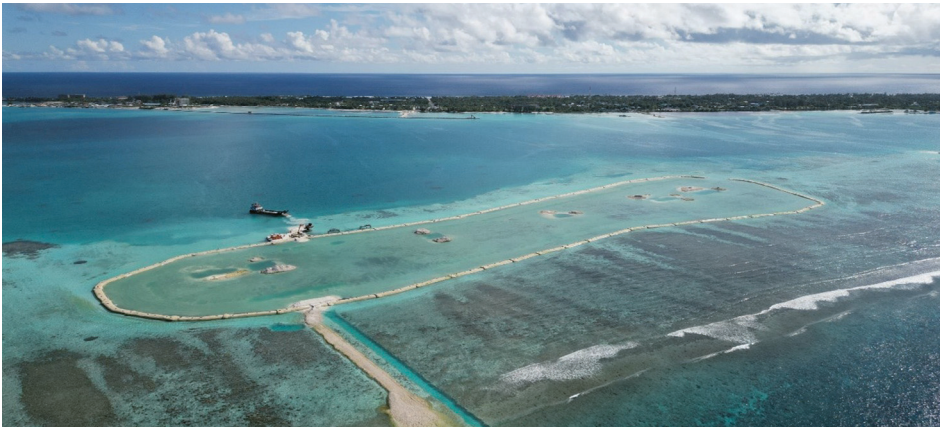
FIGURE 8

First layer of geotextile tubes for the enclosure of resort island 2 reclamation footprint (01/06/2023).

- Sand-filled geotextile tubes for creating the outline and the coastal protection of the resort islands 1, 2 (Figure 8) and 3 (Pilarczyk, 2008). The coastal protection consists of two layers of geotextile tubes and the enclosure of the footprint has been implemented by installing the first layer of the geotextile tubes.

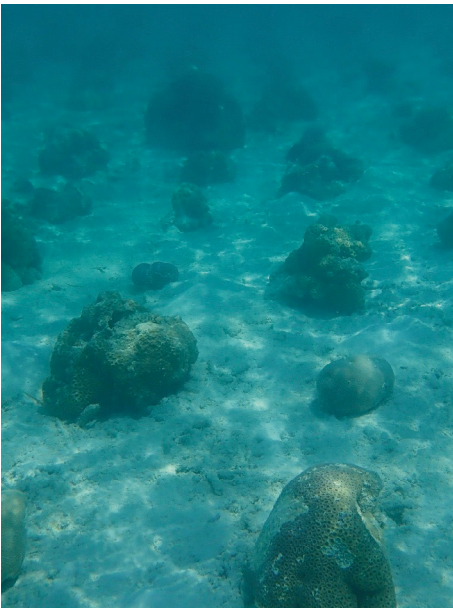
FIGURE 10

Corals placed on seabed in recipient sites.

Van Oord appointed three local dive groups with marine biologists to execute this task of relocating more than 73,000 coral colonies within the provided timeline of the project. The relocation works lasted a total of three months. The sub-contractors removed coral colonies from the reclamation footprints using hand tools, such as a hammer and chisel. The detached corals were then safely transported by boats to nearby selected recipient sites. Detached corals were categorised based on their growth forms: fragile coral colonies were placed on frames (Figure 9) whereas massive and sub-massive coral colonies were placed freely on the seabed (Figure 10) or fixed using a cement mixture.

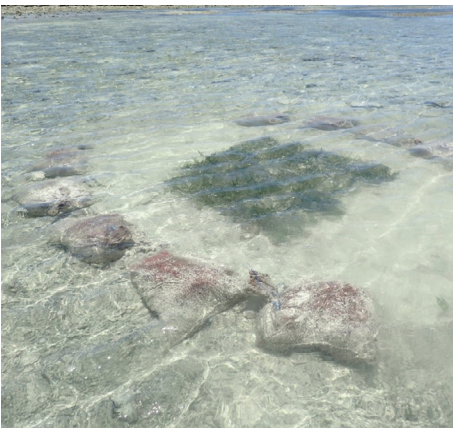
FIGURE 11

Replanted seagrass in wave active sites has been protected with hessian bags filled with rock.

Even though the ESIA indicated that the project will have an impact on the seagrass meadows, no mitigation measures were imposed. However, Van Oord implemented a seagrass pilot programme relocating a total of 640 seagrass sods of 0.125 m<sup>2</sup> from the reclamation footprint of Maradhoo, to three specifically chosen locations nearby Feydhoo. Van Oord has worked closely with local stakeholders to replant those sods in different patterns (see indicatively Figure 11) to examine the survivability of the pilot programme and to scale it up in future endeavours.

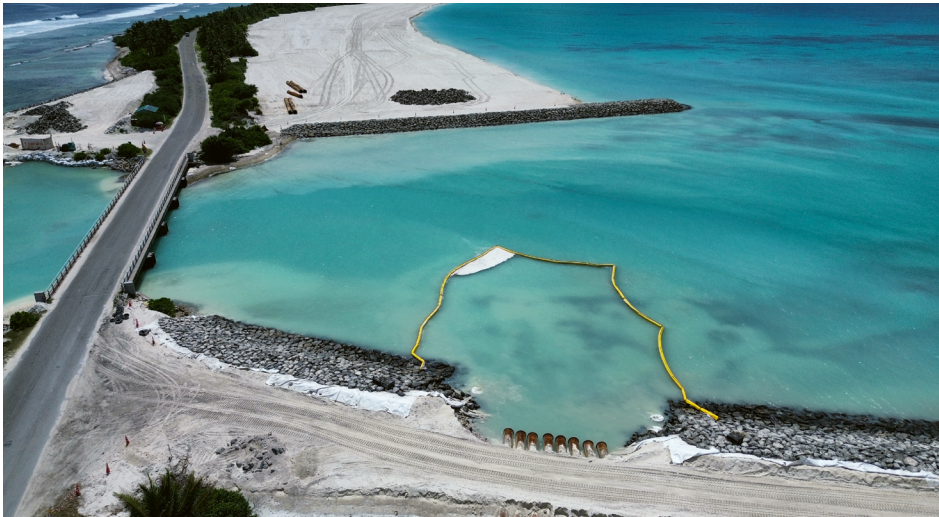
FIGURE 12

Installed silt screen for the Hankedé reclamation and the south groyne of Hithadhoo zone 2 reclamation.

Figure 12 shows the installed silt screen at Hankede reclamation. The outfalls consist of 8 pipes of 1 m diameter. The silt screen is placed around those pipes to further contain dispersion of sediments further away from the immediate vicinity of the reclamation outfalls. This limits the negative impact of sediment induced turbidity clouds originating from the reclamation works onto the coral reefs within the atoll. It is anticipated that the amount of suspended fine sediments that the silt screen would need to prevent from spreading increases as the reclamation filling progresses. As an indication, the turbidity just outside of the silt screen in Hankede was measured with a water quality EXO3 probe on 3 August 2023, one day prior to the completion of Hankede reclamation. The exact location of measurement was the

water column in front of the groyne located in the south of Hithadhoo zone 2 reclamation (Figure 12), 85 m from the silt curtain. Spot measurements on this location indicated turbidity of 37.53 ± 0.02 NTU, whereas the turbidity in the buoy in the British Loyalty Shipwreck did not exceed 3 NTU within the following days. It is safe to consider that the sediment that managed to pass the silt screen was deposited relatively fast, due to the low current speeds in this particular location.

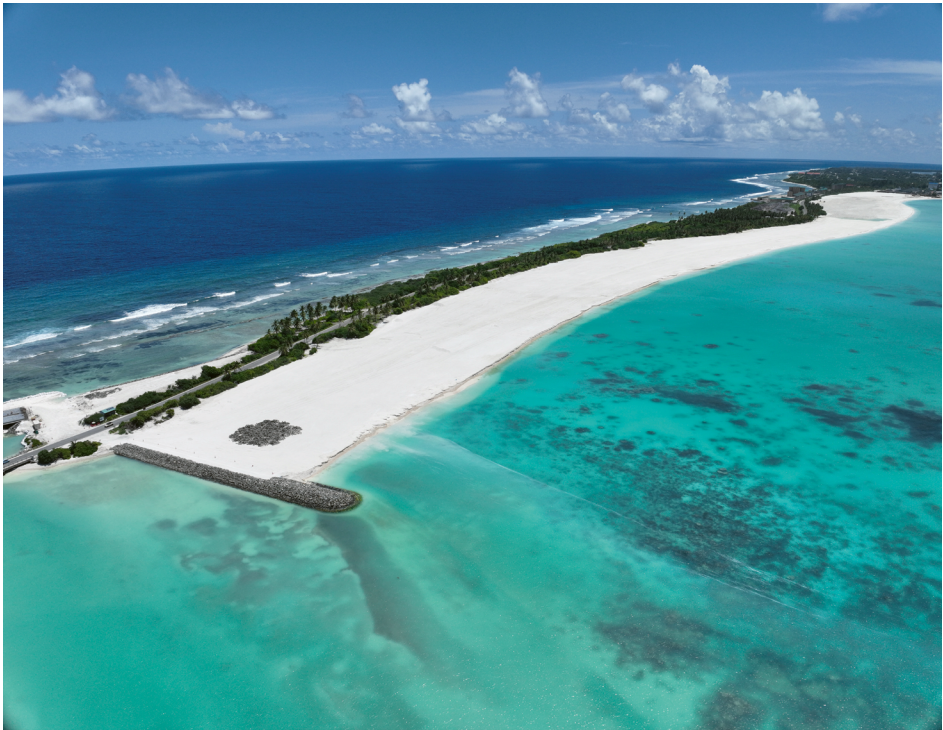
**FIGURE 16**  
Reclamation at Hithadhoo zone 2 on 14 August 2023, with groyne constructed in the south of the reclamation and the natural beach started forming in the inner side of the atoll.

The reclamation in Hithadhoo zone 2 took place in several stages as indicated in Figure 16 due to its elongated shape, to accommodate the unobstructed execution of reclamation works and to accommodate the function of the Hithadhoo commercial port. Thus, Hithadhoo zone 2 reclamation started on 28 May 2023 and was completed on 1 August 2023. The floating pipelines were installed on the southmost and the northmost locations of the footprint, whereas the reclamation outfalls were placed in the middle of the length of the reclamation, close to the marine protected area of the British Loyalty Shipwreck. The choice of the outfalls aimed at accommodating the efficiency of the reclamation execution. Even though the distance from the MPA is substantially small, the use of silt screens combined with the placement of an environmental buoy in the MPA (Figure 2) resulted in a thorough monitoring of the reclamation process and ensured that no turbidity exceedances were recorded within the British Loyalty Shipwreck area.

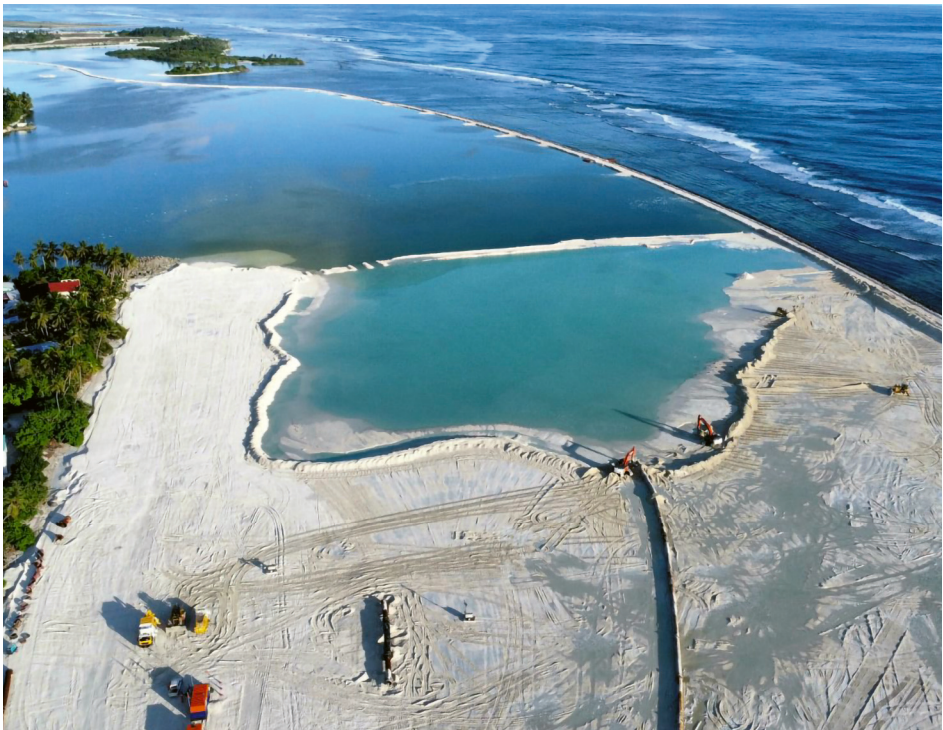
**FIGURE 17**  
Maradhoo reclamation footprint progress on 12 June 2023 (floating pipeline discharging sediment mixture from the north).

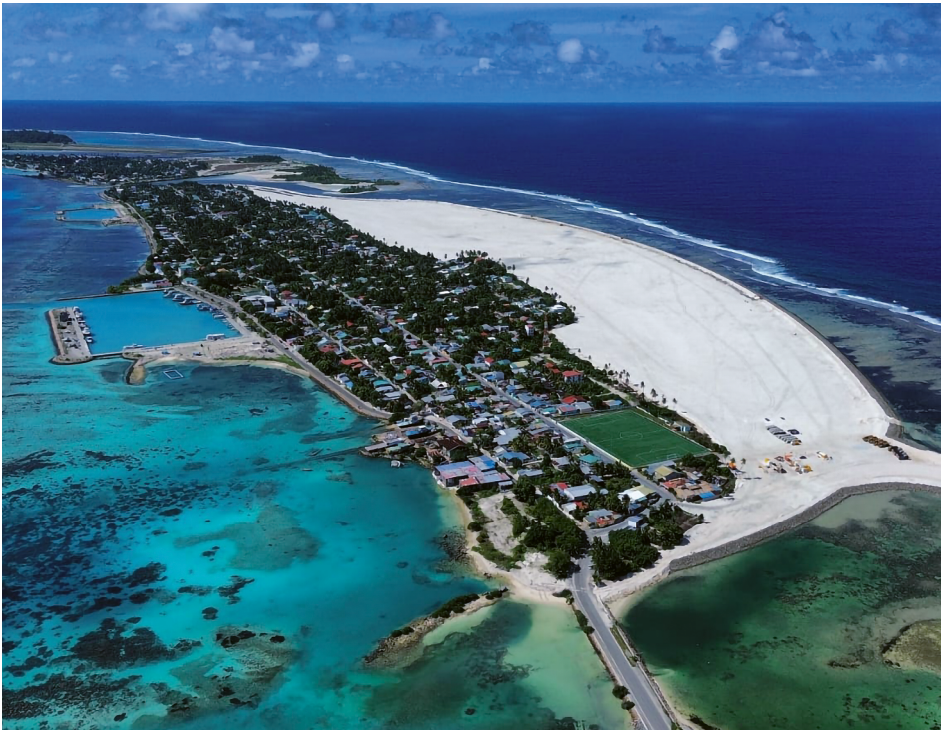
**FIGURE 18**  
Maradhoo reclamation footprint on 14 August 2023 (drone photo taken from the north edge of the reclamation). The location on the north side where the floating pipeline cross the main street is indicated with red box.

Maradhoo reclamation was implemented between 31 May and 25 June 2023 (see Figure 18). The floating pipelines were placed from the inner atoll, crossing over the main street and discharging sediment mixture from the north (see Figure 17) and the south side of the reclamation, whereas the reclamation outfalls were placed midway in the enclosure sand and rock bund. The floating pipelines were protected with road humps made of sand, so that the reclamation could proceed according to plan and the traffic through Maradhoo-Feydhoo, Maradhoo and Hithadhoo islands remain unobstructed. As shown in Figure 17, an intermediate bund was constructed across the reclamation area to further assist in fine sediment containment from the offshore side of the atoll. Since the outfalls are placed in the offshore side of the reclamation, there was no possibility of using silt curtains for sediment containment in the last stage of the reclamation. However, the strong currents ensured that no sediment plume could possibly form.

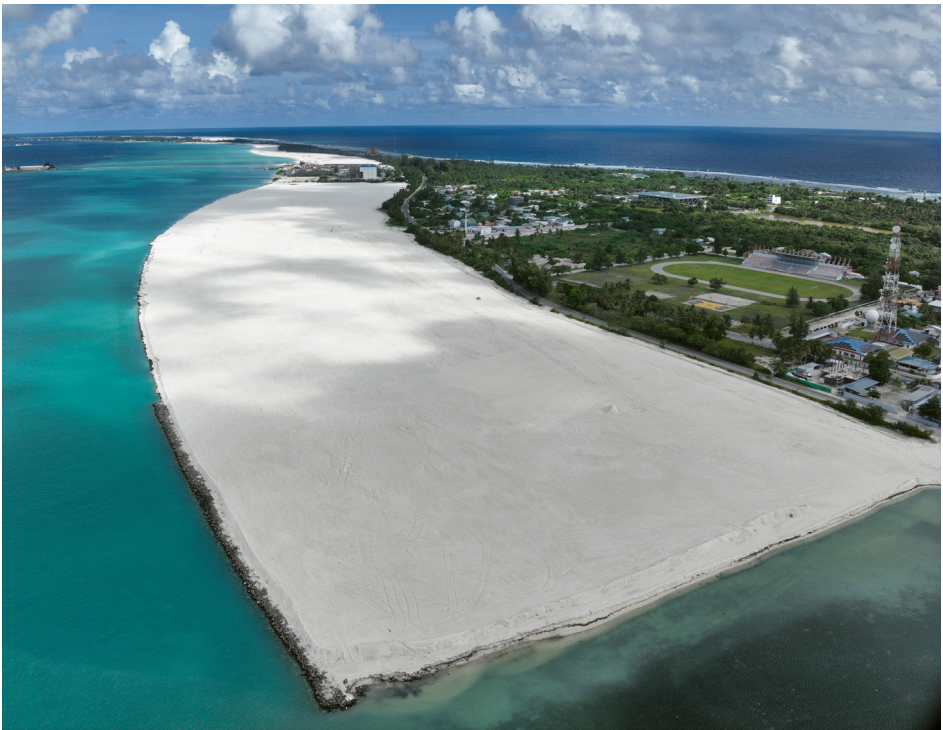
**FIGURE 19**  
Hithadhoo zone 1 reclamation on 13 August 2023 (drone photo taken from the north side of the reclamation).

Hithadhoo zone 1 reclamation was executed between 1-17 July 2023. The floating pipeline was installed from the south side of the reclamation. It must be highlighted that this was the first reclamation completed with sediment taken entirely from the southeast borrow area, whereas Maradhoo and Hithadhoo zone 2 were filled by sediment coming both from south and southeast borrow areas. This is part of the general strategy to periodically switch borrow areas to control the sediment dispersion and the plumes generated locally due to the dredging operations. The reclamation outfall was placed in the midway of the rock bund enclosure and silt screens used to ensure containment of sediment dispersion further from the reclamation area.

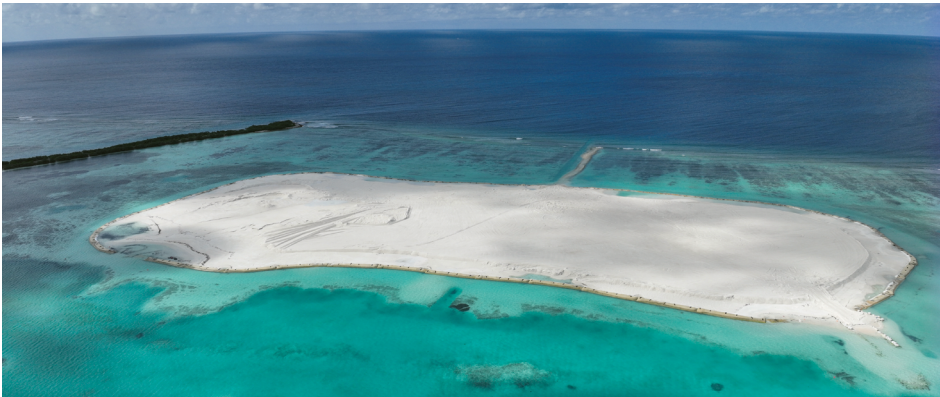
**FIGURE 20**  
Resort island 1 reclamation on 13 August 2023 (drone photo taken from the south of the island). In the southwest of the island the opening used as the reclamation exit can be seen.

Resort islands 1 and 2 reclamations took place 18-23 July 2023 and 26-29 July 2023, respectively. Resort island 1 was filled with sediment from southeast borrow area, whereas resort island 2 was filled with sediment from south borrow area, once again to maintain low turbidity generated by the dredging operations. As previously indicated, the enclosure of the reclamation footprint was accomplished by sand-filled geotextile tubes. The final design of the islands included two layers geotextile tubes, one placed on top of the other. The enclosure was made by installing the first layer of the lower tubes. However, in the circumference of the enclosure, one geotextile tube in the west/southwest of the islands was not placed to serve as the reclamation exit, which was covered by silt screens. The resort islands 1 and 2 after the completion of the reclamation procedure can be seen in Figure 20 and Figure 21, respectively.

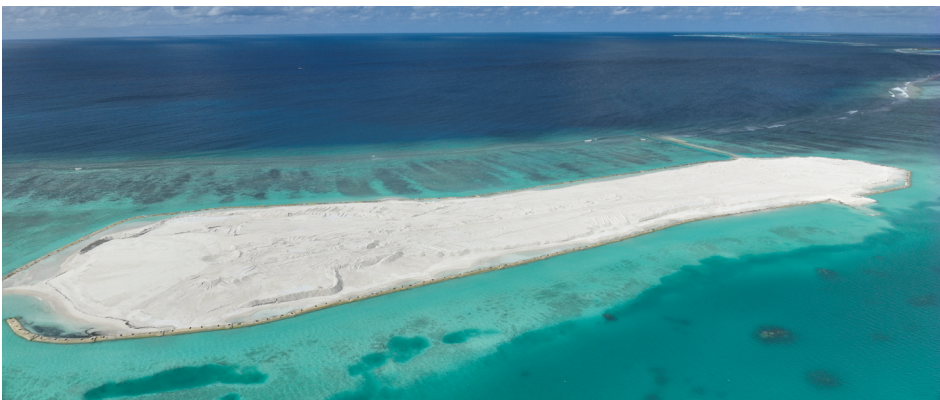
**FIGURE 21**  
Resort island 2 reclamation on 13 August 2023 (drone photo taken from the south of the island). The opening used as reclamation exit is visible in the west of the island.

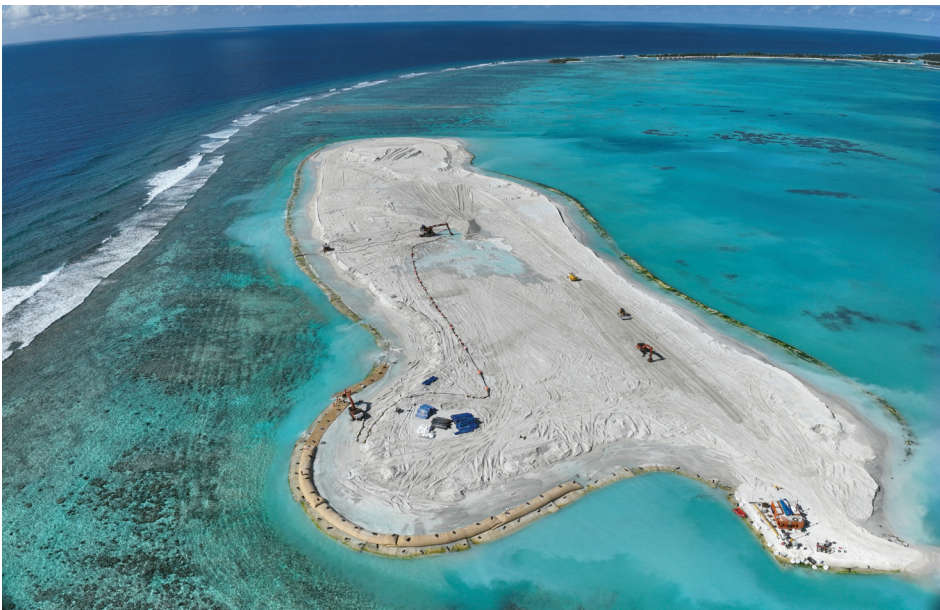
**FIGURE 22**  
Resort island 3 reclamation footprint on 14 August 2023 (drone photo taken from the west of the island). In the lower left of the photo you can see the second layer of geotextile tubes being installed.

Final stage of the reclamation sequence has been the execution of the resort island 3 (Figure 22) and the Hankede (Figure 23) reclamations. The enclosure of the resort island 3 consists of geotextile tubes whereas Hankede consists of sand bunds. Those reclamations collectively were executed between 1-7 August 2023. The major reason for this choice was that for resort island 3, even after creating the enclosure, it was not constantly above water. Thus, the only possibility of executing a closed reclamation, where the sediment mixture would stay within the area of the island would be if the reclamation took place during low tide. The rest of the time, sediment mixture was placed in Hankede reclamation. Silt curtains were used here as well to contain sediment dispersion.

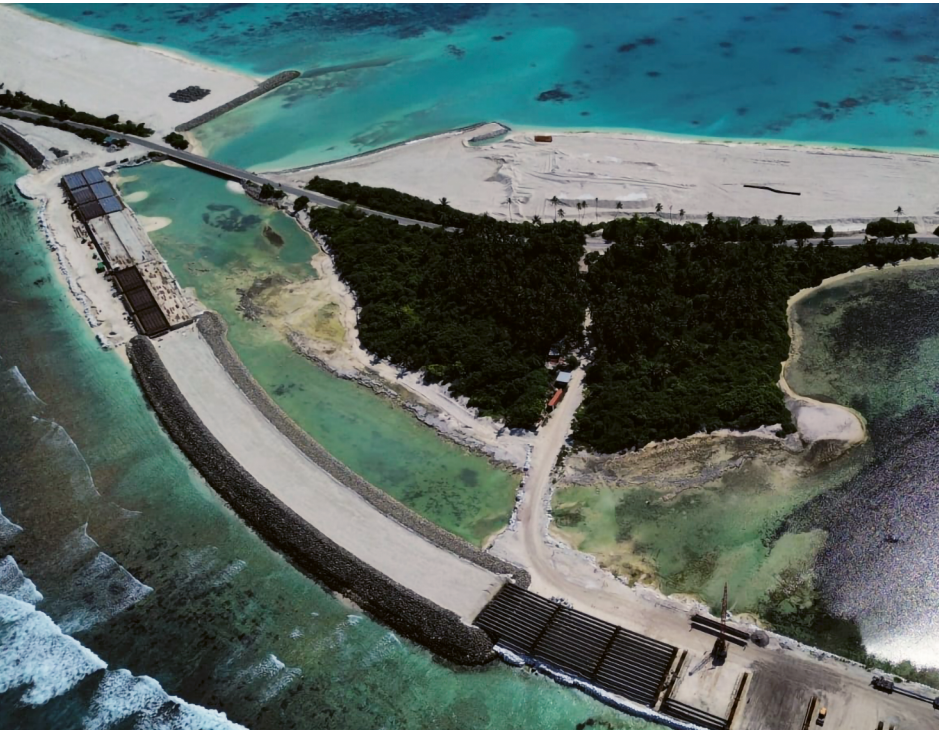
**FIGURE 23**  
Hankedere reclamation completed on 14 August 2023.
