ENVIRONMENTAL MANAGEMENT AND MITIGATION MEASURES: ADDU CITY PROJECT

Dredging and reclamation projects can significantly impact local ecosystems. Negative impacts can be minimised by adopting proper environmental management and mitigation, from preparation to completion phase. Addu City project sets an example of implementing novel construction methodologies and successfully addressing environmental challenges. The project has created over 200 hectares (ha) of climate resilient land for housing and touristic development. Enclosure of footprints, relocation of corals and seagrass (at pilot level) before reclamation process, and monitoring sediment impact in the nearby marine protected areas during dredging and reclamation are exemplary of the management approach applied to ensure minimisation of potential negative environmental impacts.

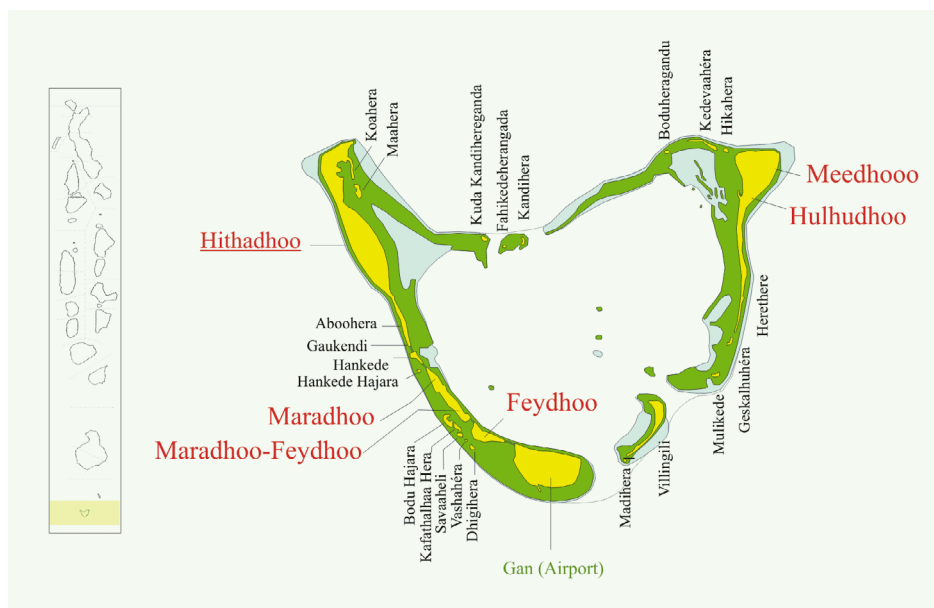
FIGURE 1

Location of the Addu Atoll in the Maldives and its islands [Ahmed, 2008].

The Addu City dredging and reclamation project (referred hereafter as the project) took place in the Addu or Seenu Atoll (Figure 1). This southernmost atoll of the Republic of Maldives. Addu City consists of the inhabited islands of Gan, Feydhoo, Maradhoo, Hithadhoo and Hulhumeedhoo (Hulhudhoo-Meedhoo).

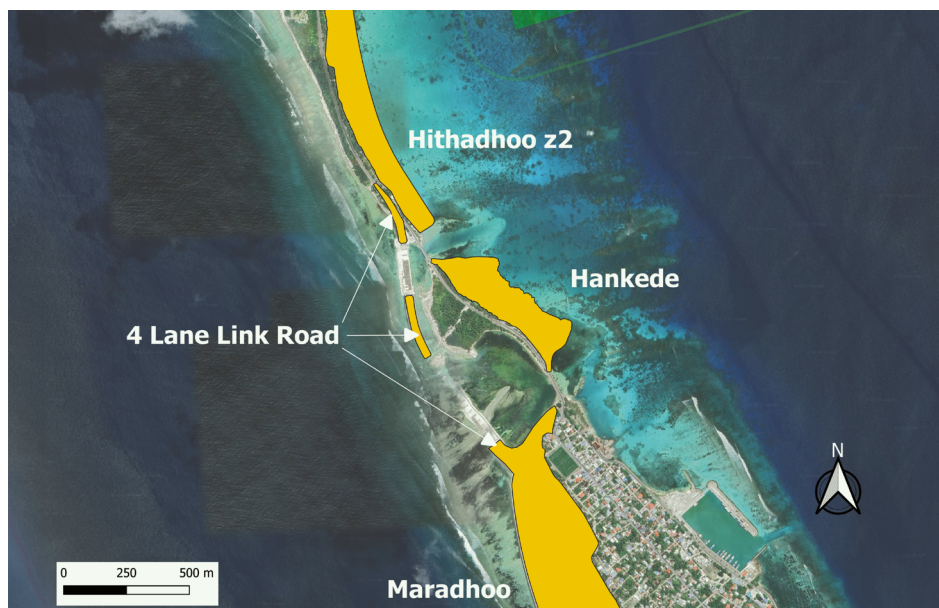
FIGURE 3

Focus on the area of the Hankede island indicating the abutments for the new four lane link road.

This article will focus on the strategy and execution of points 1–4, with a specific focus on the dredging and reclamation sequence, and the impact on the environment. The reclamations can be seen in Figure 2 and Figure 3. The potential impacts of the project

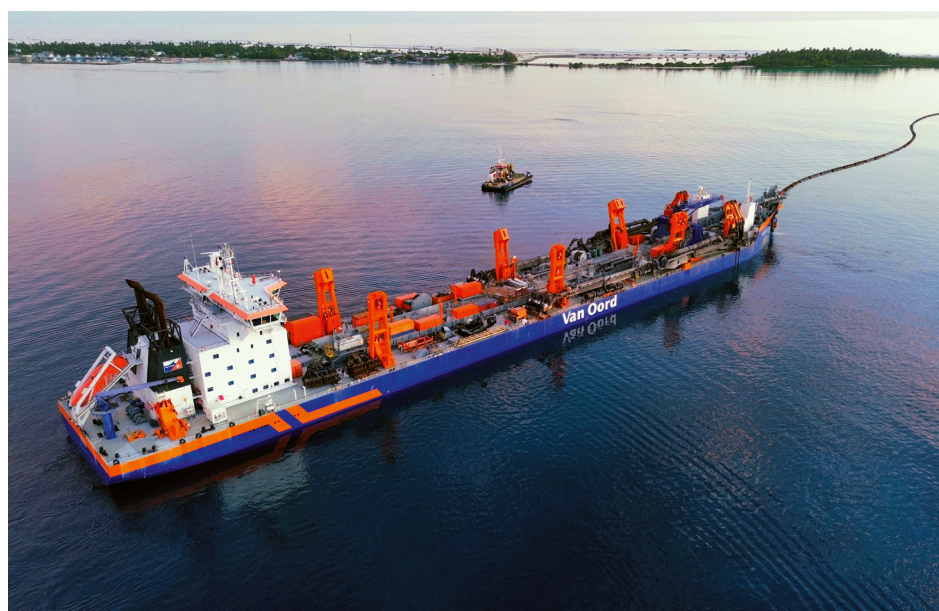
FIGURE 4

The trailing suction hopper dredger HAM 318 in Addu City, Maldives during reclamation of Hithadhoo zone 2.

The dredging and reclamation was executed by the trailing suction hopper dredger (TSHD) HAM 318 with hopper capacity of 39,467 m³, two suction pipes of 1,200 mm and maximum dredging depth of 135 metres [Van Oord, 2016].

The vessel is capable of under-keel overflow and is equipped with an environmental or green valve [PIANC, 2010]. The environmental valve is a butterfly valve in the overflow system of the TSHD aimed at reducing the formation of air bubbles in the overflow mixture. This results in more stability of the near-field overflow plume, which increases the settling of the generated plume on the seabed. This way the spatial extent of the plume is

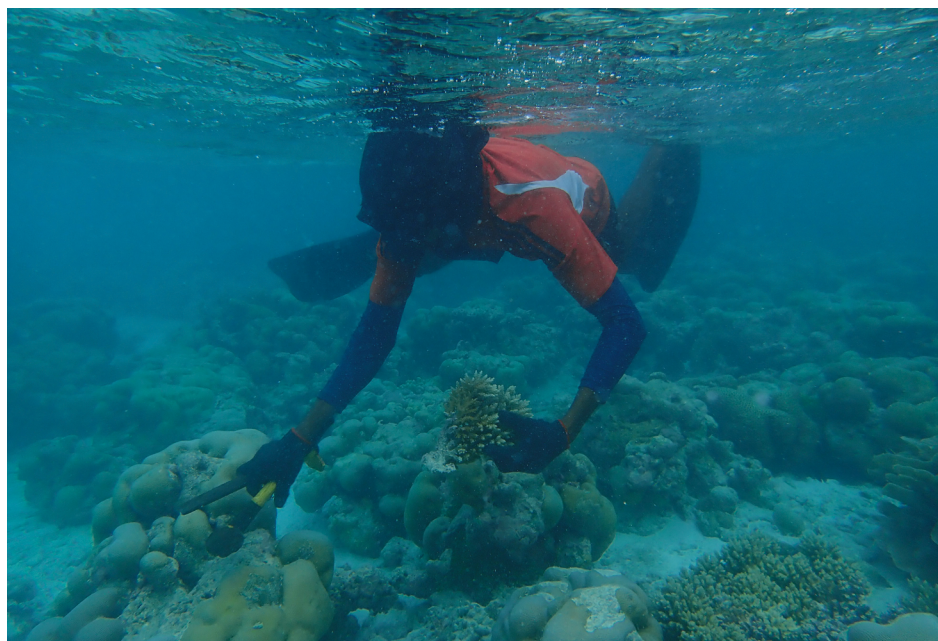
**FIGURE 5**

Corals collected within the reclamation footprint of island resort 3 during coral relocation works.

- Preparatory works for coral relocation. A selection of corals from the reclamation footprints needs to be transferred to suitable recipient sites. Van Oord, with the support of a local sub-contractor has performed coral relocation pre-survey in July 2022 to assess quantitatively and qualitatively existing coral reefs within reclamation footprints (see Figure 5) and immediate vicinity. Moreover, an assessment of potential recipient sites within Addu Atoll was made. Those sites should have the same or similar environmental conditions to ensure that corals will survive and grow in the new environment. The results of the pre-survey were used to identify number, species and type of donor corals and the most suitable recipient site for each category of donor corals.

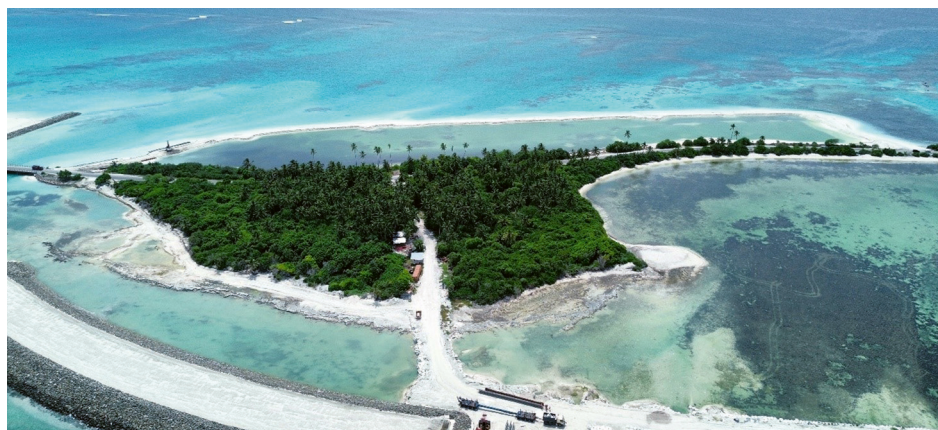
**FIGURE 6**

Sand bund for the enclosure of Hankede reclamation footprint (28/07/2023).

- Sand bunds, in case the final reclamation is expected to have a form of a beach. Such footprints include the Hithadhoo zone 2 and Hankede (Figure 6) reclamations.
- Sand and rock bunds up to the reclamation

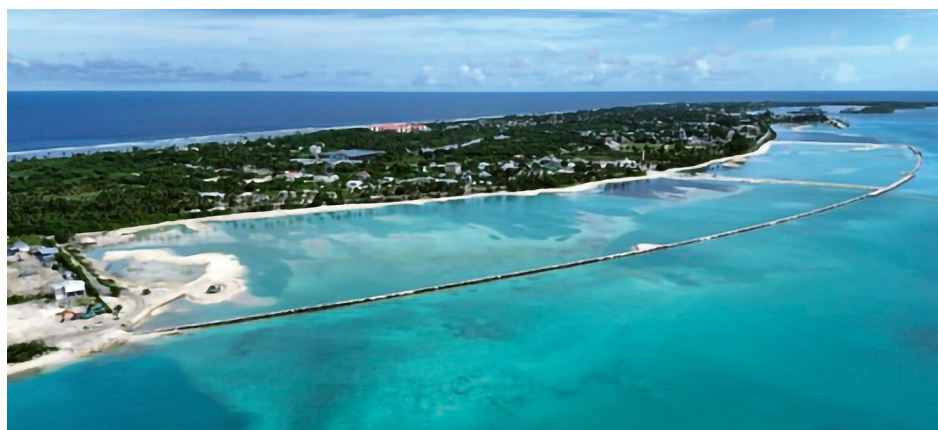
**FIGURE 7**

Rock bunds for the enclosure of Hithadhoo zone 1 reclamation footprint (24/06/2023).

level, in case that coastal protection works have been foreseen. Such footprints include Maradhoo and Hithadhoo zone 1 (Figure 7) reclamations.

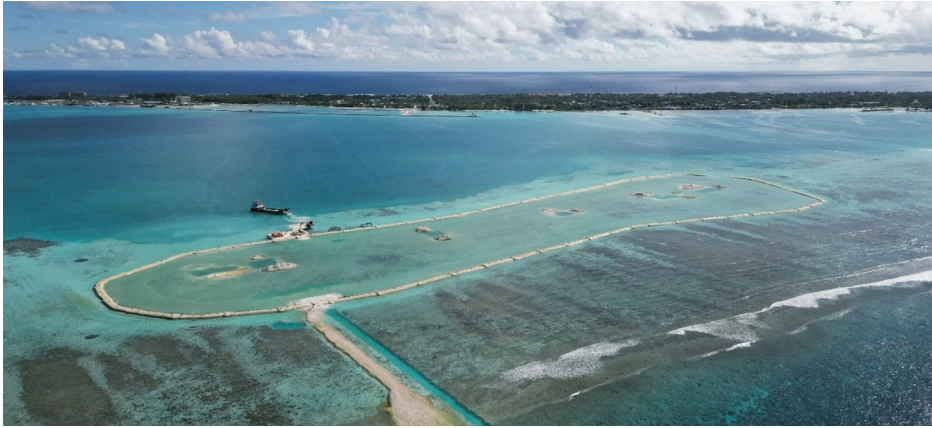
FIGURE 8

First layer of geotextile tubes for the enclosure of resort island 2 reclamation footprint (01/06/2023).

- Sand-filled geotextile tubes for creating the outline and the coastal protection of the resort islands 1, 2 (Figure 8) and 3 (Pilarczyk, 2008). The coastal protection consists of two layers of geotextile tubes and the enclosure of the footprint has been implemented by installing the first layer of the geotextile tubes.

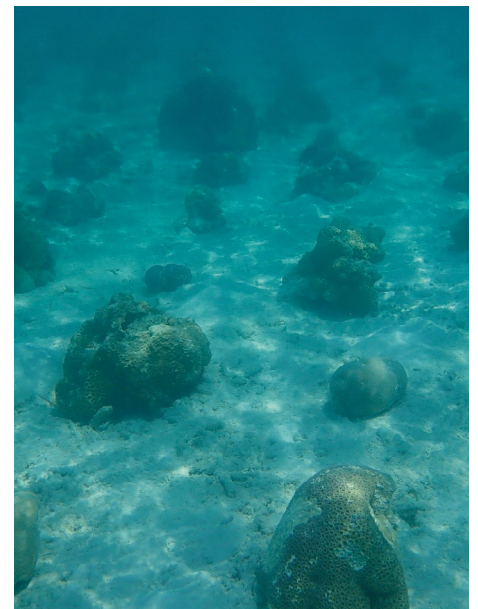
FIGURE 10

Corals placed on seabed in recipient sites.

Van Oord appointed three local dive groups with marine biologists to execute this task of relocating more than 73,000 coral colonies within the provided timeline of the project. The relocation works lasted a total of three months. The sub-contractors removed coral colonies from the reclamation footprints using hand tools, such as a hammer and chisel. The detached corals were then safely transported by boats to nearby selected recipient sites. Detached corals were categorised based on their growth forms: fragile coral colonies were placed on frames (Figure 9) whereas massive and sub-massive coral colonies were placed freely on the seabed (Figure 10) or fixed using a cement mixture.

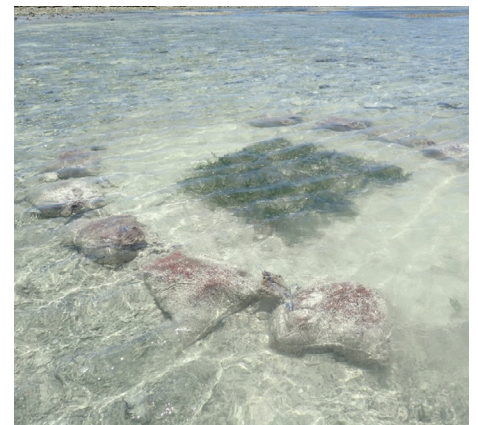
FIGURE 11

Replanted seagrass in wave active sites has been protected with hessian bags filled with rock.

Even though the ESIA indicated that the project will have an impact on the seagrass meadows, no mitigation measures were imposed. However, Van Oord implemented a seagrass pilot programme relocating a total of 640 seagrass sods of 0.125 m² from the reclamation footprint of Maradhoo, to three specifically chosen locations nearby Feydhoo. Van Oord has worked closely with local stakeholders to replant those sods in different patterns (see indicatively Figure 11) to examine the survivability of the pilot programme and to scale it up in future endeavours.

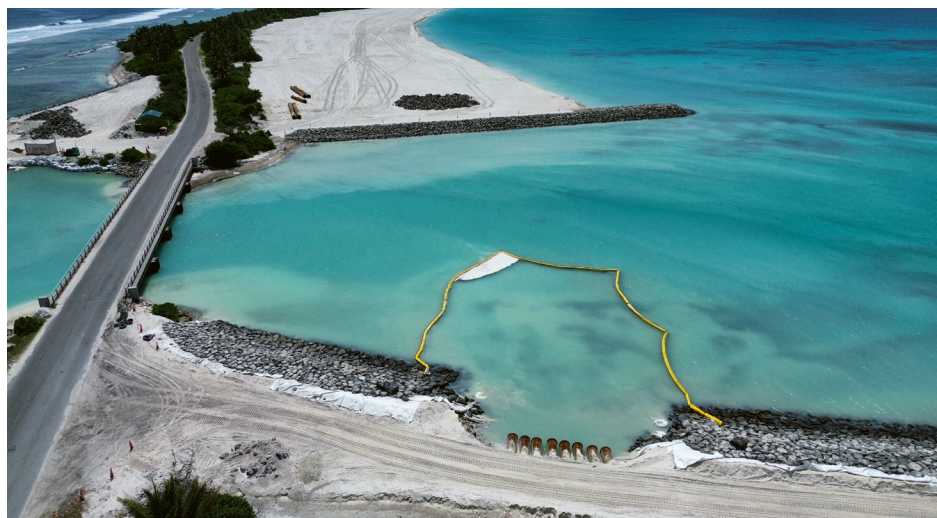
FIGURE 12

Installed silt screen for the Hankedere reclamation and the south groyne of Hithadhoo zone 2 reclamation.

Figure 12 shows the installed silt screen at Hankede reclamation. The outfalls consist of 8 pipes of 1 m diameter. The silt screen is placed around those pipes to further contain dispersion of sediments further away from the immediate vicinity of the reclamation outfalls. This limits the negative impact of sediment induced turbidity clouds originating from the reclamation works onto the coral reefs within the atoll. It is anticipated that the amount of suspended fine sediments that the silt screen would need to prevent from spreading increases as the reclamation filling progresses. As an indication, the turbidity just outside of the silt screen in Hankede was measured with a water quality EXO3 probe on 3 August 2023, one day prior to the completion of Hankede reclamation. The exact location of measurement was the

water column in front of the groyne located in the south of Hithadhoo zone 2 reclamation (Figure 12), 85 m from the silt curtain. Spot measurements on this location indicated turbidity of 37.53 ± 0.02 NTU, whereas the turbidity in the buoy in the British Loyalty Shipwreck did not exceed 3 NTU within the following days. It is safe to consider that the sediment that managed to pass the silt screen was deposited relatively fast, due to the low current speeds in this particular location.

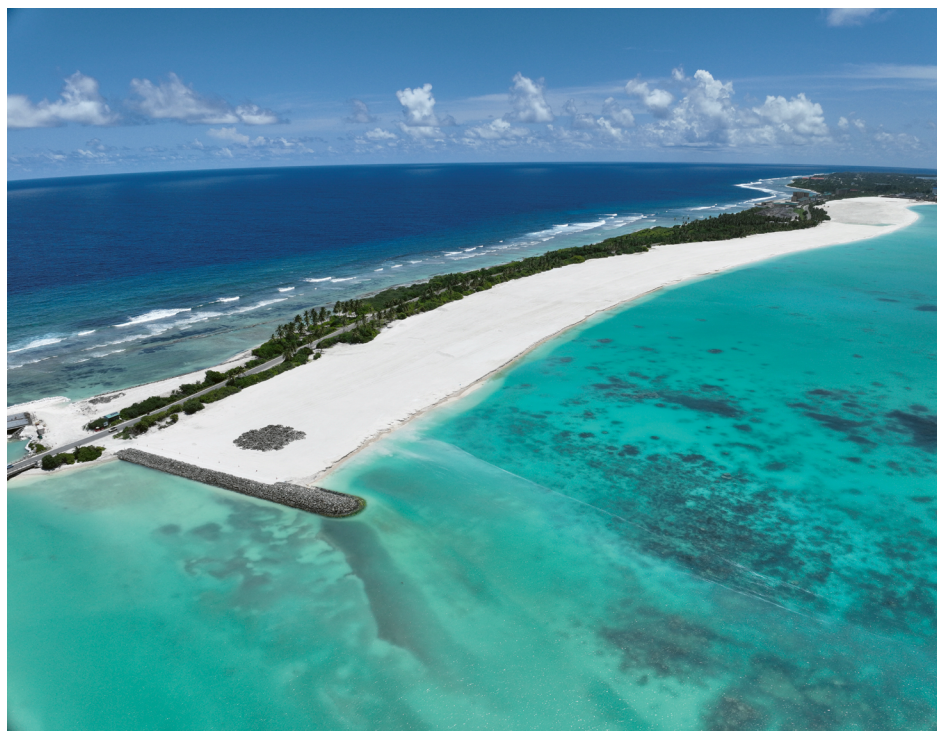
FIGURE 16

Reclamation at Hithadhoo zone 2 on 14 August 2023, with groyne constructed in the south of the reclamation and the natural beach started forming in the inner side of the atoll.

The reclamation in Hithadhoo zone 2 took place in several stages as indicated in Figure 16 due to its elongated shape, to accommodate the unobstructed execution of reclamation works and to accommodate the function of the Hithadhoo commercial port. Thus, Hithadhoo zone 2 reclamation started on 28 May 2023 and was completed on 1 August 2023.

The floating pipelines were installed on the southmost and the northmost locations of the footprint, whereas the reclamation outfalls were placed in the middle of the length of the reclamation, close to the marine protected area of the British Loyalty Shipwreck. The choice of the outfalls aimed at accommodating the efficiency of the reclamation execution. Even though the distance from the MPA is substantially small, the use of silt screens combined with the placement of an environmental buoy in the MPA (Figure 2) resulted in a thorough monitoring of the reclamation process and ensured that no turbidity exceedances were recorded within the British Loyalty Shipwreck area.

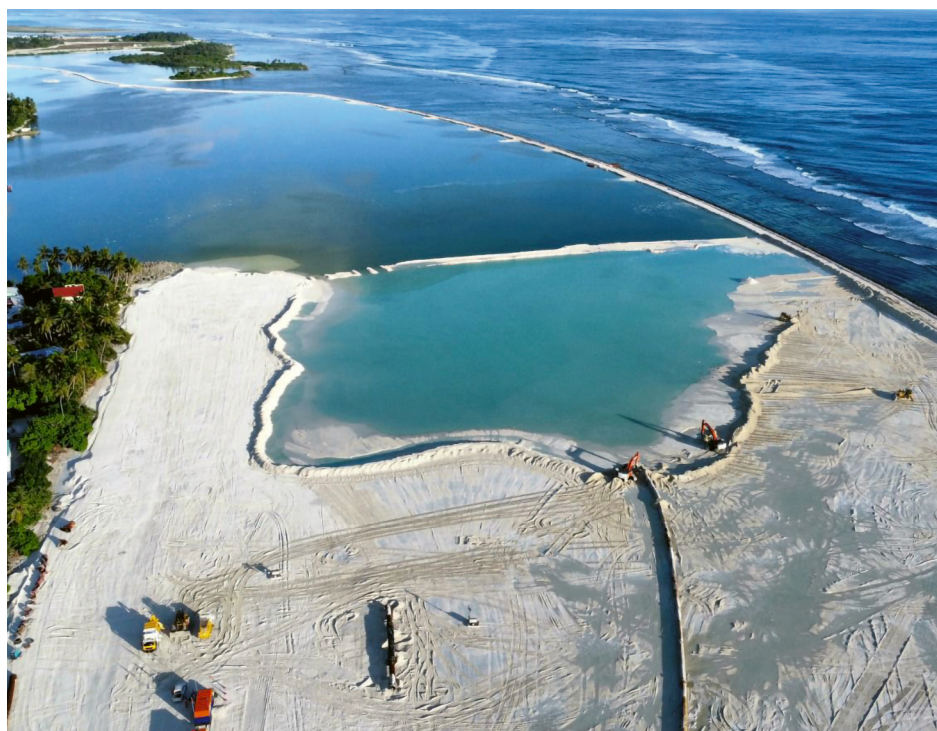
FIGURE 17

Maradhoo reclamation footprint progress on 12 June 2023 (floating pipeline discharging sediment mixture from the north).

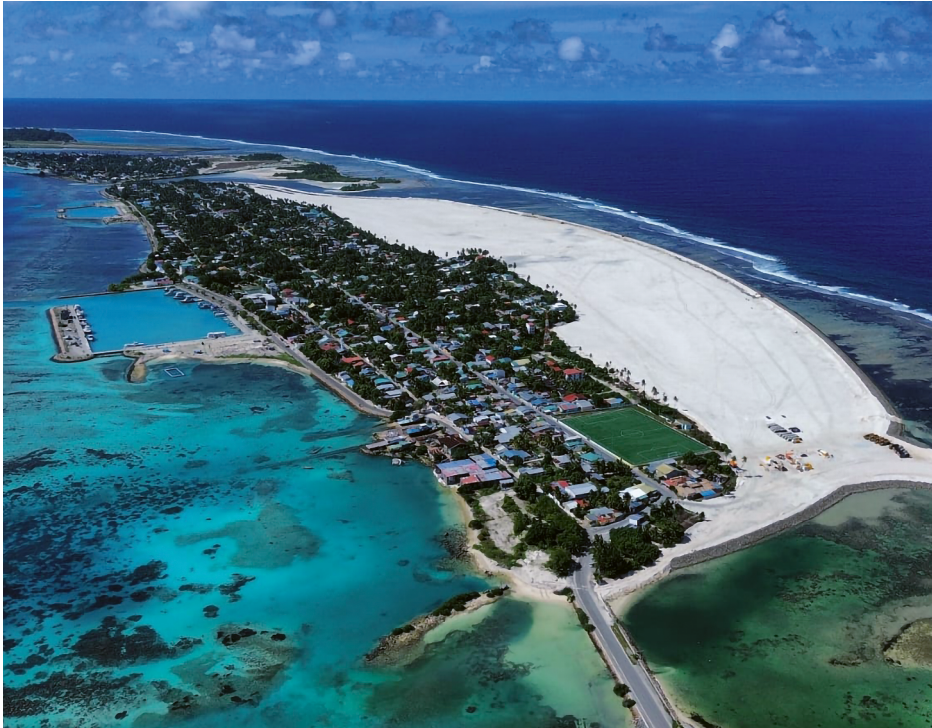
FIGURE 18

Maradhoo reclamation footprint on 14 August 2023 (drone photo taken from the north edge of the reclamation). The location on the north side where the floating pipeline cross the main street is indicated with red box.

Maradhoo reclamation was implemented between 31 May and 25 June 2023 (see Figure 18). The floating pipelines were placed from the inner atoll, crossing over the main street and discharging sediment mixture from the north (see Figure 17) and the south side of the reclamation, whereas the reclamation outfalls were placed midway in the enclosure sand and rock bund. The floating pipelines were protected with road humps made of sand, so that the reclamation could proceed according to plan and the traffic through Maradhoo–Feydhoo, Maradhoo and Hithadhoo islands remain unobstructed. As shown in Figure 17, an intermediate bund was constructed across the reclamation area to further assist in fine sediment containment from the offshore side of the atoll. Since the outfalls are placed in the offshore side of the reclamation, there was no possibility of using silt curtains for sediment containment in the last stage of the reclamation. However, the strong currents ensured that no sediment plume could possibly form.

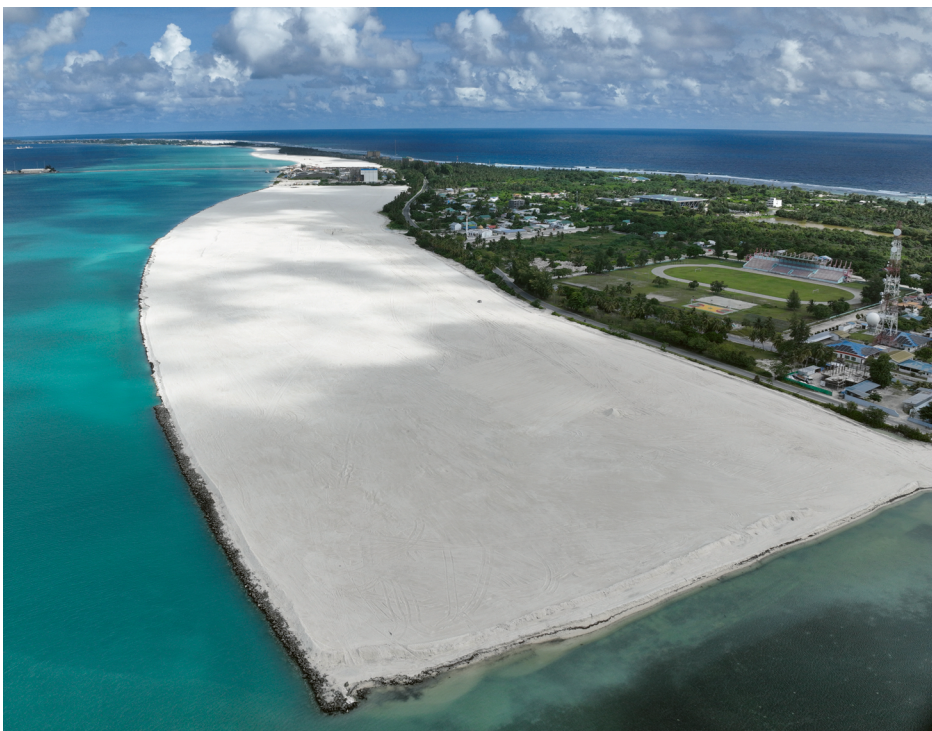
FIGURE 19

Hithadhoo zone 1 reclamation on 13 August 2023 (drone photo taken from the north side of the reclamation).

Hithadhoo zone 1 reclamation was executed between 1-17 July 2023. The floating pipeline was installed from the south side of the reclamation. It must be highlighted that this was the first reclamation completed with sediment taken entirely from the southeast borrow area, whereas Maradhoo and Hithadhoo zone 2 were filled by sediment coming both from south and southeast borrow areas. This is part of the general strategy to periodically switch borrow areas to control the sediment dispersion and the plumes generated locally due to the dredging operations. The reclamation outfall was placed in the midway of the rock bund enclosure and silt screens used to ensure containment of sediment dispersion further from the reclamation area.

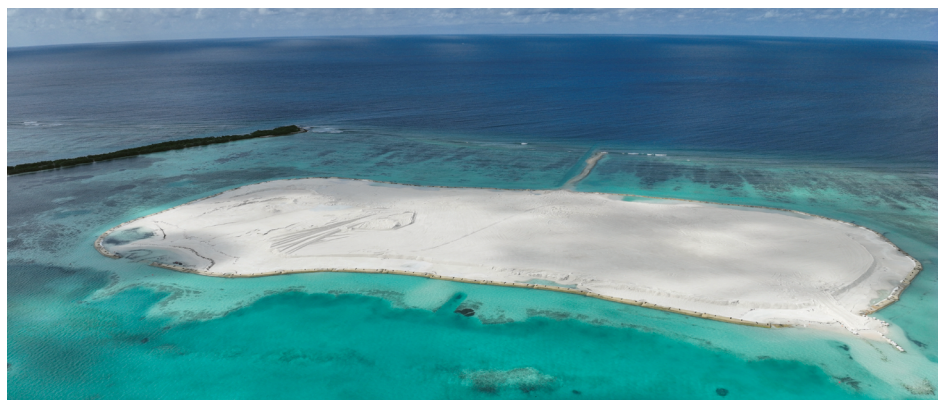
**FIGURE 20**

Resort island 1 reclamation on 13 August 2023 (drone photo taken from the south of the island). In the southwest of the island the opening used as the reclamation exit can be seen.

Resort islands 1 and 2 reclamations took place 18-23 July 2023 and 26-29 July 2023, respectively. Resort island 1 was filled with sediment from southeast borrow area, whereas resort island 2 was filled with sediment from south borrow area, once again to maintain low turbidity generated by the dredging operations. As previously indicated, the enclosure of the reclamation footprint was accomplished by sand-filled geotextile tubes. The final design of the islands included two layers geotextile tubes, one placed on top of the other. The enclosure was made by installing the first layer of the lower tubes. However, in the circumference of the enclosure, one geotextile tube in the west/southwest of the islands was not placed to serve as the reclamation exit, which was covered by silt screens. The resort islands 1 and 2 after the completion of the reclamation procedure can be seen in Figure 20 and Figure 21, respectively.

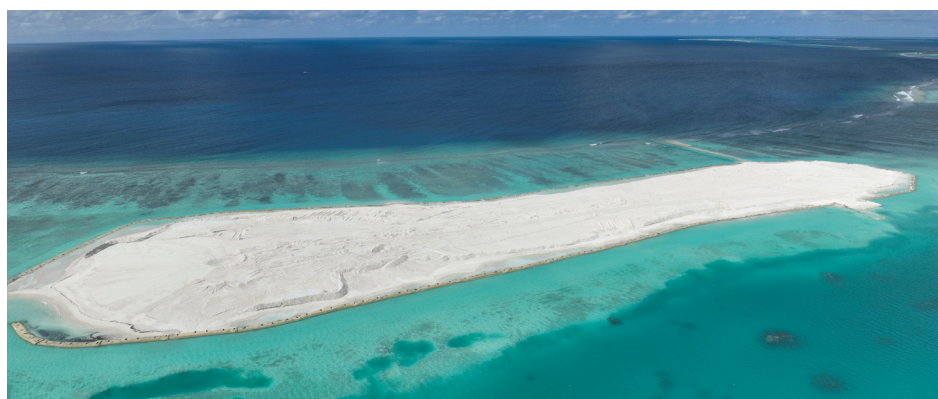
**FIGURE 21**

Resort island 2 reclamation on 13 August 2023 (drone photo taken from the south of the island). The opening used as reclamation exit is visible in the west of the island.

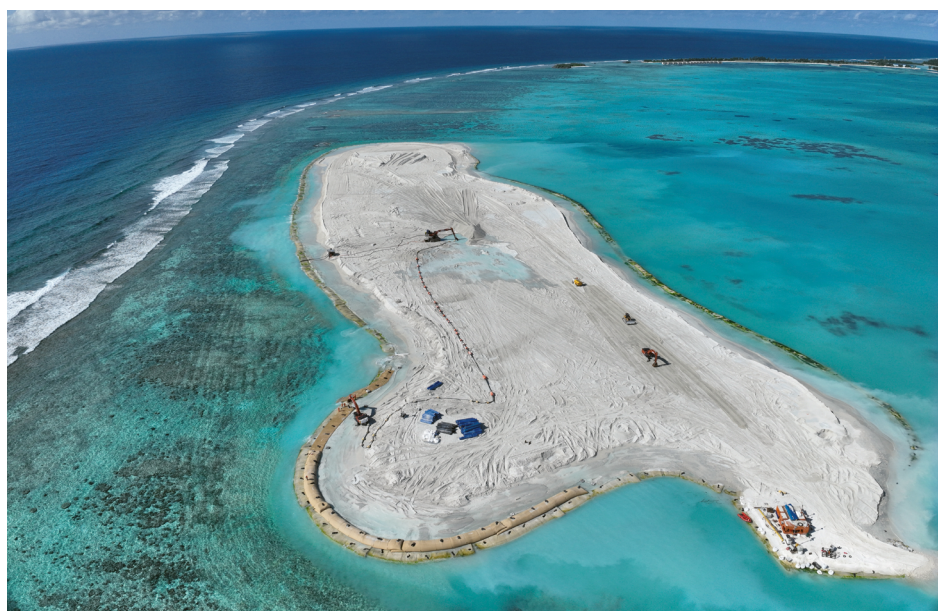
**FIGURE 22**

Resort island 3 reclamation footprint on 14 August 2023 (drone photo taken from the west of the island). In the lower left of the photo you can see the second layer of geotextile tubes being installed.

Final stage of the reclamation sequence has been the execution of the resort island 3 (Figure 22) and the Hankede (Figure 23) reclamations. The enclosure of the resort island 3 consists of geotextile tubes whereas Hankede consists of sand bunds. Those reclamations collectively were executed between 1-7 August 2023. The major reason for this choice was that for resort island 3, even after creating the enclosure, it was not constantly above water. Thus, the only possibility of executing a closed reclamation, where the sediment mixture would stay within the area of the island would be if the reclamation took place during low tide. The rest of the time, sediment mixture was placed in Hankede reclamation. Silt curtains were used here as well to contain sediment dispersion.

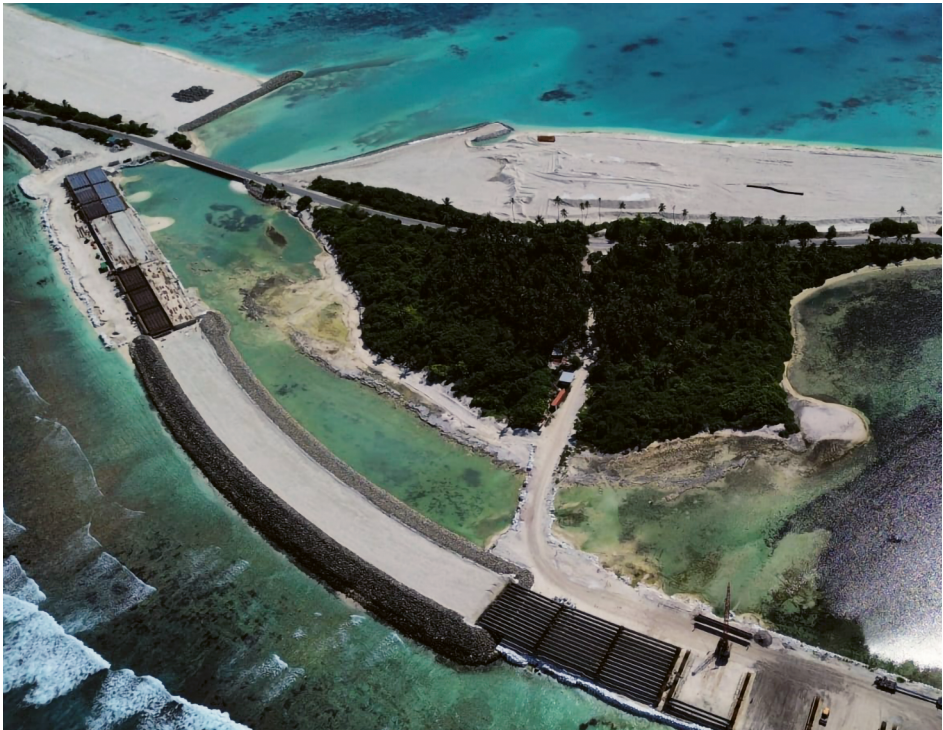
FIGURE 23
Hankede reclamation completed on 14 August 2023.
