D. Rakhorst, D. de Wilde and C. Schot

# Seaward Coastal Defence Scheme Eierland

As early as the 12th and 13th centuries, the united sand barrier in the north of The Netherlands, divided into the separate islands such as Texel and Vlieland known as the Wadden Isles. The coast of Eierland in the NW corner of the Isle of Texel has been eroding for more than a century, and since 1979 this has been subject to sand replenishment.

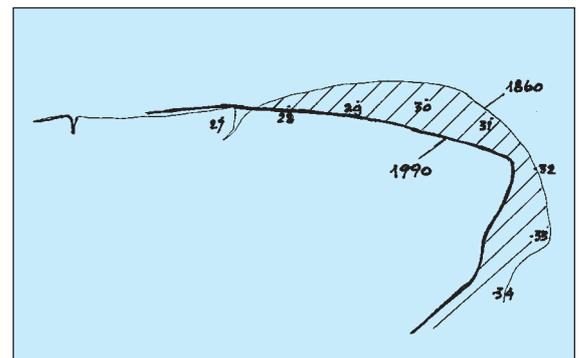
Figure 3. The coast of Eierland has been eroding for more than a century; shown here erosion between 1860 and 1990.

The Wadden Isles in the north of The Netherlands were originally a united sandy barrier. As a result of storms in the 12th and 13th century a channel originated between the islands Texel and Vlieland. Also Eierland became a separate island; the construction of a driftsand dam in 1630 reunited it with Texel again (Figure 3).

In time a sandy area formed in front of this dike which is presently known as the Slufter area. Because of this barrier, the flow rate in the Eierlandse Gat increased, the Head of Eierland eroded and the Vliehorst increased in strength. From 1700 to the beginning of the 20th century there was a balance in the situation around Eierland, even though there was an enormous coastal increase between 1850 and 1880.

Since 1880 the coast of Eierland has been eroding, presently at about 6 to 8 metres a year. The most important reason for the erosion is the tidal currents between Texel and Vlieland. At high tide the water flows in along the top of Texel and carries the sand away from the coast of Eierland. At low tide the water flows out through a channel, the Engelsmangat, centrally located between Texel and Vlieland, to an outer delta offshore the coast of Vlieland. Eventually waves carry this sand to the coast of Vlieland.

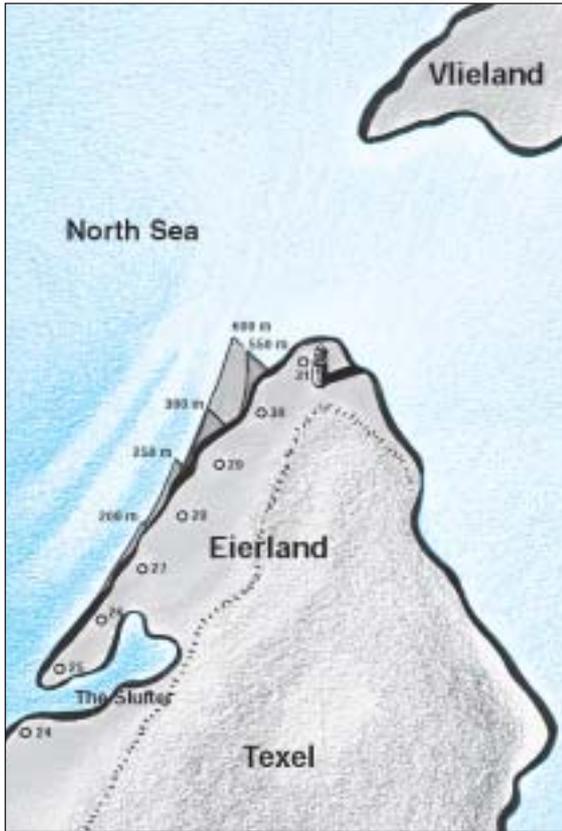
Figure 4. Combined dam solutions 2 and 4 at the head of Eierland, as explained in the text below.

Having established the cause of the coastal erosion, the search for solutions began (Figures 4 and 5). After the first wide-range selection, the following options were selected:

1. 1500 m dam at km 30.5
2. 600 m dam at km 30.5
3. 600 m dam at km 30.5 and 800 m dam at km 29.5

4. Beachhead series consisting of:
  - 550 m dam at km 30.5
  - 300 m dam at km 29.5
  - 250 m dam at km 28.5
  - 200 m dam at km 27.5

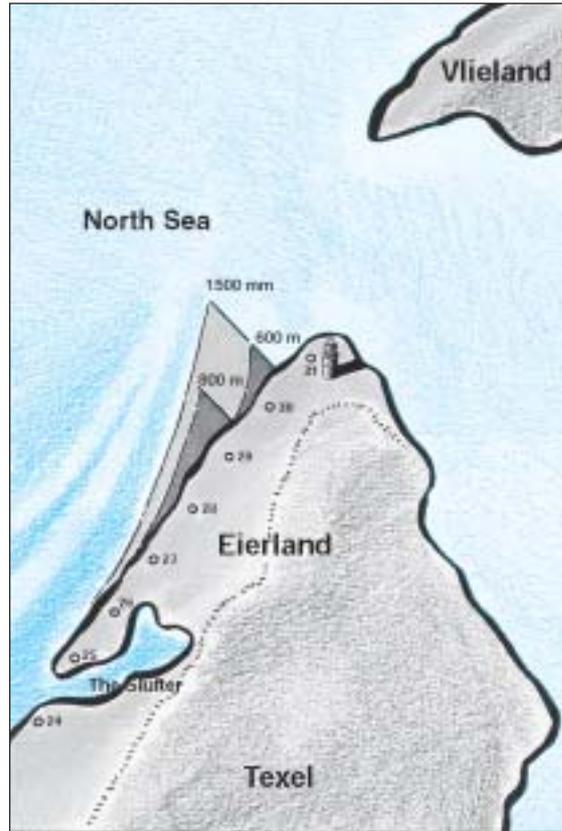
Figure 5. Combined dam solutions 1 and 3 at the head of Eierland, as explained in the text below.

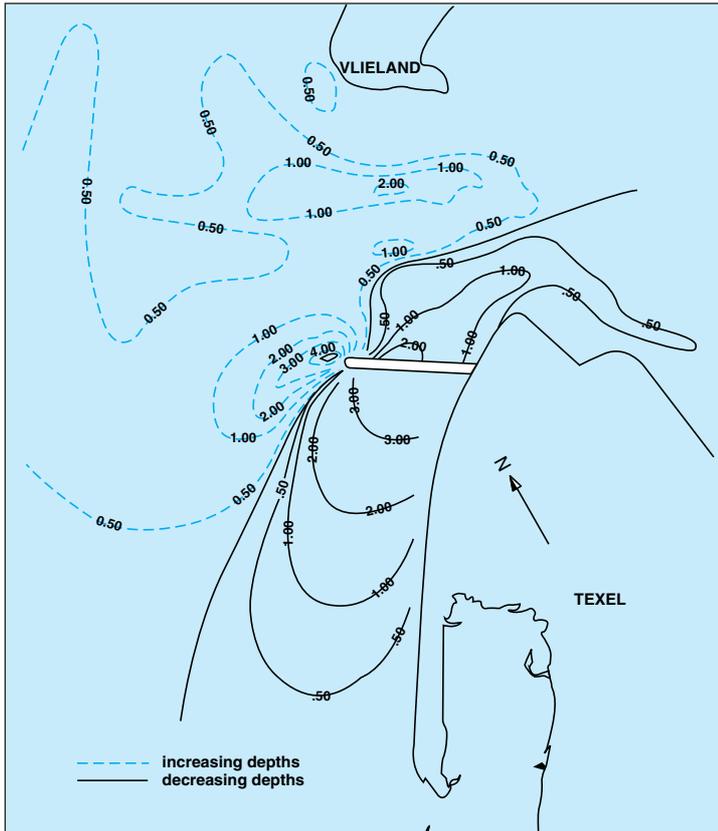
Figure 6. Sea bottom changes in metres as a result of a 1200-metre-long dam, according to a Delft Hydraulic Laboratory SCOUR model.

This is caused by the strong coastal curving at km 30.5. In all solutions the sedimentation is rather sluggish and will have to be (at least temporarily) supplemented. There need not be any concern about the sedimentation of the Slufter mouth. An erosion hole will appear in front of the dam. Since there will be hardly any change in the discharge of the Eierland sea outlet, the present balance of the inner delta will be maintained. However, several changes in the outer delta may occur, especially if the dam is longer and closer to the Head of Texel. Since the sand supply will be partially stopped, one can assume that the sedimentation of the NW sector of the inner delta will diminish or even stop (Figure 6).

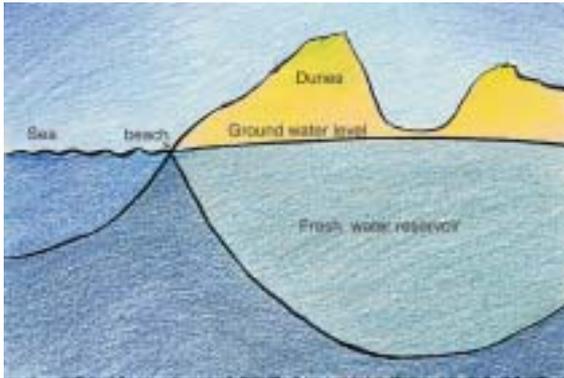
Figure 7. Groundwater level in the present situation.

None of the measures will cause serious ecological changes in the inner or outer delta. The shoals and channel areas will remain the same. Also the Slufter area will barely be influenced. The main change will be the creation of a foreshore. A small dam will yield a small foreshore, a large (lengthy) dam will supply a large one. The existence of a foreshore will, however, raise the groundwater level in the nearby dunes. The result being a wetter dune area and possibly dune lakes will appear (Figures 7 and 8).

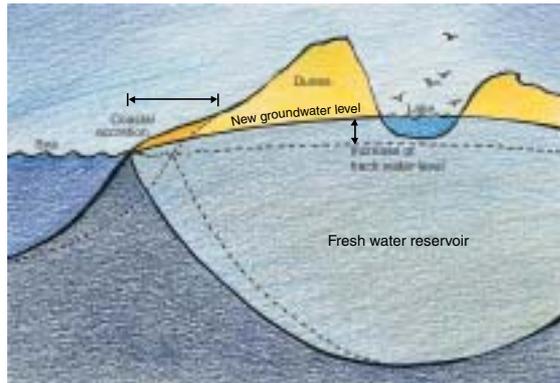
Figure 8. Groundwater level rise in a situation altered by coastal accretion.

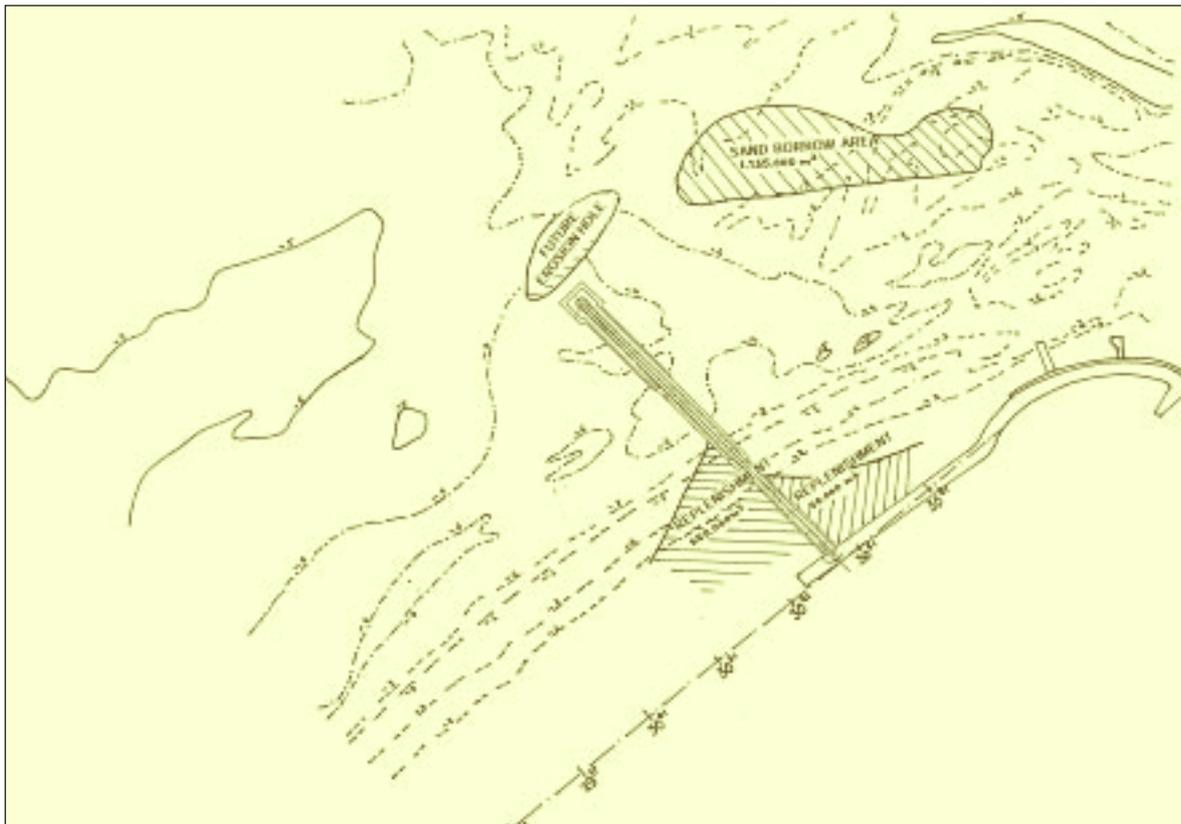
Figure 9. Drawing with chosen solution and morphological intervention.

Starting point was a dam length of 550 m, from the most seaward MLW-line. Up to the foot of the dune the total length of the dam will then be 800 m.

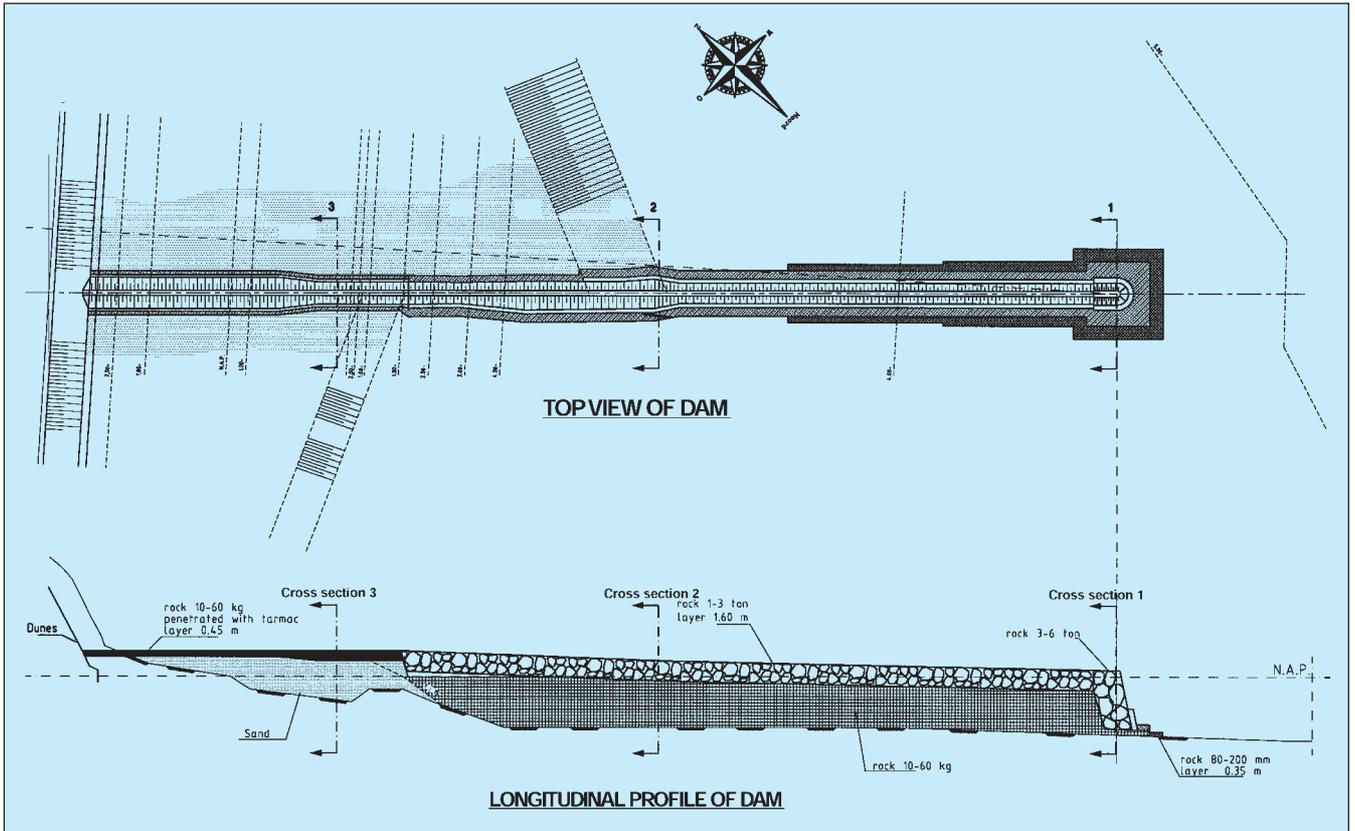
Figure 10. Top view and longitudinal profile of the dam.

Calculating the realistic slopes of the underwater sea-shore, an approximate 300 m seaward displacement of the MLW-line was found. Accordingly a shore inclination of 1:100 needs a foreshore of approx. 250 m at NAP +1.5 m. In this section the dam will be at a height of about 0.5 m above foreshore level, to assure that the sand will be retained. This height is further necessary to keep the water from flowing across the dam. (About once a year NAP +2 m will be surpassed.) The head of the dam will be at NAP +0.5 m. This dam height was established mainly because of the demand to make the dam passable most of the time. At the same time eventual sand transport across the dam is negligible. The height incline of the dam is gradual, from NAP +2 m to NAP +0.5 m (see Figure 10).

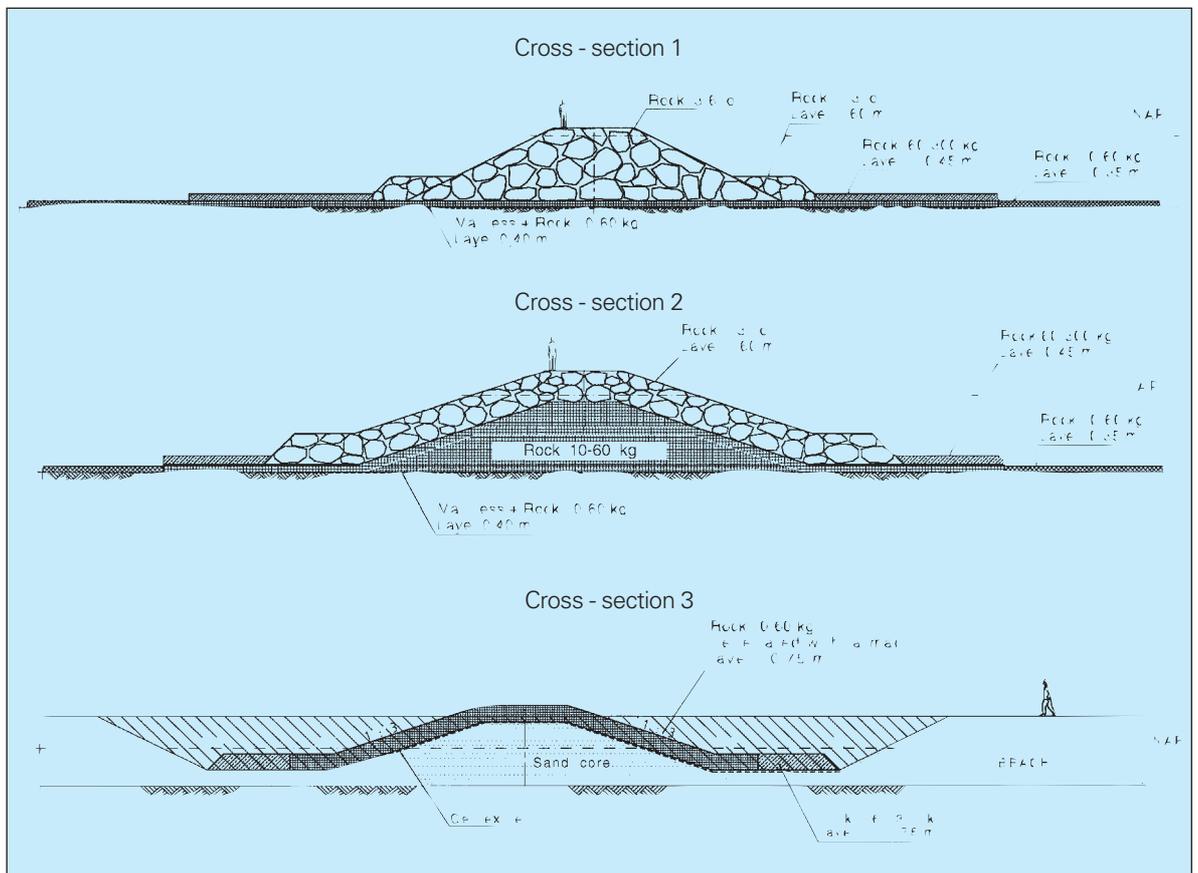
Figure 11. Cross-sections indicated in Figure 10 are shown here: 1) at the head; 2) in the middle section; and 3) at the beach.

- beach: sand body covered by rock fill penetrated with asphalt, in order to obtain a strong and inexpensive cross-section;
- body: rockfill with core, because of tight and cheap construction; and
- head: one type of rock fill, because of solidity and the lesser importance of sand tightness.

Figure 11 shows three cross-sections: one is a cross-section at the head; two is a cross-section in the middle; and three is at the beach end.

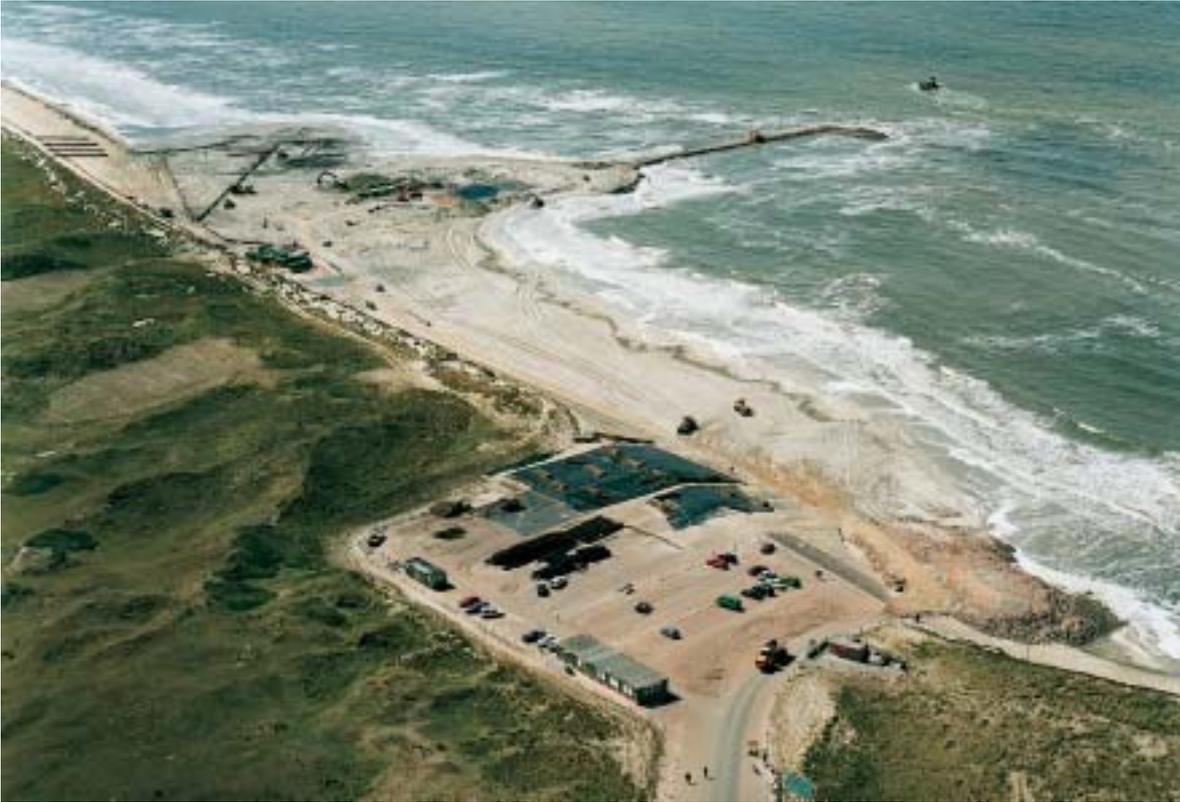
Figure 12. Work in progress at the Eierland dam as at May 1995.

The beach replenishment in 1994 has been executed by a contractors joint venture, consisting of HAM-Van Oord Werkendam bv, Boskalis Oosterwijk bv and D. Blankevoort bv. The project of the dam was tendered on 16-12-1994 and awarded to the contractors joint venture; HAM-Van Oord Werkendam bv., P. Daalders Contracting Company bv and Van Oord-ACZ bv. The construction was completed on 01-10-1995 (Figure 12).

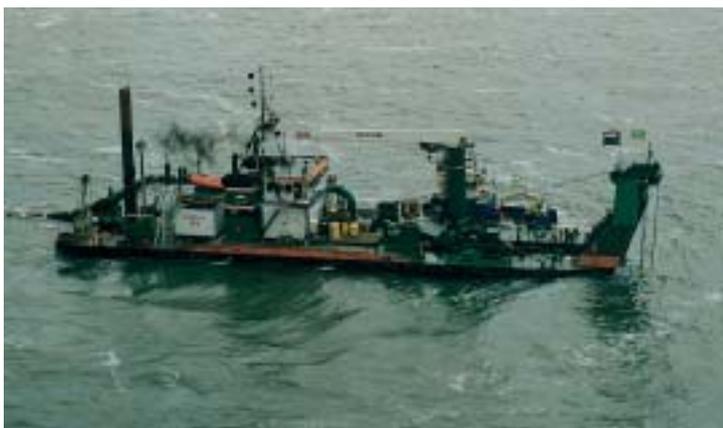
Figure 13. Cutter suction dredger Slidrecht 34 was used for beach replenishment at the start of the construction.

In 1994 already  $1.3 \cdot 10^6 \text{ m}^3$  of the replenishment of  $2.0 \cdot 10^6 \text{ m}^3$  had been placed. This sand was reclaimed by trailing suction hopper dredgers from a borrow area off the centre of Texel below the NAP -20 m line. In 1995 the remaining  $0.7 \cdot 10^6 \text{ m}^3$  of the replenishment was placed and another 0.3 million cubic metres in the neck of the dam. The latter 1 million cubic metres has been placed in seven days and has also been used to make the beach passable for construction equipment. This was borrowed by the cutter suction dredger Slidrecht 34 from an area between the future scour hole at the head of the dam and the Robbengat. In reality 100,000 cubic metres of extra sand was placed free of charge, as a result of the less expensive way of execution (Figure 13).

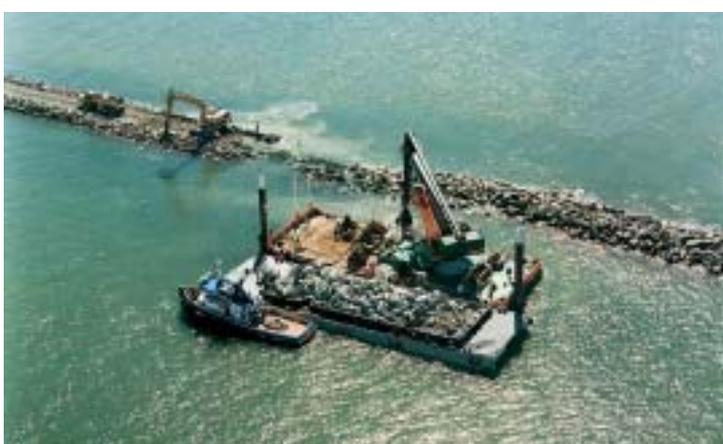
Figure 14. Close up of stone dumping on the dam.

Figures 14 and 15 show the site during the execution period. This part of the dam with a length of 275 m has been executed by excavating the (heightened) beach. On the excavated sand profile a polypropylene filter cloth with reed cover has been placed topped by a layer of stone 10-60 kg. An asphalt mixture has been poured over and in between the stones. The berms have been finished off with stone 60-300 kg.

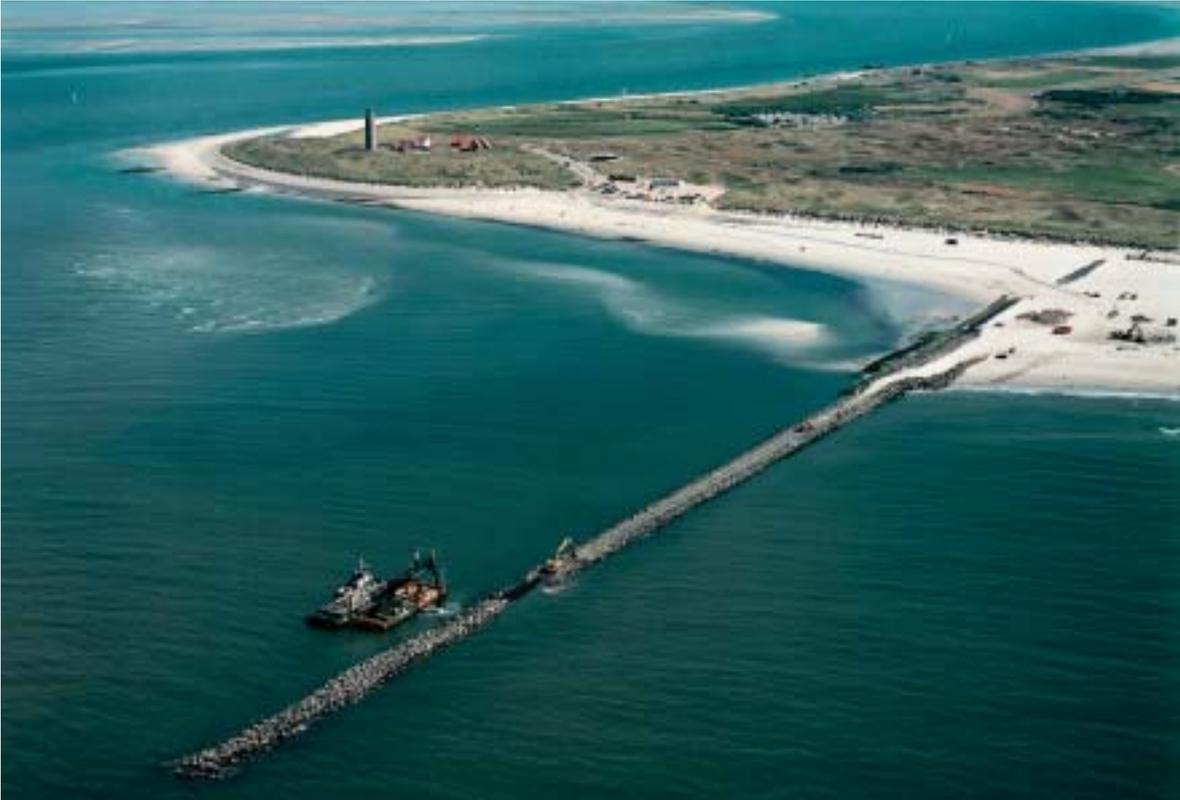
Figure 15. Overview of the Eierland dam as it nears completion.

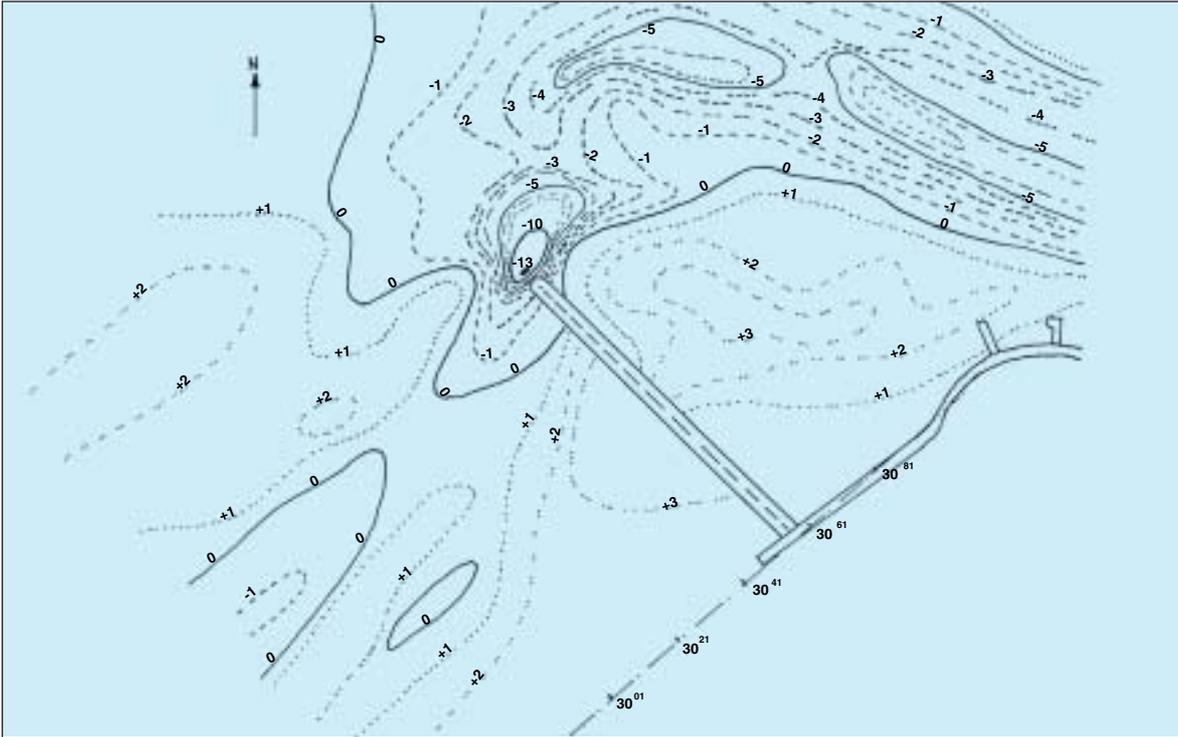
Figure 16. Sea bottom changes in metres as at December 1996.

Actual morphological developments are (Figure 16):

- a much deeper scour hole (up to NAP -18 m) than expected. This led to placement of an extra rubble layer, after the completion of the dam, and again at the end of 1996. Expectations were for a much wider and more shallow hole. Possibly because of the position in the outer delta which causes sand pressure, a smaller and deeper hole was formed;
