# MODERNISATION OF THE ŚWINOUJŚCIE – SZCZECIN FAIRWAY

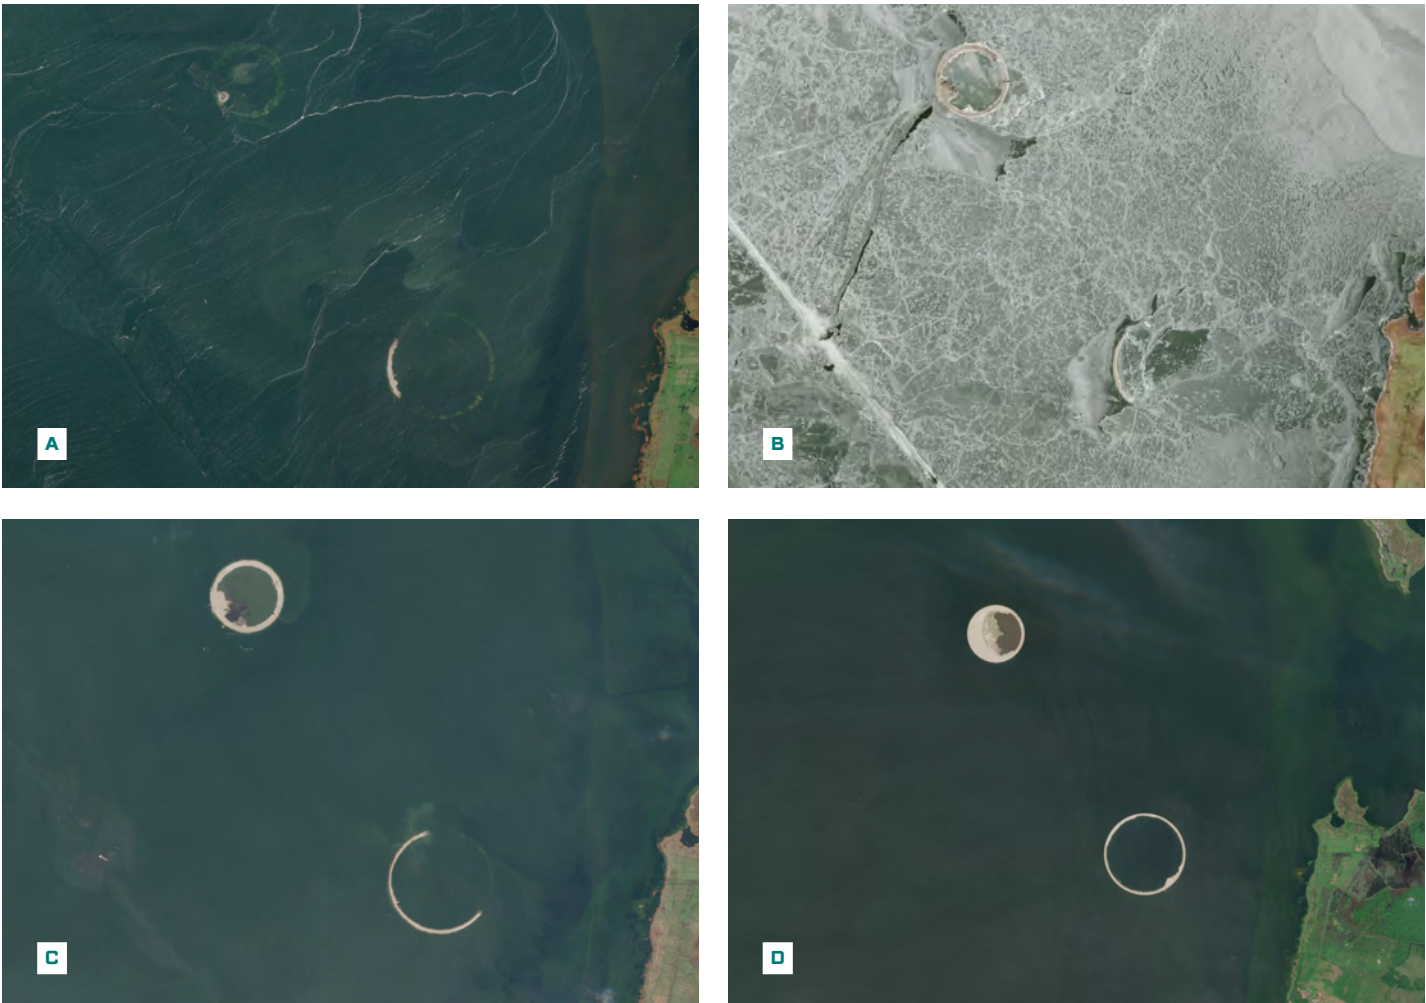
**FIGURE 1A-D**  
Artificial islands: A) October 2020; B) 2 February 2021; C) 3 April 2021; and D) 4 May 2021.

The construction sequencing of both islands, determined by the geotechnical stability and associated consolidation periods, is visualised with four satellite images shown in Figures 1A-D. Figure 1A, taken in October 2020, shows the submerged sand foundation layer at both islands. On the southern island, the western sector of the island was constructed above water first, since this part of the island required the longest consolidation period between the first and second above water

reclamation step. At the northern island, the above water operations commenced.

Figure 1B, dated February 2021, shows the first step of the above water reclamation works performed along the entire perimeter in the north. The status of the southern island remained unchanged compared to the first image. The picture shows ice covering the entire lagoon, which resulted in a short interruption of the reclamation works. Figure 1C, April 2021, shows the progress on the above water works in the south. And the fourth image (Figure 1D) shows the artificial islands at the time of hand-over to the client in May 2022.

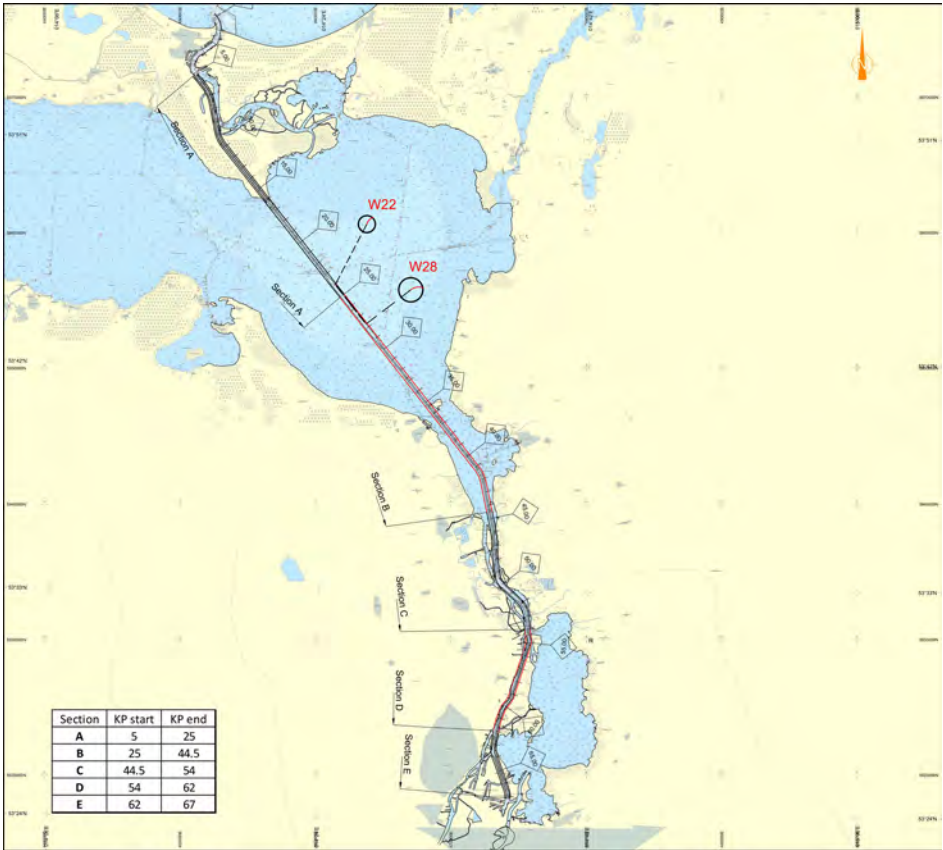
**FIGURE 2**  
Overview of UXO removal sections in project area.

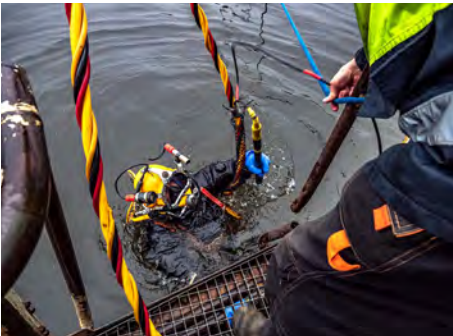
**FIGURE 13**  
UXO trained diver using handheld magnetometer.

Two different removal methods were used to execute the clearance works: removal by UXO trained divers with a handheld magnetometer and investigation and removal by means of a remote operating device (ROD).

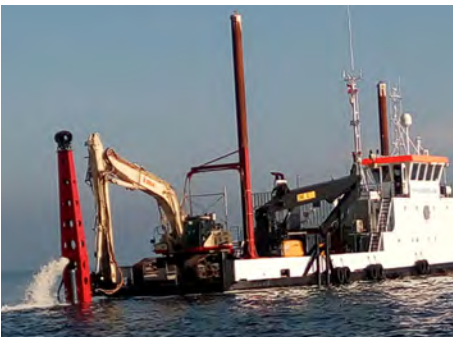
**FIGURE 14**  
Investigation and removal by remote operating device (ROD).

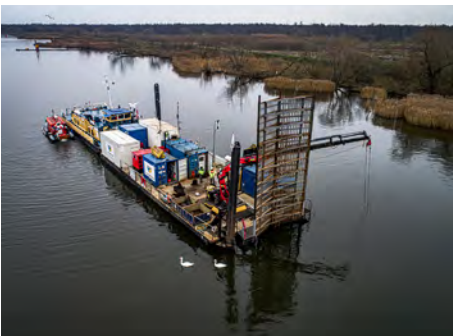
**FIGURE 15**  
Executing the clearance works in the fairway.

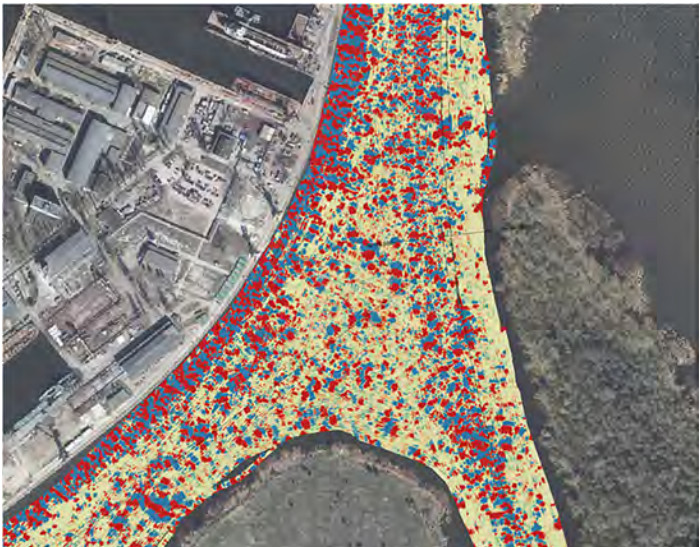
**FIGURE 16**  
Polluted areas showing the extensive amount of objects in the city of Szczecin.

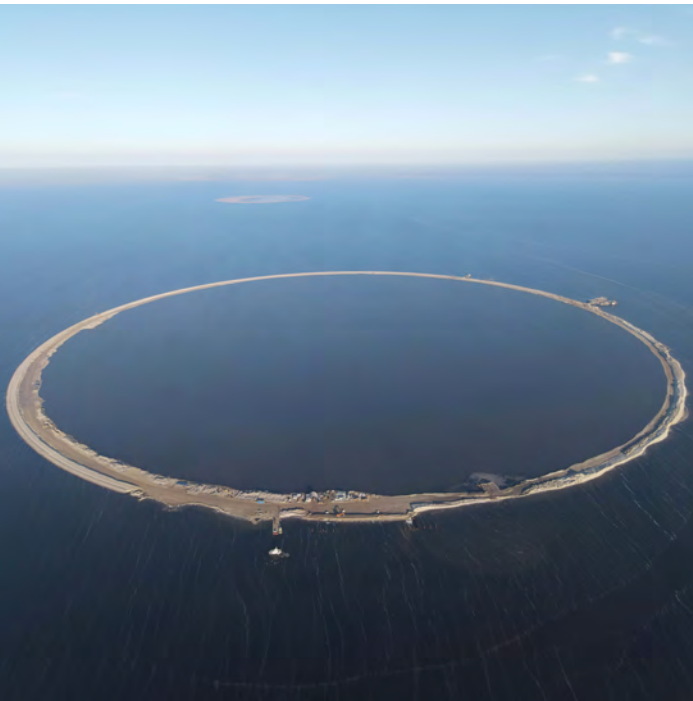
**FIGURE 20**  
New donut-shaped soil depot on the southern island.
